NILIM Research Report No.52

Initiatives by the National Institute for Land and Infrastructure Management in
Response to the 2011 Great East Japan Earthquake

Emergency Responses and Engineering Contributions by NILIM
for the Recovery from the 2011 Great East Japan Earthquake

National Institute for Land and Infrastructure Management
Ministry of Land, Infrastructure, Transport and Tourism, Japan

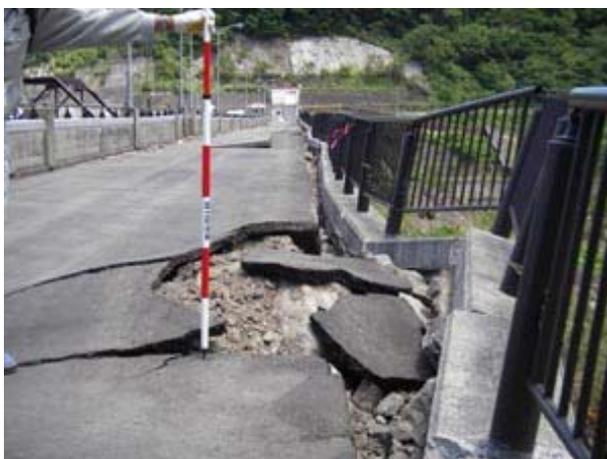
of the dam, the pavement was buckled and cracked and gaps appeared on the boundary between the parapet and pavement (Photo 3.3.4.3). The 3.11 earthquake left much smaller damage than that by the 2008 earthquake, despite some settlement of the dam body and widening of gaps at the foundation of a crest parapet due to structures buried in the dam body (the piers of the tramway left buried in the dam body at the

Photo 3.3.4.3 Crest of the Ishibuchi dam (earthquake of 2008)

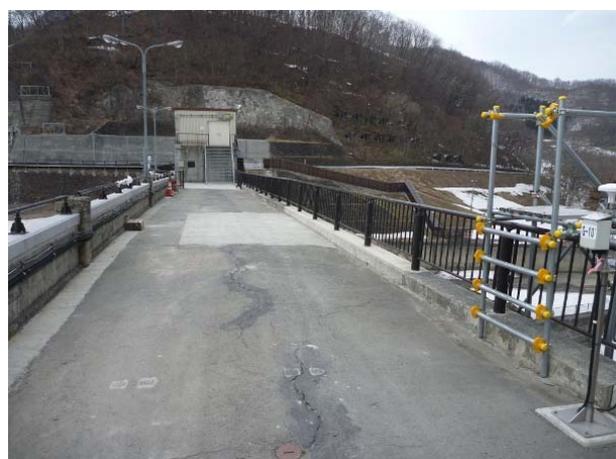
Photo 3.3.4.4 Crest of the Ishibuchi dam (3.11 earthquake)

* a trace of pavement repaired was caused by earthquake of 2008

time of construction) (Photo 3.3.4.4). Since a rather large settlement occurred at the Ishibuchi dam (approximately 55 cm near the maximum cross-section) due to the 2008 earthquake, continuous observation of displacement has been conducted using GPS sensors at the dam crest and various sites of the upstream and downstream slopes in order to monitor the movement of the dam body (Figure 3.3.4.4), and data were also obtained when the 3.11 earthquake occurred. Among such data, Figure 3.3.4.5 shows the result of the observation point G-9 of the dam crest at the maximum cross section. From the Figure, it is clear that the maximum differential settlement of about 12mm was caused by the 3.11 earthquake and a smaller scale of settlement occurred at the time of an aftershock (at a maximum of M7.1)

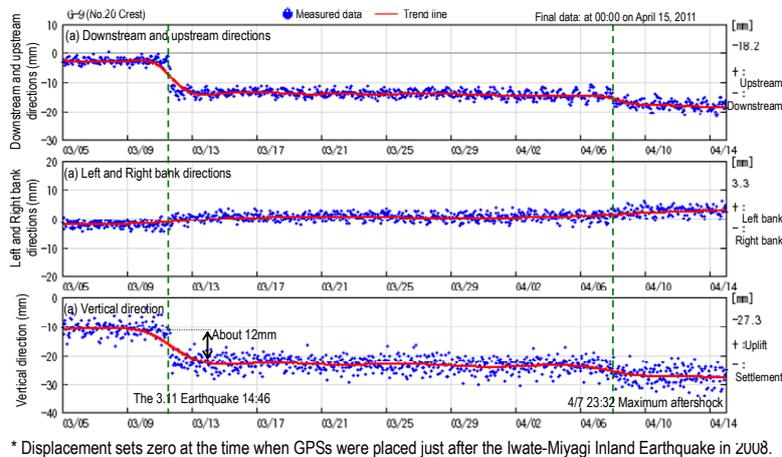
on April 7. From these data, it was found that there were no problems threatening the safety of the dam, because the earthquake-induced settlement was small and no damage was found on the cut-off wall surface at the upstream. An increase in the measured leakage (from approximately 2,000 L/min to about 3,000 L/min) reported from the special safety inspection was found to be caused by the blocking of the water level inside the channel due to adhering algae. Nonetheless, in order to take every possible measures to ensure safety, the manager has continued monitoring the data on leakage at this point and other points, and others and others.

Figure 3.3.4.5 Changes in displacement of Ishibuchi dam body observed by the GPS

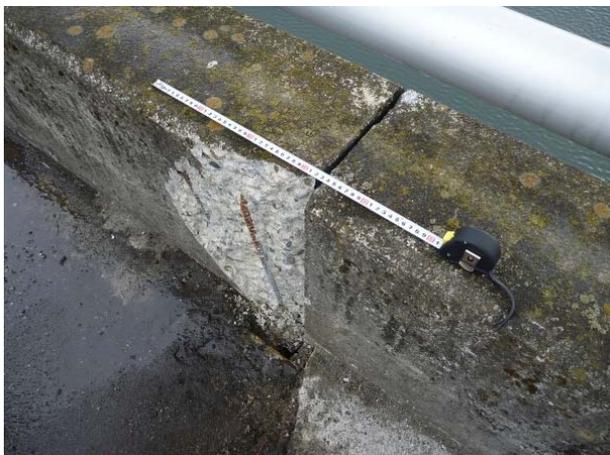
Tase dam (Figure 3.3.4.6) is a concrete gravity dam (with a height of 81.5 m) completed in 1954. The 3.11 earthquake increased the total leakage from 14 L/min to 69 L/min (Figure 3.3.4.7), and caused exfoliation of parapet concrete at the crest and opening of cracks and level differences on the crest pavement (Photo 3.3.4.5, Photo 3.3.4.6). As a result of the detailed investigation, it was concluded that there were no

problems threatening the safety of the dam from the fact that these damages were minor and leakage from each transverse joint was low at no more than about 10 L/min. However, since leakage from scuppers on the joint was observed, which had been nearly 0 L/min before the earthquake, the manager has continued monitoring the leakage with consideration to the relations with the reservoir water level in order to take every possible measure to ensure safety.

Photo 3.3.4.5 Exfoliation of parapet concrete (Tase dam)

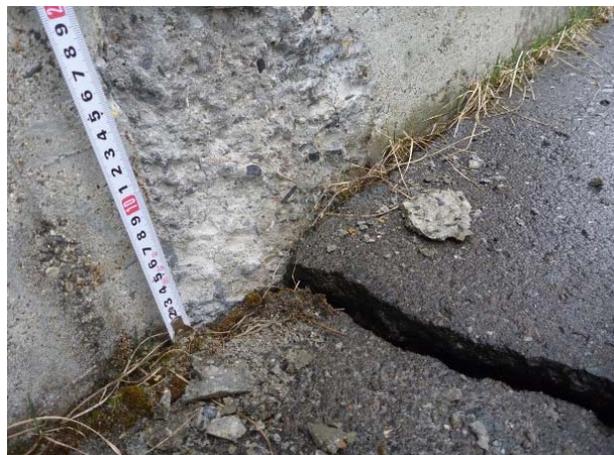
Photo 3.3.4.6 Level difference at joint of crest pavement (Tase dam)

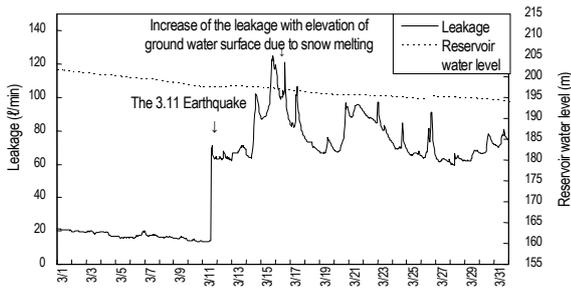
Figure 3.3.4.7 Leakage at Tase dam

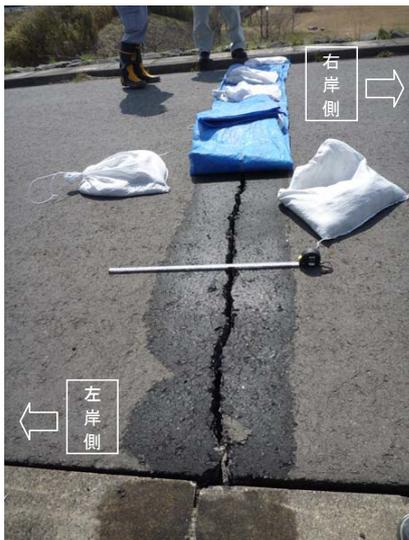
Photo 3.3.4.8 Cracks appeared upstream and downstream directions (Kejonuma dam)

subsided quite rapidly after that, and it has been stabilized at 50L/min since March 15 (Figure 3.3.4.10). The 3.11 earthquake caused a settlement of 13.9cm and deformation of 5.8cm towards the downstream direction near the center of the crest, where the maximum deformation was observed. At the crest of the dam body, several cracks were extended to the downstream and upstream directions, of which 2.5-3cm of cracks were observed on the left bank (Photo 3.3.4.8). There was an opening between the curb along the center to the left bank of the crest and the pavement (Photo 3.3.4.9). As for the investigation, there were no damages threatening the safety of the dam, however, continuous monitoring of leakage (seepage) is needed.

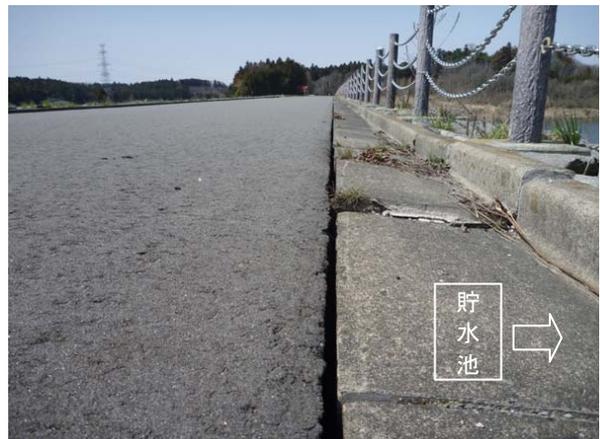
Photo 3.3.4.9 Opening between curb at the crest center and pavement (Kejonuma dam)

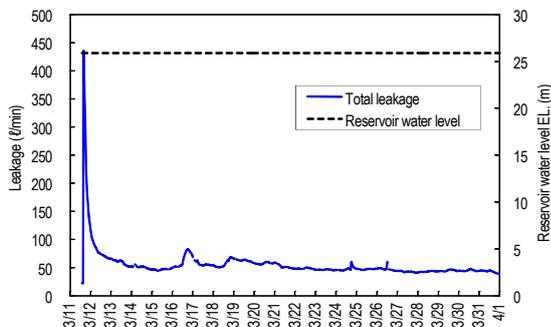
Kejonuma dam is an earthfill dam (with a height of 24.0m) completed in 1995. After the 3.11 earthquake, the total leakage (seepage) increased rapidly from 20L/min to 430L/min. At this dam, leakage is observed

at different locations: namely, the left bank, center, right bank and borehole. A large increment of leakage is observed at the right bank of the dam, with the increment from 7L/min to 290L/min. The leakage

Figure 3.3.4.10 Leakage at Kejonuma dam

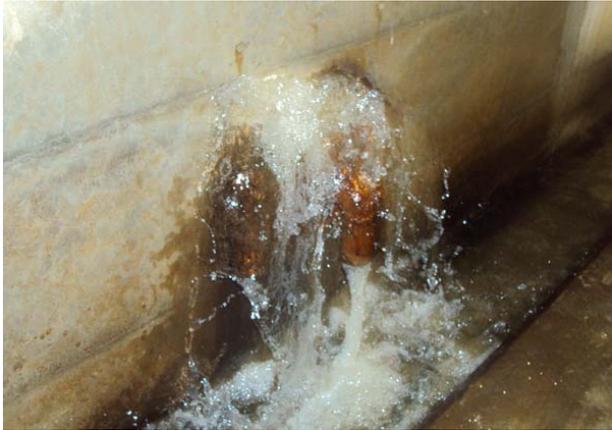
Photo 3.3.4.10 Leakage from the transverse joint (2J3) (Kamuro dam)

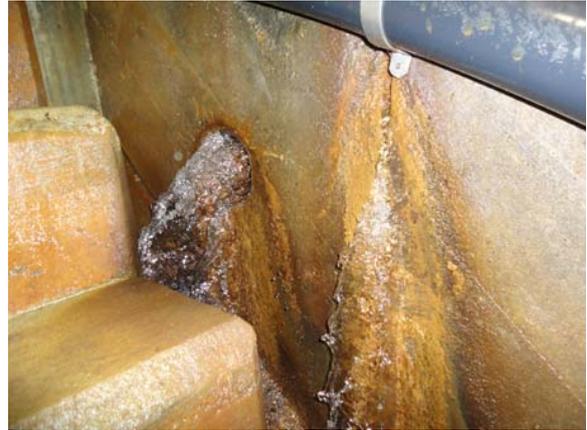
Photo 3.3.4.11 Leakage from the transverse joint (J9) (Takasaka dam)

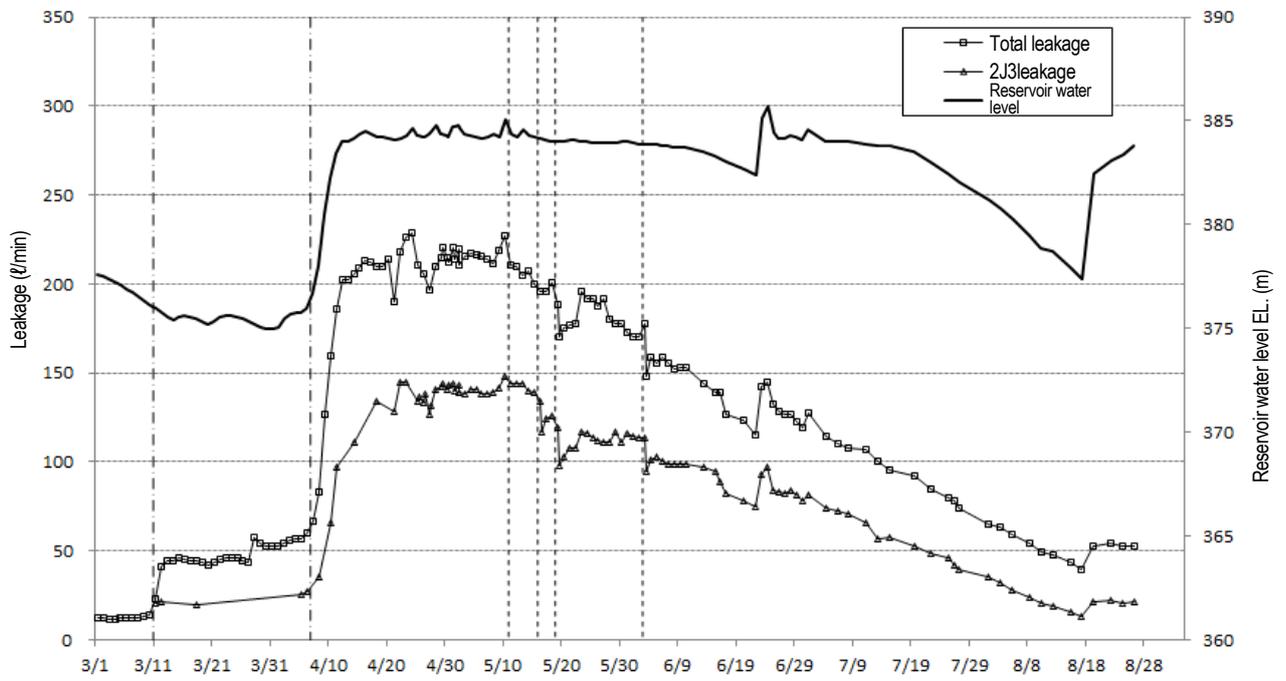
Figure 3.3.4.13 Time history of leakage at Kamuro dam

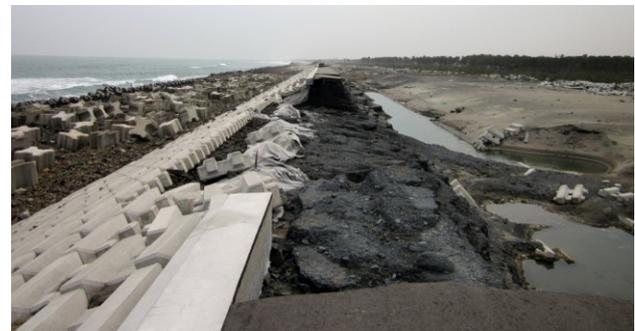
Earthquake found many cases where the landward slope toe was scoured (Photo 3.3.5.1); this suggests that the loss of base due to scouring led to the washout of landward slope armoring soil, the washout of body soil, and the final collapse of coastal dikes (Figure 3.3.5.4).

Photo 3.3.5.1 Partially Collapsed Three-Surface Armored Coastal Dike and Scouring Situation at the Landward Slope Toe (Kabasaki Coast, Iwanuma City, Miyagi Prefecture)

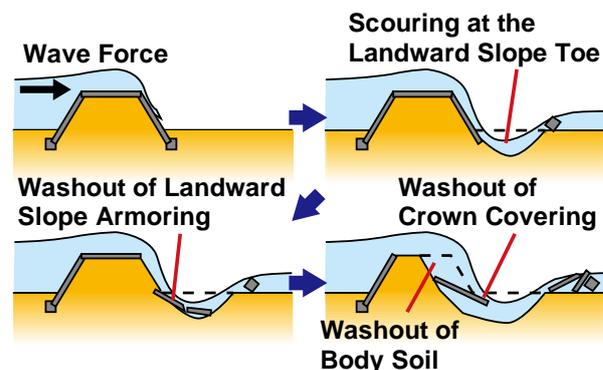
Figure 3.3.5.4 Collapsing Process starting at

Landward Slope Toe

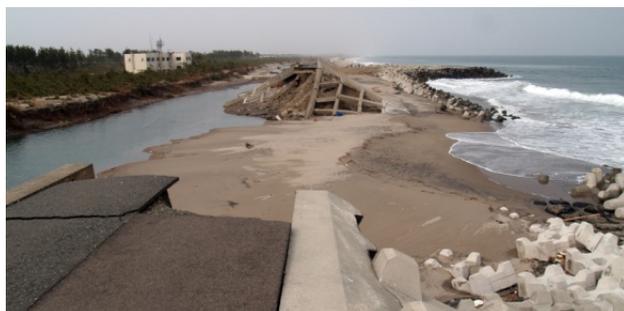
In the case (as shown in photo 3.5.5.2) where the armoring soil was partially lost, or a part of the base soil remained even though the dike armoring was completely lost, the dike was judged to be in a state of “partial collapse.”

Photo 3.3.5.2 Completely Collapsed Coastal Dike (Ninokura Coast, Iwanuma City, Miyagi Prefecture)

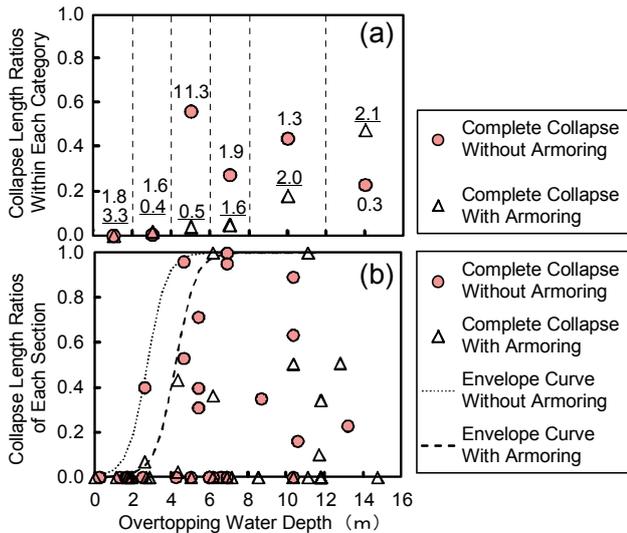
The investigation of 63 sections with a total length of 35.4 km focusing on the landward slope toe armoring suggested that, for an overtopping water depth of less than 12 m, toe armoring worked well to lower the complete collapse length ratio, as shown in Figure 3.3.5.6 (a). Investigations on each section showed a similar tendency (Refer to Figure 3.3.5.7 (b)).

Figure 3.3.5.7 Relation of Landward Slope Toe Armoring to Damage Severity

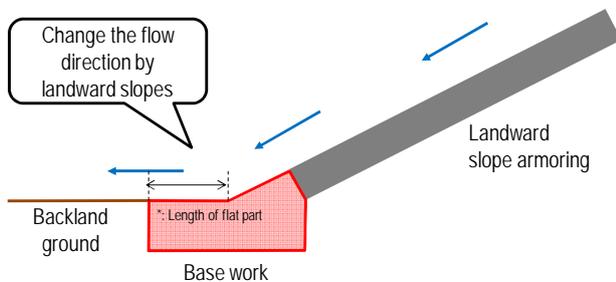
Figure 3.3.5.15 Proposed Improvement on Landward Slope Toe

Figure 3.3.5.15 illustrates a proposed structure for

having the overtopping water pop up at the toe; the key point is to completely alter the flow direction of the water stream coming down along the landward slope to such a direction (e.g. horizontal) that the water flow will not collide with the ground. Note that the model experiments revealed that a relatively flat part which is short compared to the water stream thickness will not sufficiently alter the stream direction, and that, on the other hand, an improved ground soil around the base supports the base, and furthermore the improved part and the base work together in an integrated way as a protection gear altering the stream direction to the horizontal direction, makes the scouring point move far from the toe, and finally lowers the occurrence probability of collapse starting.

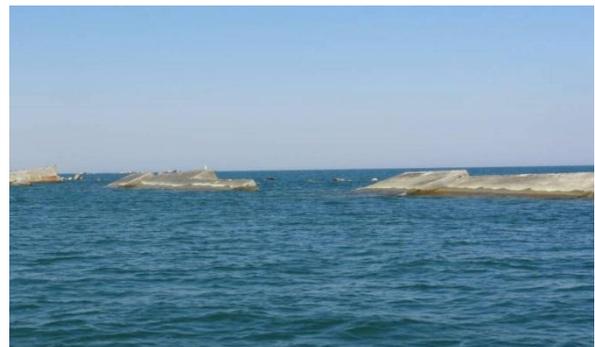
Photo 3.3.7.1 Soma port breakwater devastation state

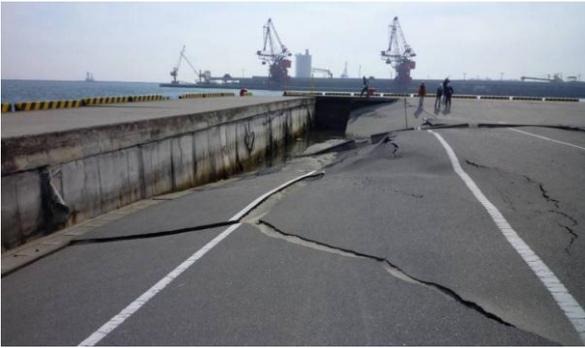
because most of the ports in Miyagi prefecture have thin sedimentary layers compared to the ports of Fukushima and Ibaraki prefectures, which may have prevented strong amplification of the earthquakes. Damage to the wharves was in the form of bulging of head line towards the normal seaward side (Photo 3.3.7.2), as well as sloping of the walls and collapse of the rear apron (Photo 3.3.7.3), etc.

Photo 3.3.7.3 Sunken wharf apron at Onahama Port

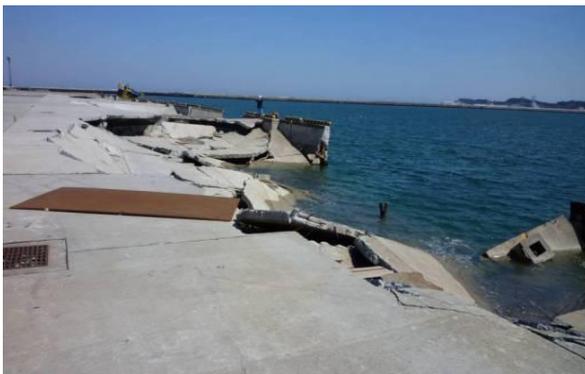
There was remarkable damage to the wharves at Soma and Ibaraki ports, due to seismic movements. Particularly at Soma Port, the wharf collapsed at many places. Apparently, first the seismic movements caused the wharf to bulge towards the sea side, and while the rear apron part was sunken, a rip current of the tsunami caused a huge water level difference, leading to the washout (Photo 3.3.7.4). There are very few examples of such extreme damage caused by the compound action of seismic movements and tsunami.

Photo 3.3.7.4 Collapsed wharf at Soma Port

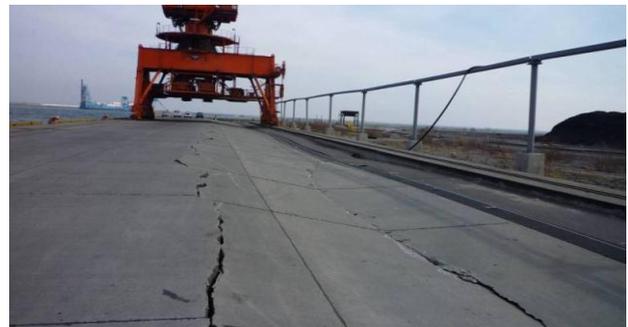
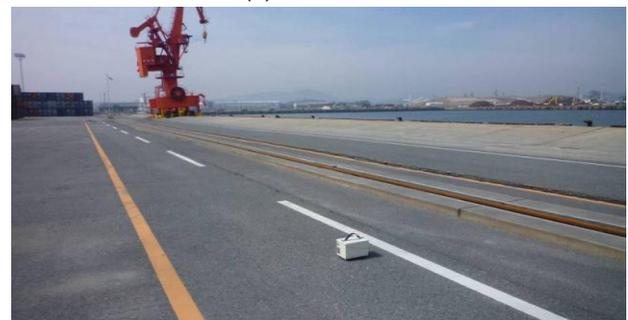
3.3.7.1. The peak frequency of micro-tremor H/V spectrum corresponds to the frequency greatly amplified by the earthquake. If the peak frequency of less than 2Hz can cause significant transformation of the wharf, an earthquake can easily cause damage. The peak recorded at Pier 3 was less than 2 Hz, while it was more than 2 Hz at Pier Otsurugi, which corresponds well with the scale of the damage to these sites.

(a) Pier no. 3

(b) Otsurugi Pier

Photos 3.3.7.5 Damage situation of wharf apron at Onahama Port

As a restoration measure response, advise was provided in response to a request received from the site at Onahama Port. Specifically, the caisson-type wharf at Onahama port was inclined, so the angle of inclination was checked and it was compared with a wharf that had restricted service due to damage caused by a previous earthquake. As for the base of cargo handling crane, the crane base at the land side could use a bearing pile, but the design documents confirmed that some piles were not reaching up to the base support, therefore, it was recommended to make a solid base in case of a need for urgent restoration. It was also suggested to move the sea side base landward, as the transformation of wharf causes the crane rail span to expand.

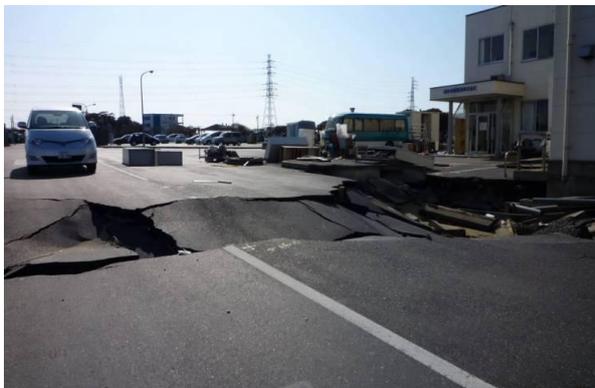
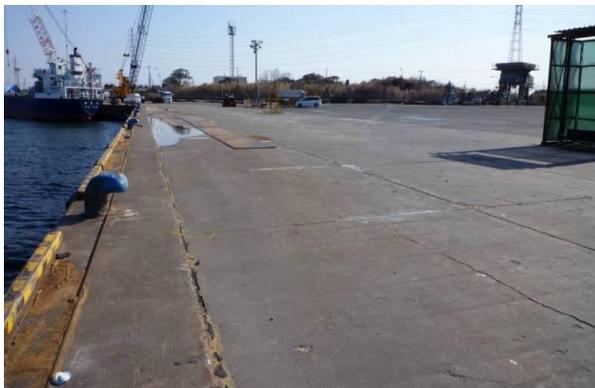
At Kashima Port, there was a huge contrast between the damage caused to Berths A-B and berths C-D berths at Nankokyo Pier. As shown in Photo 3-3.7.6, the paved surface around berths A-B collapsed, while there was no damage to the adjoining berths C-D. The micro-tremor H/V spectrum for both sites is shown in Fig. 3.3.7.2. The peak of H/V spectrum is not clear in berth D part, while the amplitude is not much above 1. This kind of micro-tremor H/V spectrum in normal times is characteristic of very favorable ground conditions, such as bedrock sites. On the other hand, the micro-tremor H/V spectrum in normal times of berth A part showed a clear peak of approximately 1.5 Hz, which corresponds to the huge damage.

(a) Berth A

(b) Berth D

Photo 3.3.7.6 Damage situation of wharf apron at Kashima port

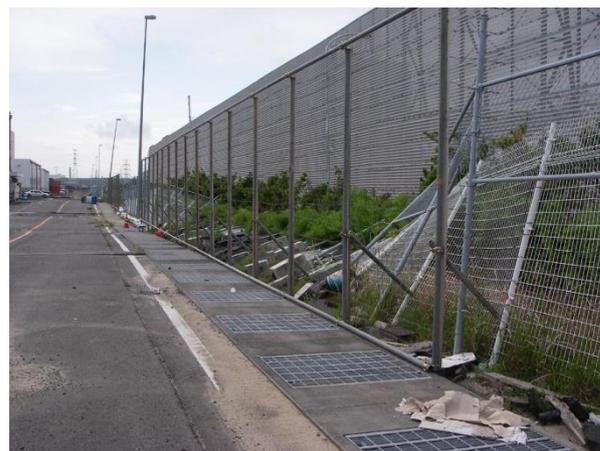
(a) Damage of fence (North pier section of Minato-district, Hitachinaka Port Area, Ibaraki Port, drifted containers were removed)
(Crown height of walls T.P. + 2.20m, Observed tsunami height T.P. + 4.32m)

Photo 3.3.7.7 Damage of tsunami-induced debris (cargo containers)

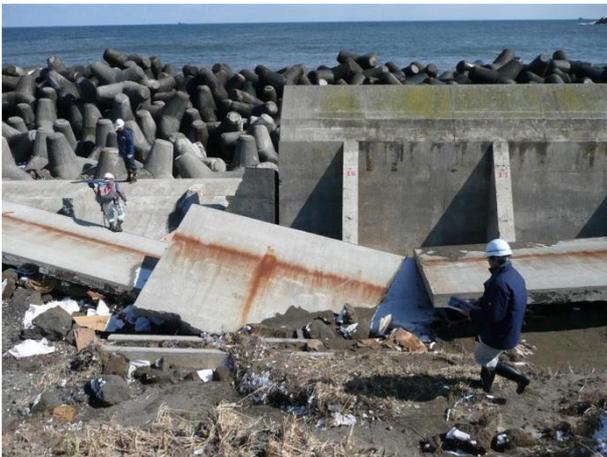
(a) Collapsed seawalls in Ichikawa district, Hachinohe Port

(Crown height of walls T.P. + 5.4m, Observed tsunami inundation height T.P. + 8.38m)

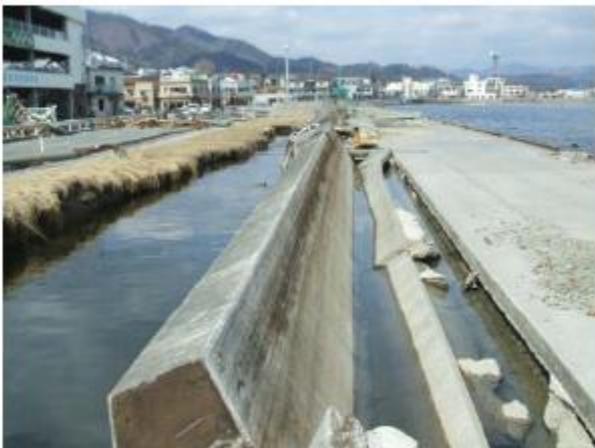
(a) Seawalls collapsed to landside (Chayamae district, coastal protection area in Ofunato Port) (Crown height of walls T.P. + 3.40m, Observed tsunami trace height T.P. + 8.07m)

As for the damage of seawalls, “collapse of main body” appeared with following failure patterns: 1-(1) development of cracks, 1-(2) damage due to collision of driftage, and 1-(3) removal of top part from joint of main body. Extent of damage was least in (1) and largest in (3). “Scouring and displacement of main body” appeared with the following failure patterns: 2-(1) slight scouring of paved ground in front and behind the main body, 2-(2) extensive wash away of ground due to

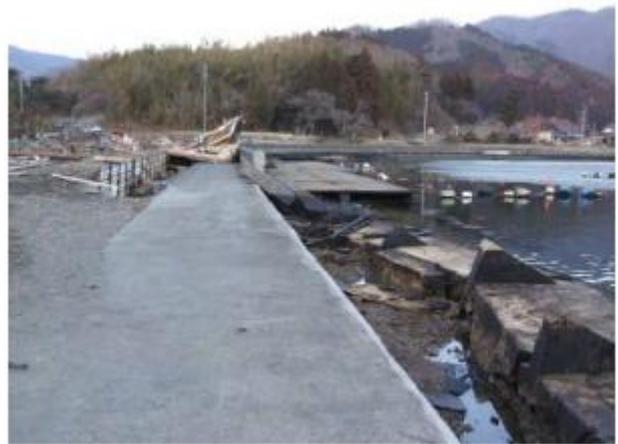
(b) Seawalls collapsed to seaside (Nagahama district, coastal protection area in Ofunato Port) (Crown height of walls T.P. + 3.00m, Observed tsunami trace height T.P. + 10.02m)

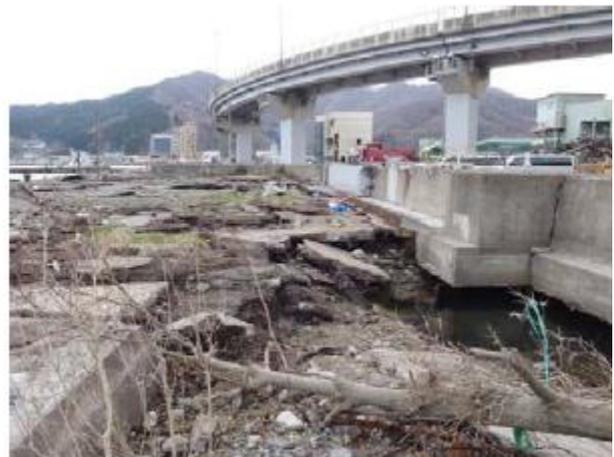
(c) Scouring observed on seaside (Suga district, coastal protection area in Kamaishi port) (Crown height of walls T.P. + 4.00m, Observed tsunami trace height T.P. + 8.64m) Photos 3.3.7.9 Tsunami damage to coastal protection facilities

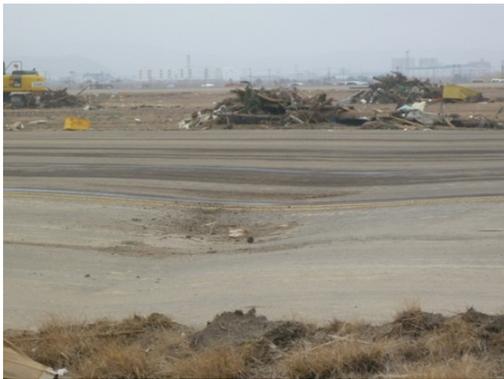
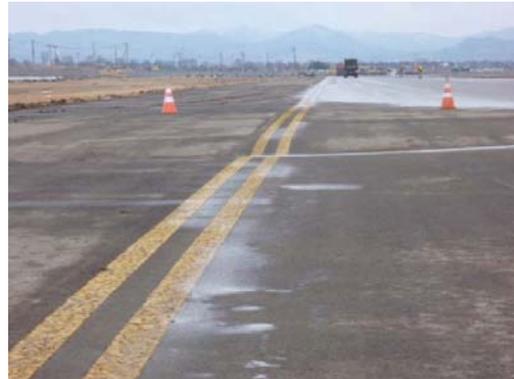
(a) Shoulder (forefront) and taxiway

(b) Shoulder (left) and taxiway

Photo 3.3.8.2 Status of Localized Settlement at the Road Intersection

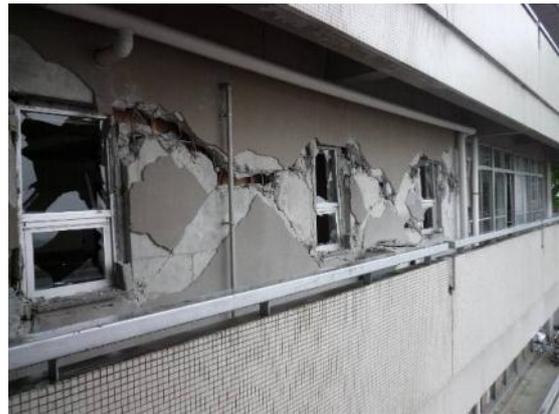
Photo 3.3.9.2 Shear failure of non-structural wall

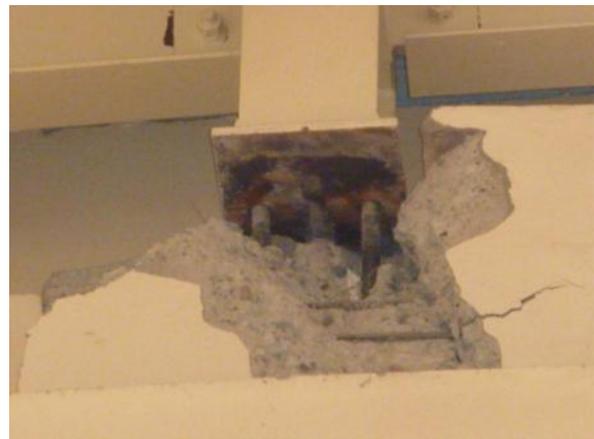
On the other hand, damage types (1) and (2) mentioned above were not seen in gymnasiums built by the current building codes (29 gymnasiums). They suffered damage of other types, namely (3) Abrasion or cracks in concrete at the joints (bearing support parts) of RC columns and Steel roof frames, (4) Deflection of roof horizontal braces, (5) Cracks in column base concrete, and (6) Others (overturning of floor struts, etc.). However, the damage level of these types was determined⁴⁾ as minor in almost all cases, except for 1 gymnasium which suffered moderate damage. Unlike the damage rate of gymnasiums designed by the old building codes, the damage level of buildings designed by the current building codes was determined as minor in most cases, and there was no major damage. Further it was seen that among the damage types described earlier, the rate of type (3) Damage at the joints (bearing support parts) as shown in Photo 3.3.9.3 was comparatively high. The types of damage and their countermeasures are described in "Design Recommendations for Composite Constructions"⁸⁾ of the Architectural Institute of Japan for example. Also, the methods of designing RC columns, gable walls and Steel roof joints used in

Photo 3.3.9.3 Example of damage at RC column and Steel roof joints (bearing support parts)

seismic diagnosis and seismic reinforcement include those such as first finding out the seismic intensity acting on the roof surface from the horizontal load-carrying capacity of the top story, and then calculating the roof shear force depending on the roof area ratio, or if an abbreviated calculation method is desired, calculating the required strength by multiplying the weight that should be transferred from the roof surface by $0.55 \times A_i \times F_{es}$.¹⁰⁾ Suitable design methods like these can reduce the damage to these parts from earthquakes.

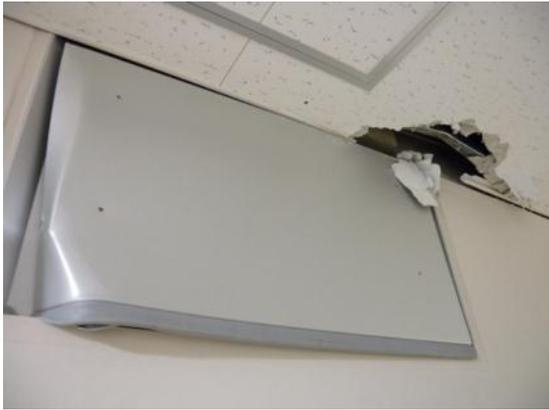
Photo 3.3.9.4 Cover broken by contact etc.

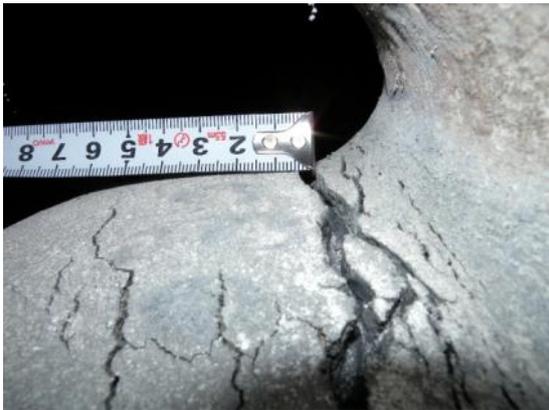
Photo 3.3.9.5 Cracks in lead damper

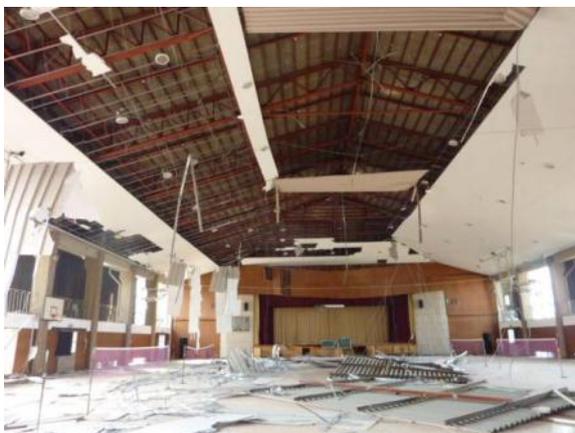
More damage was observed to the nonstructural components with the older construction method. Also, the damage type of breaking and falling was observed to the nonstructural components installed in higher places. As for ceilings, the damage tended to be greater with more severe structural damage, for example damage to the horizontal braces on the roof or to the roof joints (supports) (Photos 3.3.9.6 and 3.3.9.7).

Photo 3.3.9.6 Collapse of furring ceiling

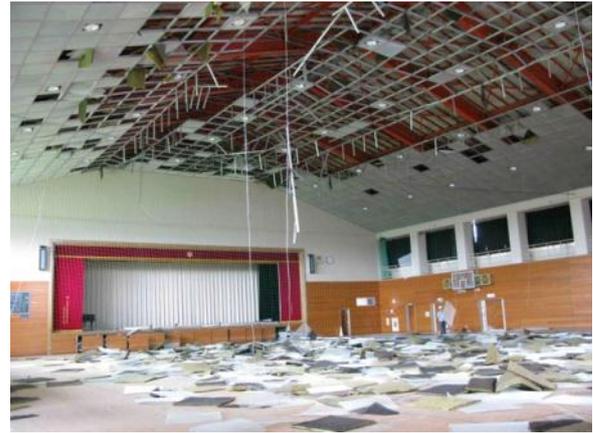
Photo 3.3.9.7 Collapse of integrated ceiling

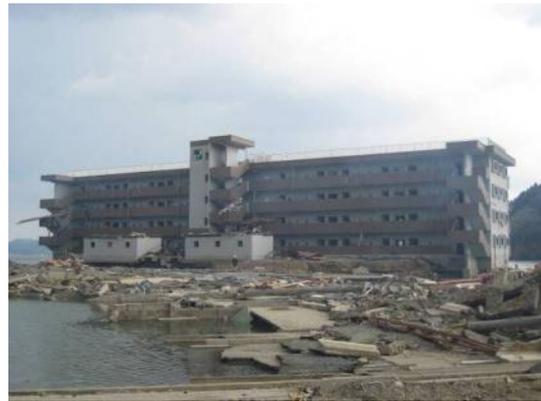
Although the flood water reached about 1m above the roof level, excluding the damage to non-structural elements, there was no structural damage to the building framework by ground shaking, and it stood

ground even after the tsunami. The flood water from the tsunami reached 15.4m above ground level at the building site, and several buildings in the surrounding area were either destroyed or washed out. The ratio of the lateral load carrying capacity of the first story of Building A against the horizontal tsunami load caused by hydrostatic pressure was 1.70. The building base shear far exceeded the tsunami load acting on it, thereby the building could survive after the tsunami.

Photo 3.3.9.8 Tsunami Evacuation Building A

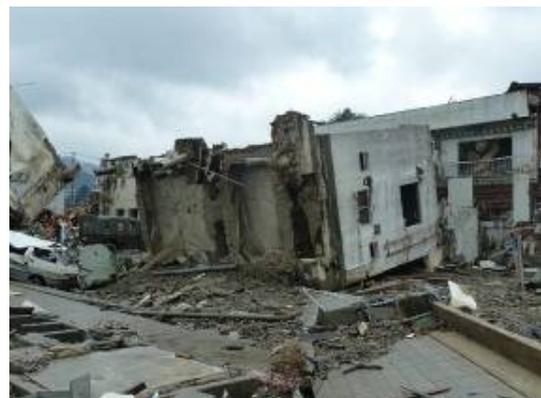
Building B is a 2-storied RC structure that is 10.5 m wide, 4.5m long and 6.1m high (see Photo 3.3.9.9). It is a wall frame structure with 1×2 span, and is located in Onagawa Town in Miyagi. The building pile was pulled out and overturned by the force of the tsunami.

The rate of the moment of resistance (including the buoyancy acting on the building and the pile pulling-out resistance) of the building against the overturning moment caused by hydrostatic pressure was about 79%, and the analysis result matched the actual damage result of the overturned building.

Photo 3.3.9.9 Building B

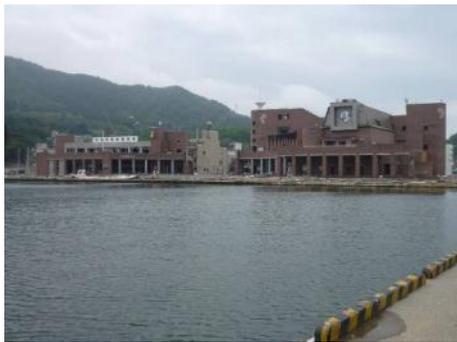
Building C has 3 and 2-story RC structures located in Onagawa in Miyagi and built in 1993 (called C-1 and C-2 buildings respectively as shown in Photo 3.3.9.10). C-1 building was higher than the tsunami height, and kept evacuees away from tsunami as a shelter. C-2 on the other hand could not save evacuees because of tsunami waves higher than the building. The ratio of the lateral load carrying capacity of the 1st story against horizontal tsunami load caused by hydrostatic pressure in Building C-1 was 1.12, and proved by the fact that it could survived after the tsunami. On the contrary, the ratio of C-2 was 0.79 and the building base shear was less than the tsunami load. Despite that it survived against tsunami in actually.

Photo 3.3.9.10 Building C

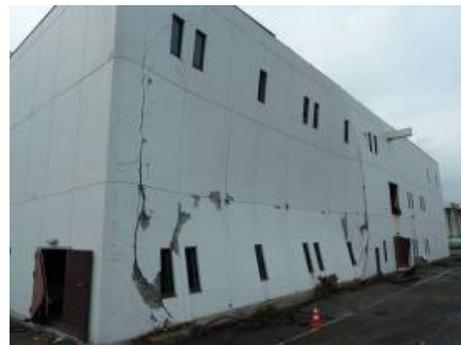
Not the whole structure but the outer walls of this building section were destroyed in this building, so that the collapsing mechanism strength due to the tsunami load will change according to the estimated folding line on the wall panel. In this study, the induced tsunami load was evaluated with a hinge mechanism model by assuming folding lines on wall surface based on the measurement result of the wall deformation. The

damage investigation confirmed traces of water (5.0m) inside the buildings and as a result, the tsunami load acting on this wall was calculated presuming that the hydrostatic pressure behind the walls also exerted force in addition to the wave force in front of the wall. The work exerted by the external force of the tsunami was 98% of the work generated by the internal force of the building in hinge mechanism. Thus the estimated external force of the tsunami matched the actual extent of damage.

Photo 3.3.9.11 Building D

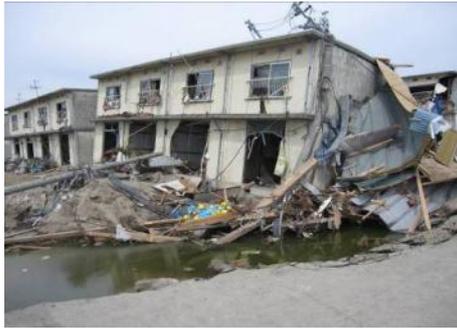
Building E, a 2-storied wall frame type precast RC structure built in 1970 (consisting of ribbed medium sized concrete panels) is a public housing complex (see photo 3.3.9.12). The inundation depth in front of the neighboring 3-story RC apartment complex was 7.5m. No significant structural damage was apparent in the building although it suffered damage to the gable walls on the 2nd floor because of the colliding floating materials and also tilted from scouring of the surrounding soil.

Although the lateral load carrying capacity of the building was 37% of the tsunami wave load acting on the building that was caused by the hydrostatic pressure, the analysis result did not match the actual damage status of the surviving building. This may have happened because the sea water entered through the several openings inside the building which must have helped in reducing the wave pressure acting on it.

Photo 3.3.9.12 Building E

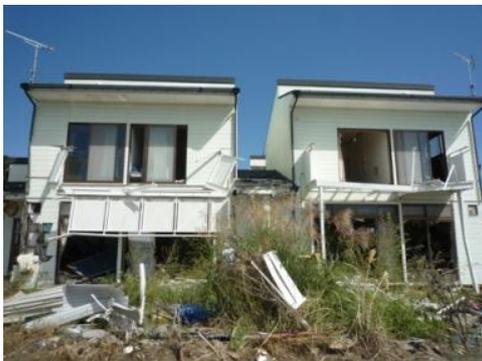
for the study was the city-provided housing (Suzaki Housing) of Higashi Matsushima (See photo 3.3.9.13)

Photo 3.3.9.13 Intact wooden public housing

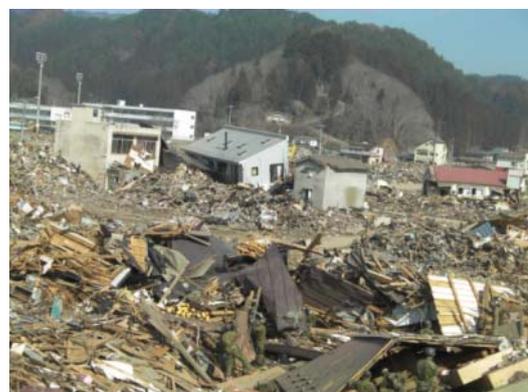
Photo 3.3.9.14 Buildings damaged by tsunami

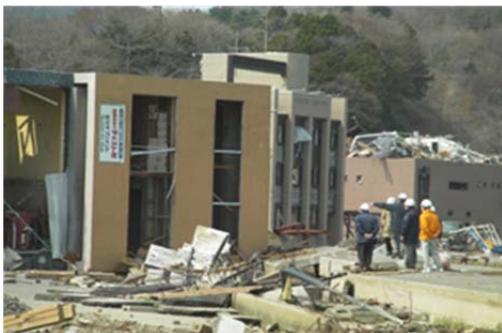
Photo 3.3.9.15 Field Survey by Building Construction Standards Association (Onagawa Town)

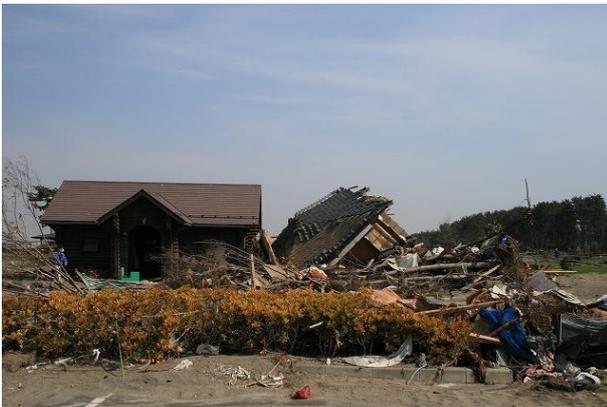
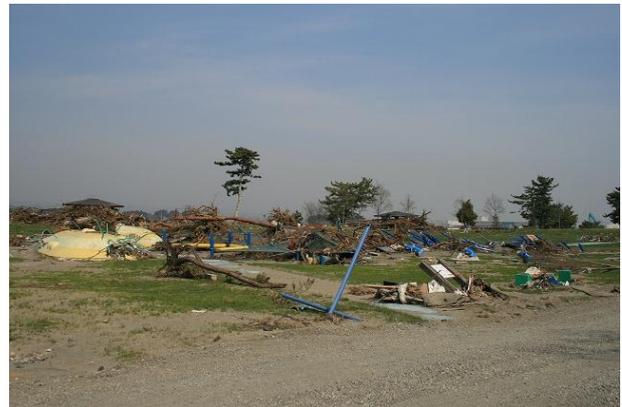
Regarding the damages by tsunami, we verified inundation damages to the facilities including buildings and playground equipment, pavement and signage in parks and green spaces (See Photo-3.3.12.1).

(a) Damage of Facility

(b) Damage of Playground Equipment

Photo 3.3.12.1 Damages of Park Facilities (Iwanuma City)

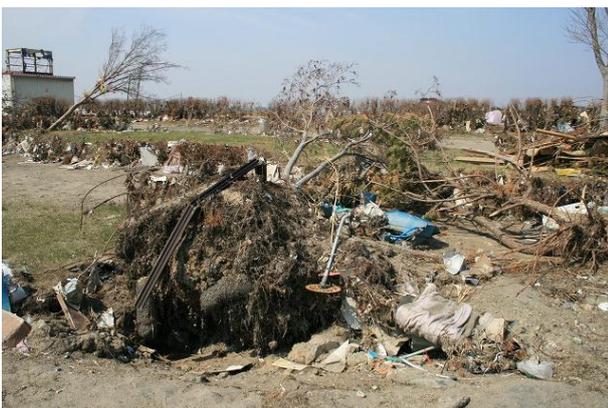
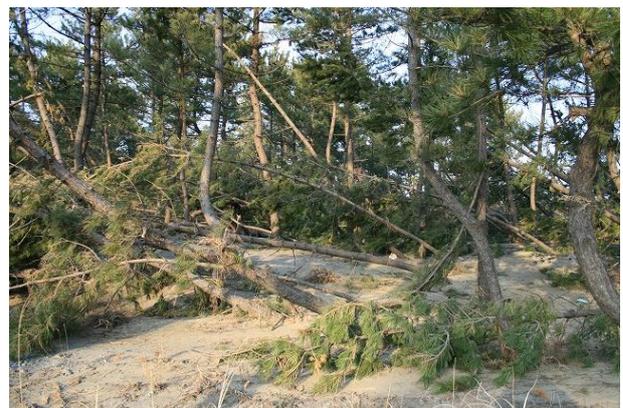
In addition, while damages of washout by lodging or breakage were observed for trees and tide prevention forests planted inside the parks (See Photo-3.3.12.2), salt damage by seawater, plant death and reduction of tree vitality by oil adhesion were verified in some species among the remaining trees (See Photo-3.3.12.3).

(a) Individual Tree (Iwanuma City)

(b) Tide Prevention Forest (Higashi-Matsushima City)

Photo 3.3.12.2 Damage and Lodging of Trees

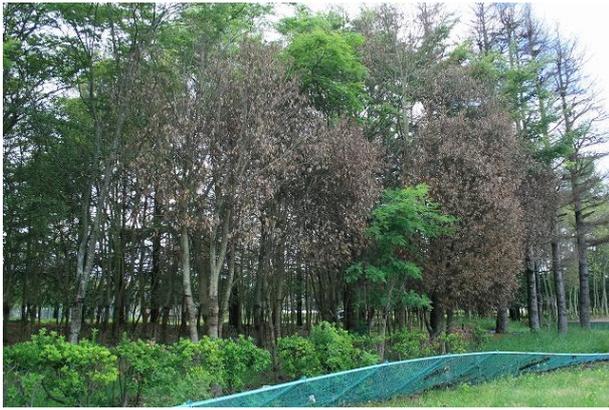
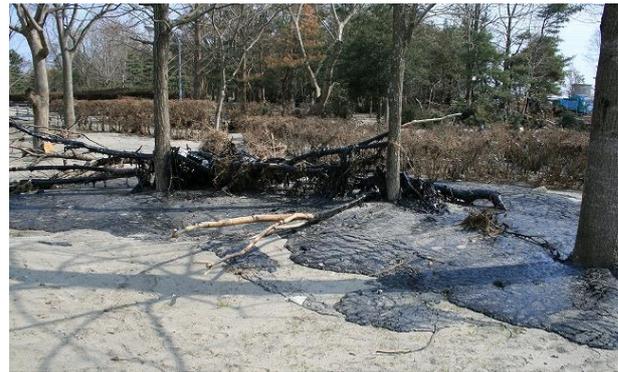
(a) Plant Death by Salt

(b) Reduction of Tree Vitality by Oil Adhesion

Photo 3.3.12.3 Growth Inhibition of Trees (Tagajo City)

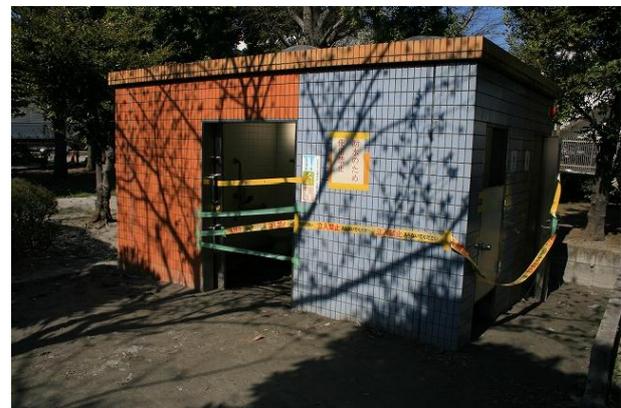
Photo 3.3.12.5 Embedding of a public lavatory by sand boiling (Urayasu City)

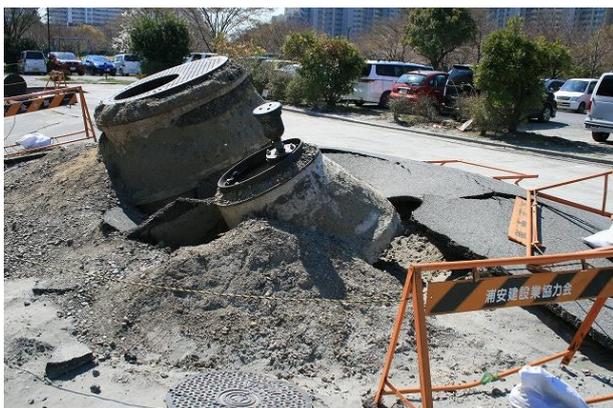
Damages were verified for buried objects like a water tank inside a park rising to the surface by ground liquefaction due to the Earthquake (See Photo-3.3.12.4). We also verified buried structures like public lavatories and benches and the bottoms of trees by sand boiling (See Photo-3.3.12.5), and cracks and unevenness in a square (See Photo-3.3.12.6). The aftermath in tree growth by sand boiling was not verified.

Photo 3.3.12.4 Surfacing of a water tank by ground liquefaction (Urayasu City)

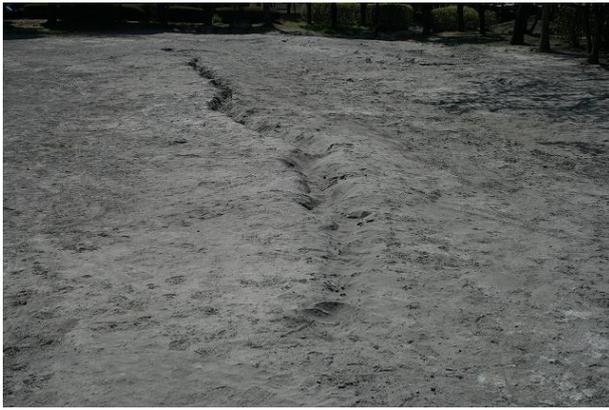
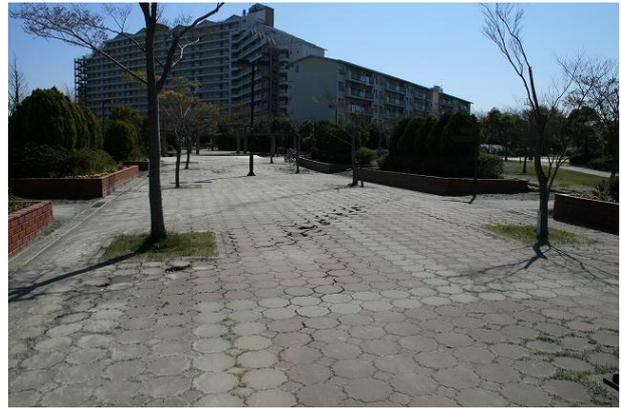
(a) Crack generated on the ground of a square

(b) Ground unevenness on the park road

Photo 3.3.12.6 Ground Unevenness (Urayasu City)

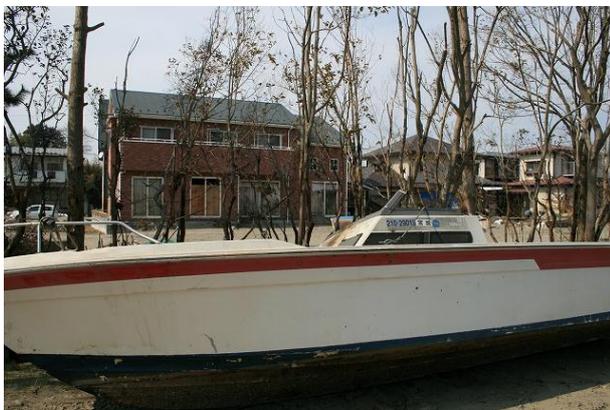
Trees and Forests inhibited a move of castaways due to the tsunami, and then mitigated or protected the secondary damage that occurred due to the move (See Photo-3.3.12.7).

Photo 3.3.12.7 Inhibition of a Castaway by Trees (Tagajo City)

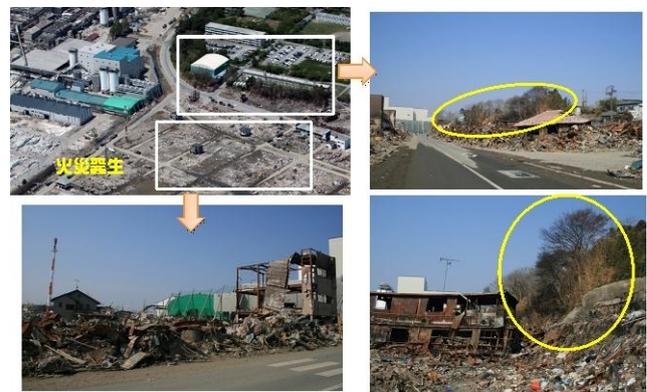
Photo 3.3.12.9 Protective Effect on Fire Spread by Forest (Ishinomaki City)

Also, the preventive effect on fire spread was verified in fires that occurred due to the Earthquake as the stoppage of spreading fire was determined at a forest (See Photo-3.3.12.9).

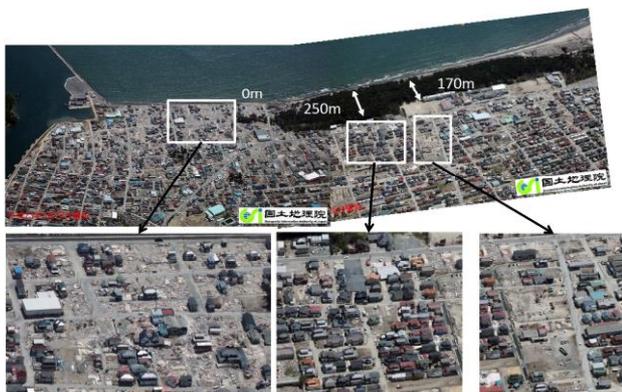
Also, these trees and forests diminished the wave power of the tsunami or surge, lowered the flow velocity and energy, and decreased the destructive force. Photo-3.3.12.8 indicates the damage situations in a place without a coastal forest and a place with one (broad or narrow forest width). The picture clearly shows the worst damage without a coastal forest, followed by with a narrow forest and with a broad forest.

Photo 3.3.12.8 Damping Effect on Wave Power by Tide Prevention Forest (Ishinomaki City)

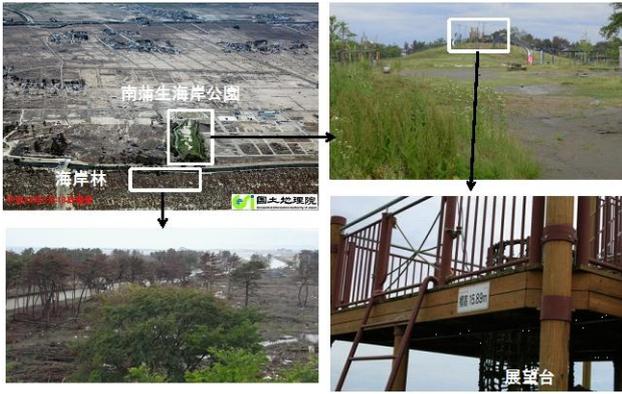
The effect of high embankment (observation deck) in the park was verified as a tentative evacuation area from the tsunami. At Minami-Gamo coast park in Sendai City, five people including staff and visitors and two pets who got left behind inside the park during the tsunami attack evacuated to the observation deck on the top of a high embankment (15.89 meter elevation), and then they were rescued by a helicopter within the day (See Photo-3.3.12.10).

Photo 3.3.12.10 Evacuation Site on High Embankment (Sendai City)

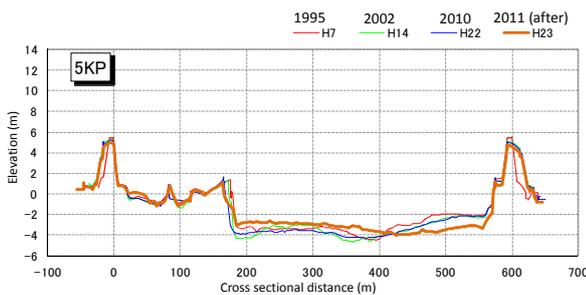
Figure 3.3.16.4 Example of Changes in the Cross Section Topography of the River (5kp)

An example of the river crossing of Kitakami River pre- and post-devastation is shown in Figure-3.3.16.4. The line of 2011 indicates the cross section after the devastation and the impact by land subsidence was adjusted by adding 0.601m of elevation.

As an overall trend, no significant changes in the shape of the river crossing have been observed though the river channel was homogenized in general as if small mounds were excavated and accumulated in the hollow.

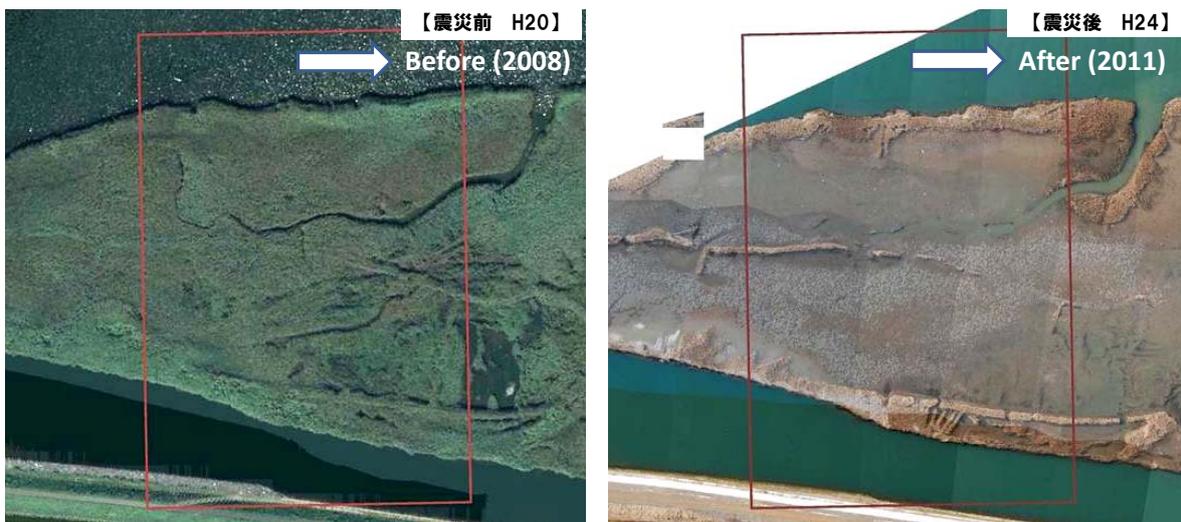
Figure 3.3.16.6 Vegetations with a Focus on the Reed Community Before and After the Earthquake (near point 2.4kp)

It is estimated that impacts by the tsunami would spread at point 0 to 9.4kp on the right bank and 0 to 8.8kp on the left bank, respectively, judging from vegetation disappearance and the existence of sediment by the tsunami. Particularly, in the island near point 2kp that may have been greatly damaged by the tsunami, most of the pre-devastated reed communities disappeared and only some parts remained on the mounds in the marginal areas (See Figure-3.3.16.6).

Aerial photographs before and after the Earthquake are shown in Figure-3.3.16.6. In the detail survey area at point 2.4kp in the right photo, only reed communities were observed as a vegetation type. Others include open water and natural bare lands, and places with a high tide level become surface water in the most natural bare lands. The reed community was observed in the marginal area or in the central mound part with approximately 30cm of relative elevation on the island, and the growth condition marked "Good" in the area with a relatively high elevation, and "Slightly Bad" or "Bad" in lower areas.

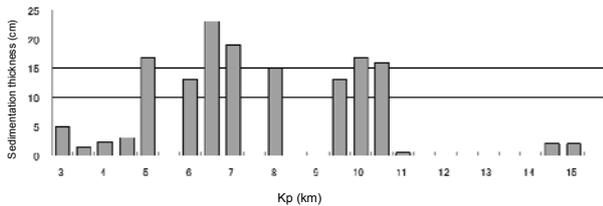
Figure 3.3.16.7 Thickness of Tsunami Sediments on the River terrace

Sediments by the tsunami were widely observed on the river terrace after investigation of the tsunami sediment in the survey area during the synoptic survey. Figure-3.3.16.7 shows the thickness.

river terrace of both banks from point 5.0 to 10.5kp, and, among them, the sediment was thicker from point 5.0 to 7.0kp with 23cm at the thickest bed (at the synoptic survey). The sedimentary cycle which indirectly shows the number of tsunami attacks was observed by up to four times at point 5.0 to 7.0kp after estimating from grading structures.

On the other hand, the thickness of the tsunami sediment decreased downstream from point 4.5kp. The reason may be considered that a flow was disturbed by the collision of a run-up wave and a down-rush on the tsunami invasion, but the details are unclear.

Also, upstream from point 11.0kp, no tsunami sediment was observed. The detailed cause is unclear though this may have been caused by a decrease in the force to drag the sandy sediment and reduce the run-up speed of the tsunami, or by some of four tsunamis occurring without arrival to the place though detailed causes are unknown. The river terrace downstream from point 10.5kp where remarkable tsunami sediments were observed was below the elevation level of 1.0m and lower than the maximum tide level.
