NILIM Research Report No.52

Initiatives by the National Institute for Land and Infrastructure Management in
Response to the 2011 Great East Japan Earthquake

Emergency Responses and Engineering Contributions by NILIM
for the Recovery from the 2011 Great East Japan Earthquake

National Institute for Land and Infrastructure Management
Ministry of Land, Infrastructure, Transport and Tourism, Japan

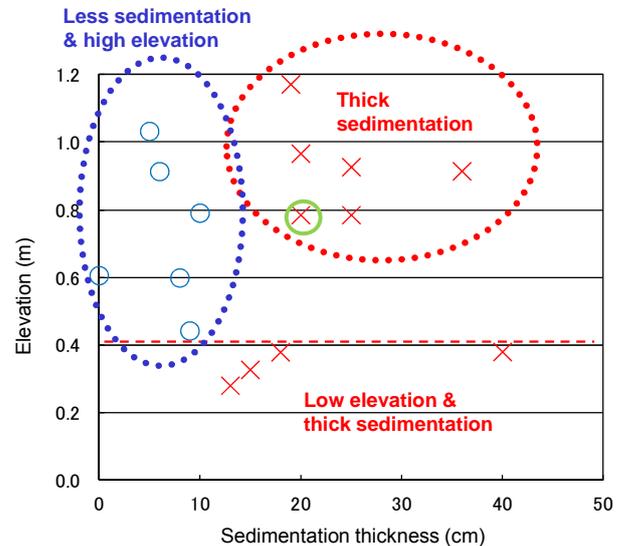
Figure 3.3.16.8 Impact on Reeds by the Elevation Level and Bed Thickness of Tsunami Sediments

At point 2.4kp of the island, reeds could be seen at approximately T.P. (or Tokyo Bay mean sea level) 0.4m or higher, and not below T.P. 0.4m. This may be due to an inhibition of growth by the salinity and sediments.

At point 6.4kp of the river terrace on the left bank, each site is at T.P. 0.4m or higher, but reeds could not be found in all sites. Regarding the place where reeds could not be found after the Earthquake in spite of the T.P. above 0.4m, some characteristics were observed on thick tsunami sediments as well as the existence of reed rhizome in a deep position before the Earthquake. In spite of the bad growth condition, however, reed growth from the rhizome in greatly deep positions was observed according to the location. The recovery from the rhizome seemed to depend on individual differences.

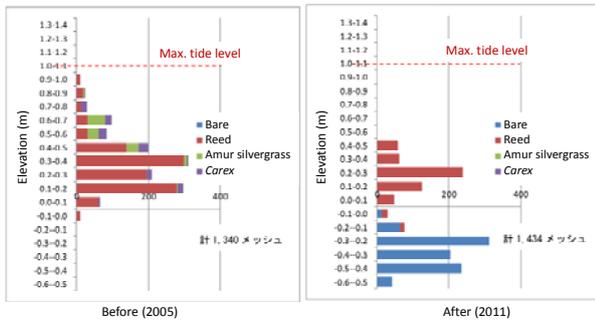
Figure 3.3.16.9 Relationship between the Elevation Level and the Vegetation Before and After the Earthquake in the Detail Survey Area at Point 2.4kp

For the vegetation before the Earthquake, although the reed community was dominant from the elevation level of 0.0 to 0.5m, evidence was observed regarding mixing growths with a salt marsh vegetation community (mixture of the *Carex rugulosa*) at 0.2m or higher and with an Amur silver-grass community at 0.4m or higher, with domination by other vegetation than the reed community at 0.6m or higher. No vegetation was found below the elevation level of 0.0m.

At present, a reed community is found in the area above the elevation level of 0.0m. In the area below 0.0m, however, the natural bare land remains as it was, or the condition has been bad in spite of growing the reed. For the future, in order that the reed community can be developed at around point 2.4kp as before, the elevation level should be considered being above 0.0m.

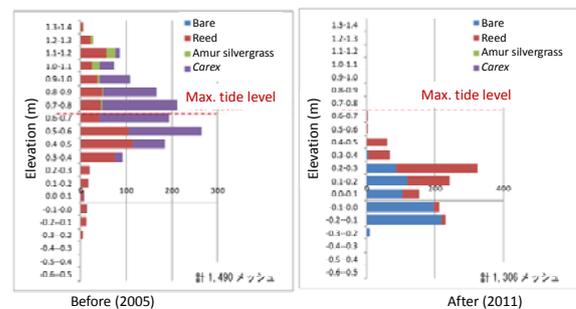
Figure 3.3.16.10 Relationship between the Elevation Level and the Vegetation Before and After the Earthquake in the Detail Survey Area at Point 6.4kp

The vegetation before the Earthquake consisted mainly of the reed and salt marsh vegetation communities (mixture of the *Carex rugulosa*). Looking at the peaks of altitude at which they appear, many salt marsh vegetation communities were observed at a bit higher level because reed communities ranged from 0.4 to 0.6m and salt marsh vegetations from 0.5 to 0.8m. The proportion of Amur silver-grass community kept high above the elevation level of 1.0m.

The vegetation observed after the earthquake is only reed communities. The high frequency of the elevation level ranged from 0.2 to 0.3m, and the same as the case of point 2.4kp, frequency distributions were polarized unlike the situation before the Earthquake.

Like point 2.4kp, no vegetation has been found in the area below 0.0m. In the area below 0.3m, reeds are sprinkled and the growth condition is bad.

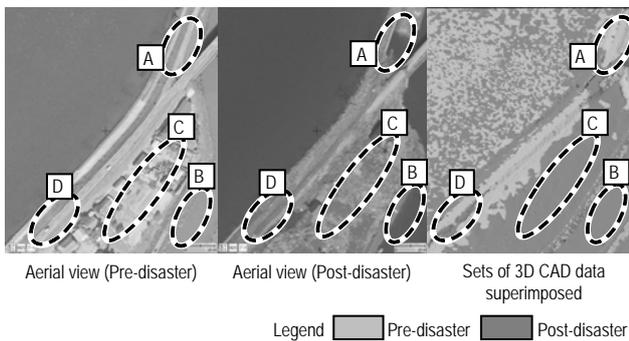
Figure 3.4.5.9 Sets of 3D CAD data superimposed

In this analysis, two sets of 3D CAD data – one for pre-disaster and one for post-disaster terrain – are superimposed for visualization, and are examined if the locations with possible damages or with large geological changes can be identified through visual inspection. Fig.3.4.5.9 shows two aerial views (before and after the disaster) and a superimposed representation of pre- and post-disaster 3D CAD data. The dike shape in two areas in the figure,

labeled A and B, shows significant changes before and after the disaster. Further examination around the dike reveals that the dry riverbed near the dike, labeled B in the figure, is inundated. Pre- and post-disaster surface geometry in the area C show changes due to piled rubble. The above-described observations clearly indicate the effectiveness of the technique, i.e. superimposed drawing of pre- and post-disaster 3D CAD data and aerial views enables easy identification of locations that may have suffered large changes in terrain profile.

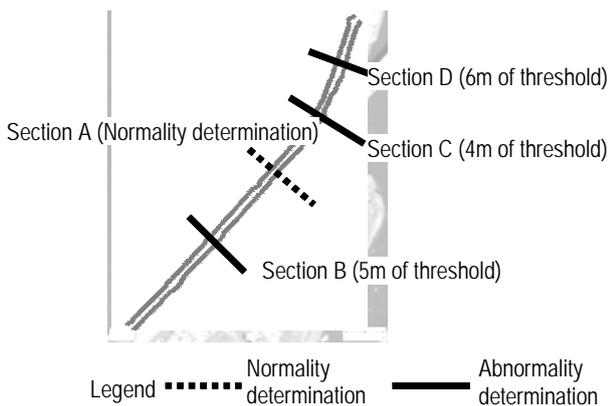
Figure 3.4.5.11 Damaged locations where lateral profiles were made

- The cross-sections B and C indicated changes in levee crown shapes, and especially the deformation of the top of slope, facing inward toward the dike, was substantial. This indicates that the method correctly detected local damages.
- The shape of lateral profile D showed significant change before and after the disaster, as also evidenced by the pre- and post-disaster aerial views around it. A close look into the aerial view around the location D (Fig.3.4.5.13) reveals large-scale deformation in the dike geometry. Actually, the area around the location D was found to have concentrated damages to where urgent rehabilitation works were implemented. This indicates that the method is capable of detecting the locations where the dike geometry underwent substantial localized deformation.

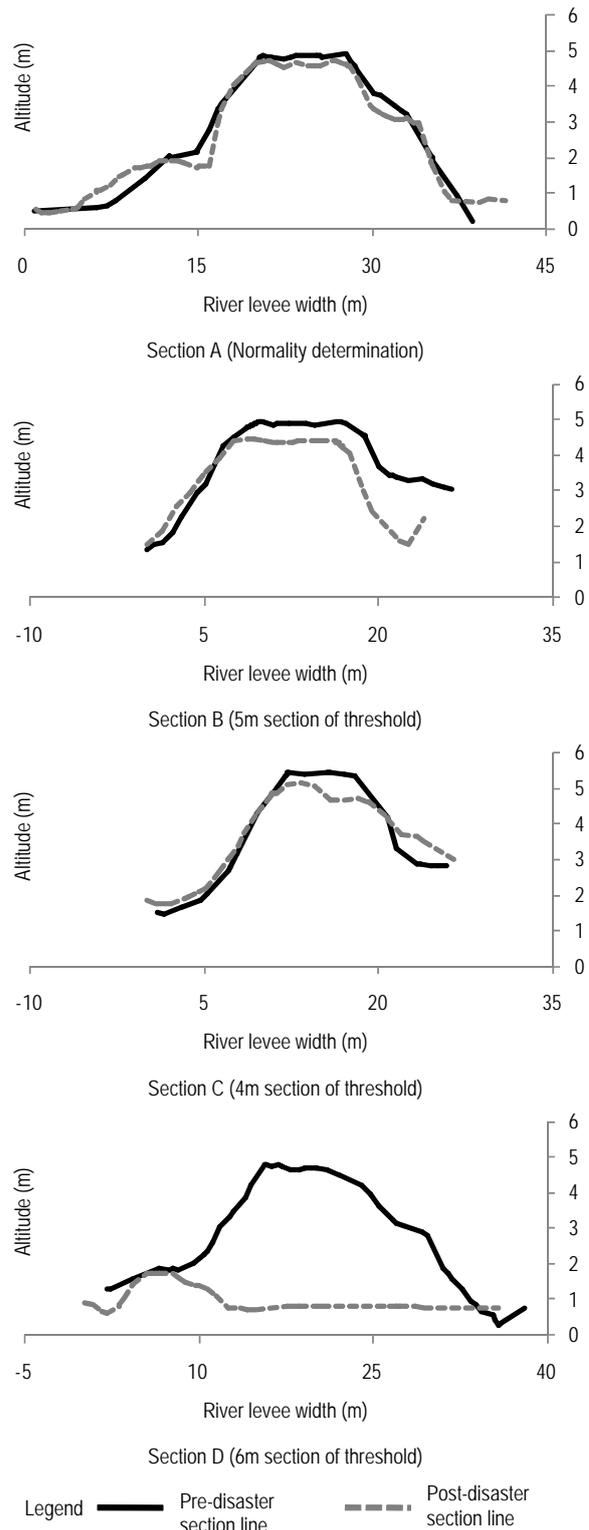
Figure 3.4.5.12 Four lateral profiles indicating varied degrees of damage

identical before and after the disaster, and the dike around it maintained its levee crown shape almost unaffected. The aerial view around this location (upper two in Fig.3.4.5.13) also suggests preservation of the road and dike structure, despite the pile of rubble. These observations clearly indicate that the method is capable of identifying unaffected or slightly affected locations.

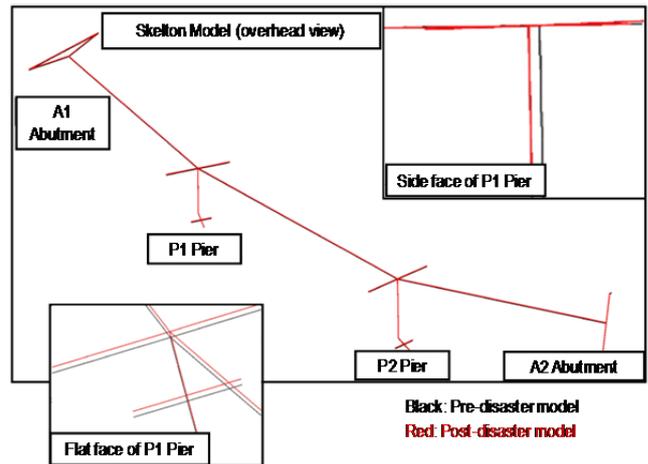
Figure 3.4.5.18 Displacement examination using the skeleton model

- The bridge, in its entirety, was displaced approximately 17cm southward, and sank 5 to 12 cm in the aftermath of the earthquake-triggered crustal changes.
- Relative displacement between each abutment base and the bridge structure was more or less naught, exhibiting no serious wrecks in abutments and bridges and deformation of the bridge as a whole.
- The skeleton model created from pre- and post-earthquake monitoring reference point measurement has demonstrated its capacity to keep track of the bridge status.
