No.18
September 2006

News Letter

Report on Buildings and Houses Damaged by the Jogjakarta Earthquake, Indonesia on June 27, 2006 Housing Production Division

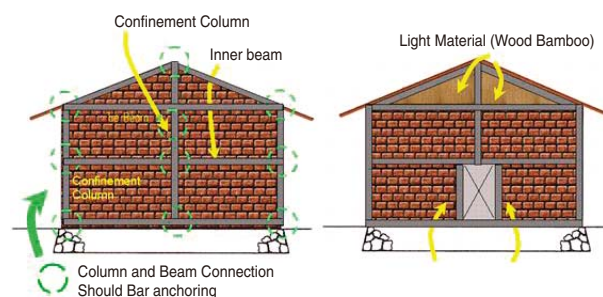
Fig. 2 Improvement of reinforced masonry house construction

The above improvements would lead to better construction quality, and lead to the creation of municipalities, regions and a nation that is more resistant to disasters affecting houses, buildings and infrastructure facilities (Fig. 2).

- 2) When planning the restoration of housing, a housing design consultation bureau needs to be established in order for houses or building owners to get advice on building restoration for single-story extension-type housing by implementing reinforced masonry techniques.
- 3) Foremen, technicians and engineers should be trained to understand the meaning of strengthening masonry walls and must be given technical information on methods of arranging reinforcement.
- 4) Regular workshops in connection with on-site testing methods for confirming the quality of masonry walls should be organized in cooperation with related institutions.
