PART TWO :

FACT FINDING

In this part, fact finding on building damages and social economic disruptions in inundation areas in 7 cities are shown.

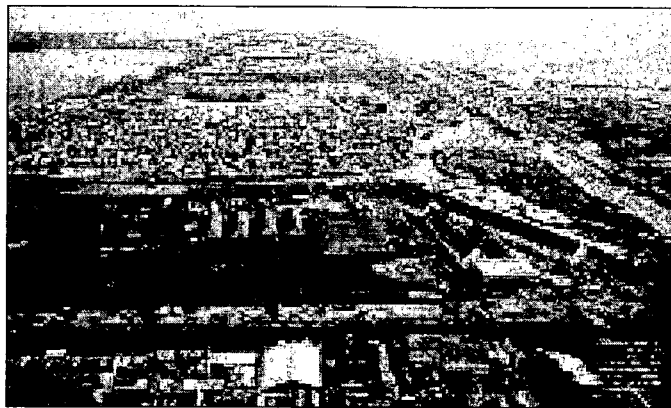
Photo 2.1.1. Existing condition of north beach, North Jakarta

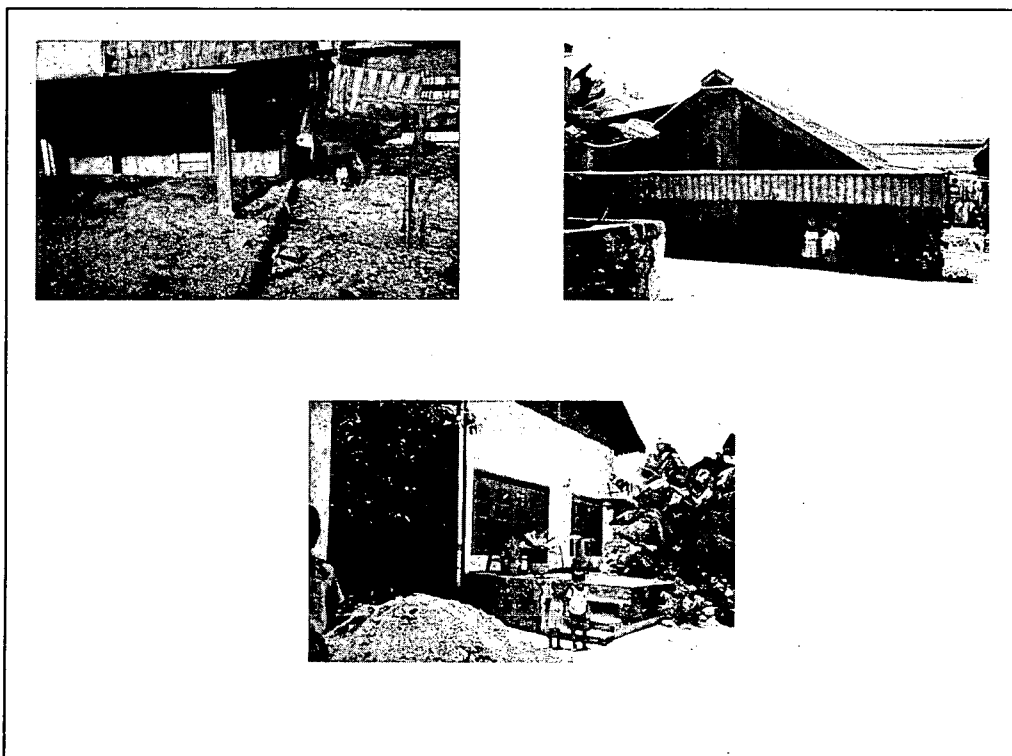
Figure 2.2.5: Sketch of the Building Physical Adaptation Method

To make inhabitants feel secure living in the area affected caused by continuously rising sea water level, building physical adaptation is done by the residents for themselves. The most common adaptation is to build a small embankment in the front entrance, or to elevate both the yard as well as floor house step by step to sea water level up. On the other hand some people who belong to middle to high-income level are able to rebuild their dwelling units drastically all at once. The rubble stone foundation of their houses is built as high as 1.5 – 2 meters from the ground, so the floors of their houses are about 1.5-2 meters above the land surface. The newly rebuilt houses are constructed about 1.5-2.0 m above the existing land surface. They realize that life time of their houses are only for 10-15 years, because within 15 years their houses will be influenced by inundation either (see figure 2.2.7).

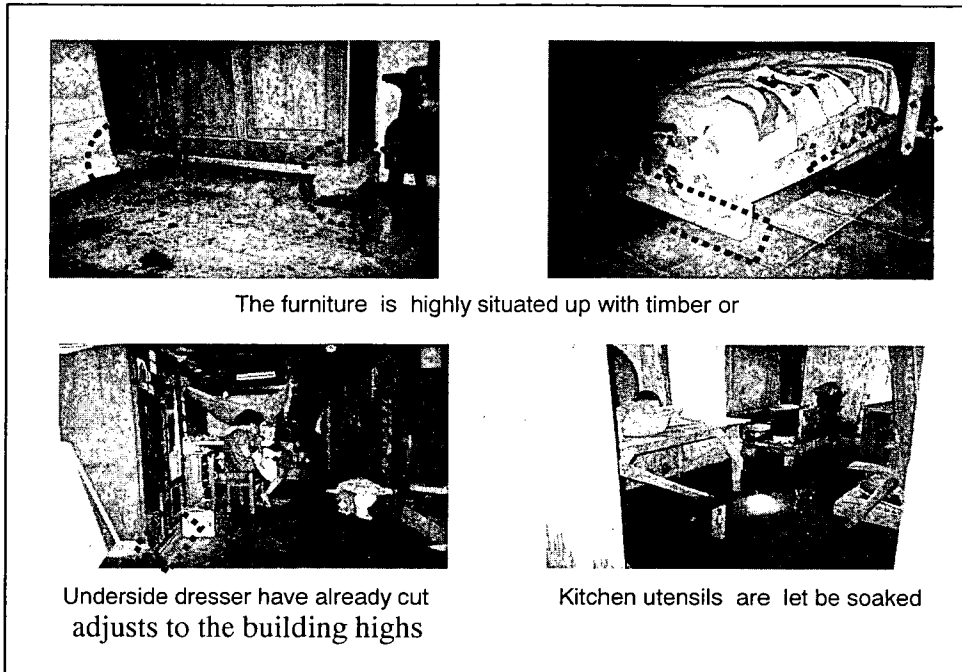
Figure 2.2.7: Furniture Adaptation

Since inundation destroyed most of household furniture and also kitchen utensils, the most common effort which is done by residents are to put furniture and kitchen utensils in the high place to secure from flood. But some people let their furniture be soaked every time. When the floor was heightened, some furniture has to be cut shorter to adjust to the new building heights. According to some respondents, generally their furniture has only three year usage time, because inundation decayed as well as had to cut completely.

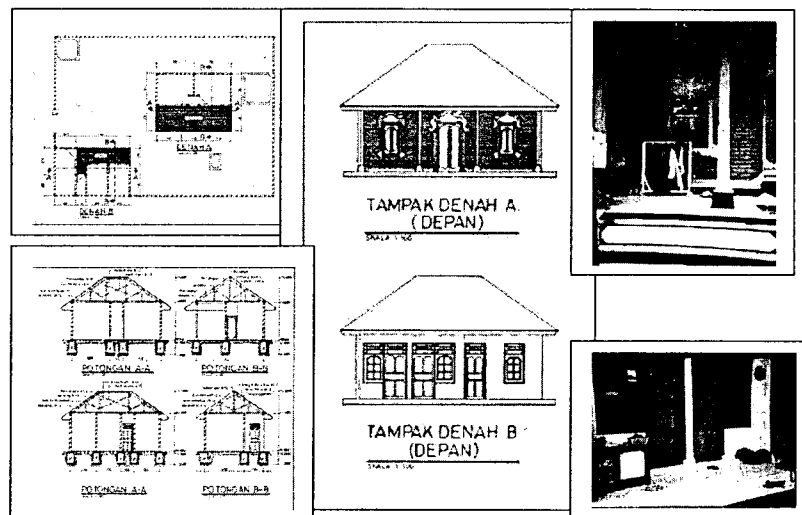
Figure 2.4.5: House in Serangan Sub district (Owner: I Nyoman Tanda)

There are some physical adaptations to adjust to the inundated area. The adaptations are as follows:

- To cover the land by sand which can absorb water quickly
- To increase the floor about 50 centimeters therefore the water cannot reach the inner house.

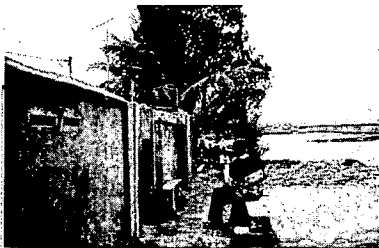
Elevation A – B (Gatep village) (Photo 2.5.2.)

Housing area is located about 100M away from coastal line. Urban drainage passes through this area but its estuary is often clogged up by sand embankment brought about flooding in the adjacent areas. In order to reduce inundation, the residents have done small dike construction and demolishing of sand embankment. However, the problem remains since sedimentation in the gulf is much faster than

abrasion. The huge wave and storm in January 2002 had destroyed the infrastructure and many houses in adjacent coast that need refurbishment afterwards.

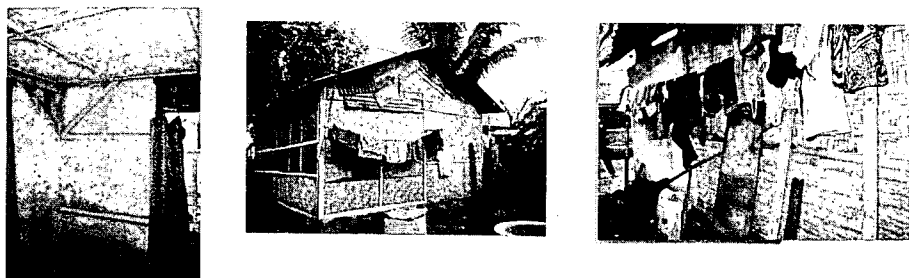
Photo 2.5.5-7. Types of Construction

- a. **Building Type:** seven houses are individual house while the other five buildings are classified as physically collective/serious/raw of house however the land and the building are splits -up in term of ownership. This condition makes irregular house lay out.
- b. **Building Construction:** most buildings are classified into permanent buildings with masonry brick wall and small concrete column. In some of those, wooden frame covered by bamboo mat or/and plywood or wooden frame with brick masonry is used.

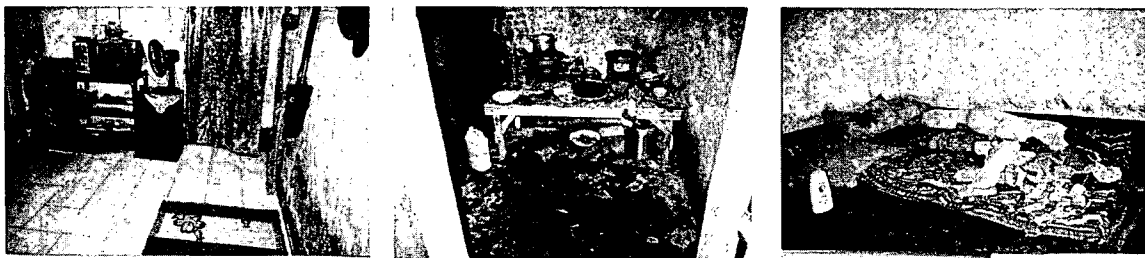
Photo 2.5.24-26. Furniture and Electronic items

Each house is equipped with very limited furniture and electronic items to avoid problems during flooding and/or inundation that regularly occur.

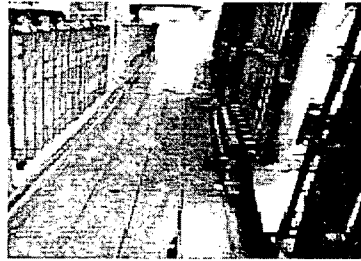
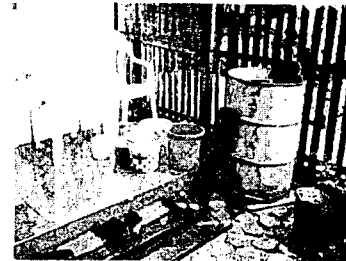
Photo 2.6.4 and 2.6.5 :
Water supply from PDAM

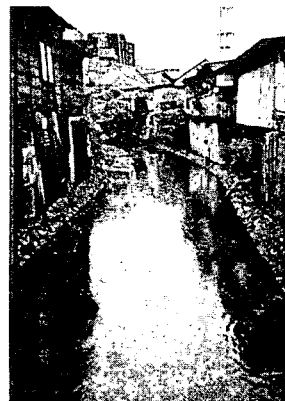
Photo. 2.7.5. Another main canal and seen that the water is overflow

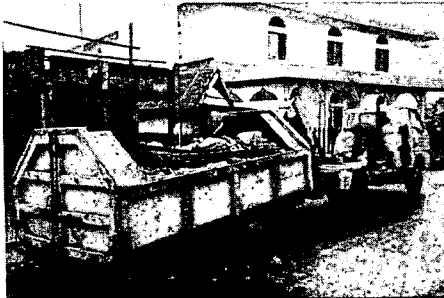
Photo. 2.7.6 Garbage Container

For garbage collection, there is one fixed container for collecting every 2 – 3 days. Even though there is a container, mostly people still through their garbage near their house, such as underneath their platform house, drainage etc.

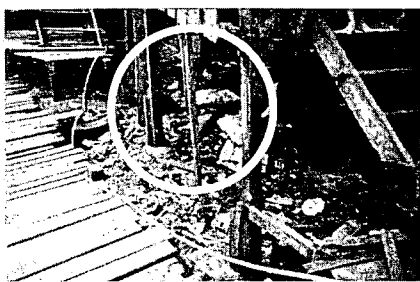
FOUNDATION				
Type	Type of House	Material	Deterioration	Figure
A	Detached	- Continuous, Stone masonry and red brick masonry.	There are unserious problems.	
B	Platform House	- Wooden Pile of 10/10 cm	Wooden piles are started being decayed because of garbage effect.

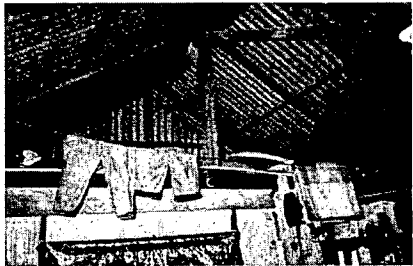
R O O F				
Type	Type of House	Material	Deterioration	Figure .
A	Detached House	- Wooden frame with zinc	There are some damage on the roof cover because of rust that can make the zinc broken and water that come into the house to damage plafond.	
B	Platform House	- Wooden frame with zinc	- Ditto -	
C	Two storey House	- Wooden frame with zinc	- Ditto -
