September 2011

**Summary of the Field Survey and Research on
“The 2011 off the Pacific coast of Tohoku Earthquake”
(the Great East Japan Earthquake)**

National Institute for Land and Infrastructure Management (NILIM)
Ministry of Land, Infrastructure, Transport and Tourism, Japan

Building Research Institute (BRI)
Incorporated Administrative Agency, Japan

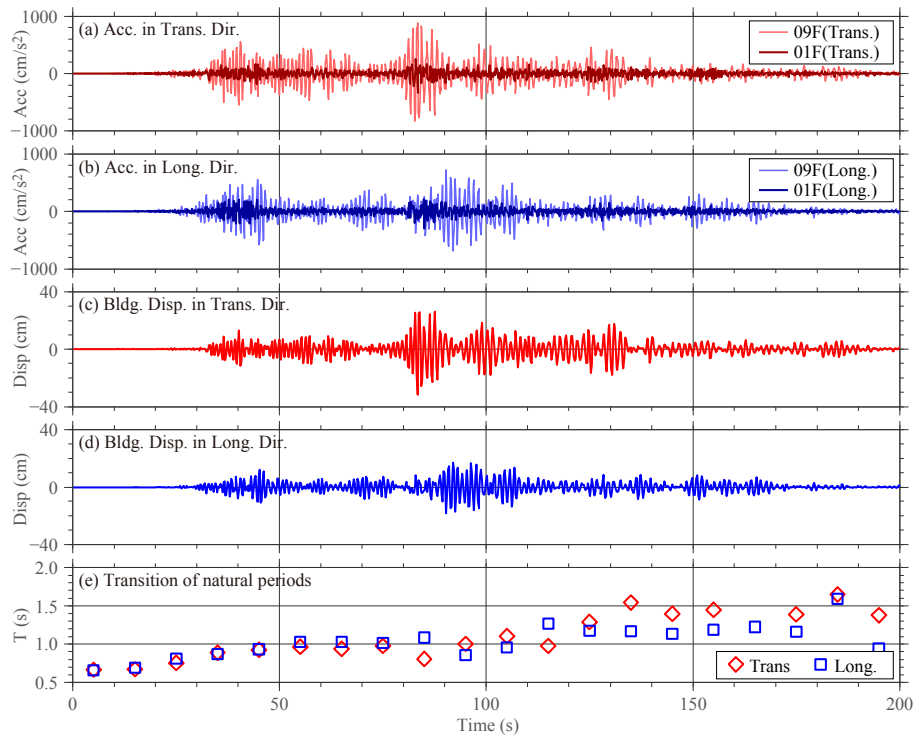
Fig. 5.3-3 Strong motion records of the research building of Tohoku University and transition of natural periods with time. (a) acceleration waveforms in the transverse direction, (b) acceleration waveforms in the longitudinal direction, (c) building displacement in the transverse direction (relative displacement to first floor of the 9-story building), (d) building displacement in the longitudinal direction, and (e) fundamental natural periods of the building that were calculated every 10 s⁵⁻³). Thick and thin lines in Fig. 5.3-3 (a) and (b) represent acceleration waveforms on the first and ninth floors, respectively.

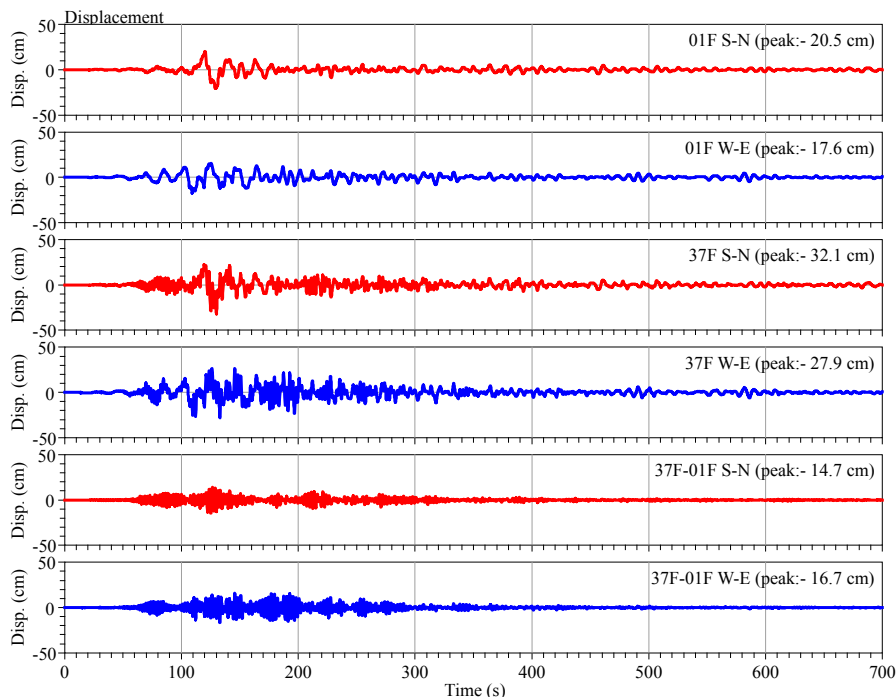
motion displacement was about 20 cm. It is understood that the ground itself was greatly shaken. A displacement of the building caused by its deformation reached 15 to 17 cm.

Fig. 5.3-4 Displacement waveforms observed at a 37-story residential building in

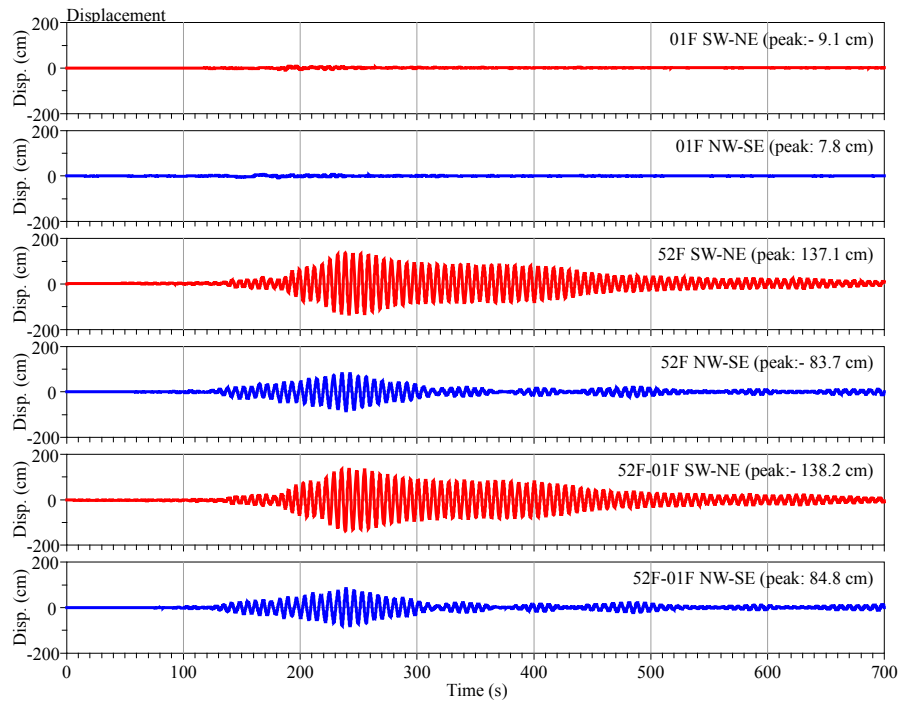
On the other hand, the response spectrum (left) in the records on the coast of Osaka Bay had a large peak at 7 s, and amplitude of the response was not much different from on the coast of Osaka Bay. The coincidence of the fundamental natural period (6.5 to 7 s) in the office building with a predominant period of the earthquake motion is considered to have caused a resonance phenomenon and then large building motions.

Fig. 5.3-5 Displacement waveforms observed at a 55-story office building in Osaka Bay area. From the top to the bottom; absolute displacements in the SW-NE and in the NW-SE on the 1st floor, absolute displacements in both of the directions on the 52nd floor, and building displacements (relative displacements of 52th floor to 1st floor) in both of the directions.

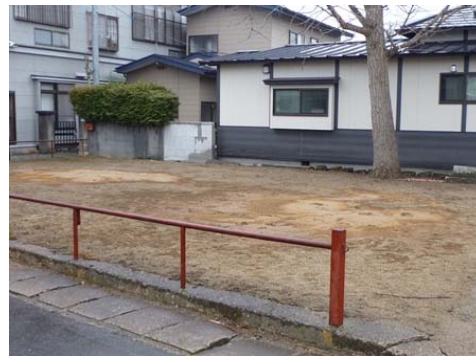
Photo 6.2-2 Sand boil due to liquefaction

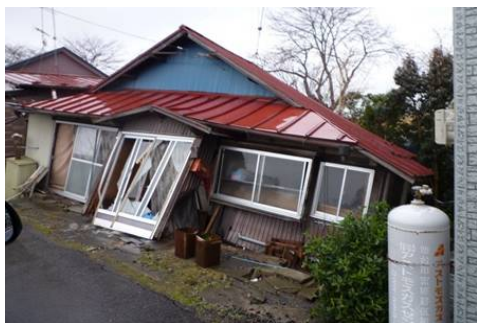
K-NET Kurihara Tsukidate (MYG004 : Instrumental seismic intensity 6.6) is set up on the hillock 3m higher (by eye measurement) than south of parking lot of Kurihara lyceum. There was a possibility of the amplification of earthquake motions (Photo 6.2-1). In Wakayanagi district, the ground was bad and sand boil due to liquefaction was observed (Photo 6.2-2). Damage to houses caused by ground transformation (Photo 6.2-3) and damage to houses with store were also observed (Photo 6.2-4).

Photo 6.2-3 Damage of houses caused by ground transformation

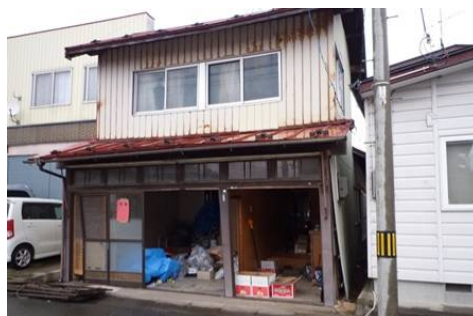
Photo 6.2-4 Damage of houses with store

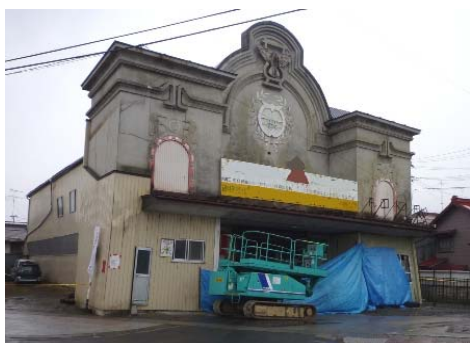
A large residual deformation was observed in the longitudinal direction in the large-scale wood building used as a movie theatre then renovated to a factory (Photos 6.2-5, 6.2-6)

Photo 6.2-5 Large-scale wood building renovated to a factory

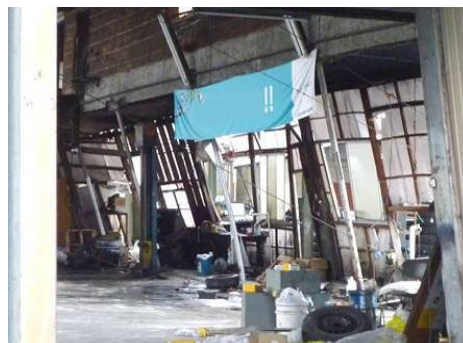
Photo 6.2-6 Inside of the building shown in Photo 6.2-5

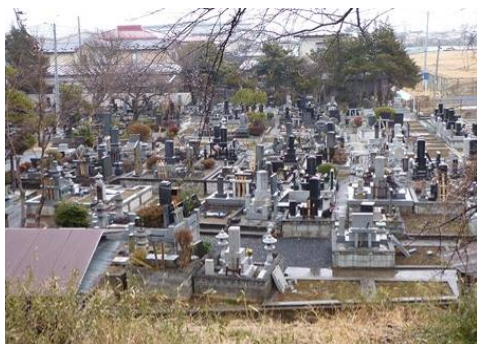
Photo 6.2-7 Overturning of tombstone

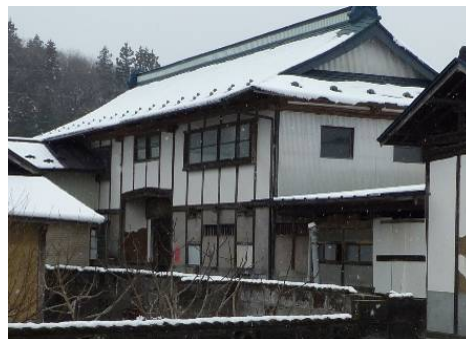
In Kurikomasakurada district, the collapse of work hut, the drop of the mud plasters of Nagaya-mon gates (Photo 6.2-8), the damage of plastered storehouses were observed, but the great damage in house was not observed.

Photo 6.2-8 Drop of mud plasters of Nagaya-mon gate (Kurikomasakurada)

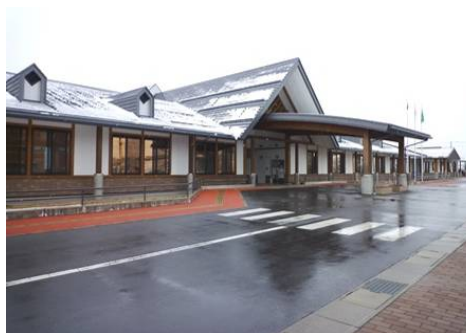
The Seismograph of Kurikoma (JMA seismic intensity 6-) is set up on the parking lot in the west of “Michinoku-Densokan (Photo 6.2-9) ”. From the exterior damage investigation, damage was not observed in “Mihcinoku-Densokan” and Kurikoma Branch office (Glulam frame structure: Photo 6.2-10).

Photo 6.2-10 Kurikoma Branch office (Glulam frame structure)

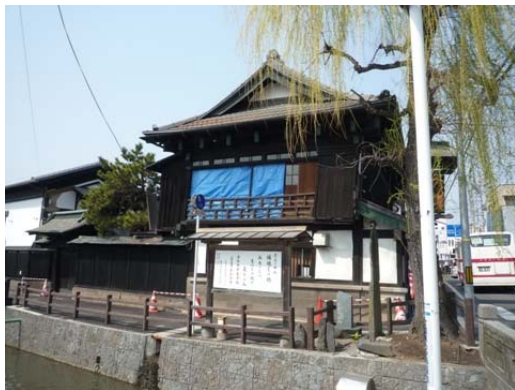
Photo 6.2-13 Damaged Japanese traditional house with large story deformation

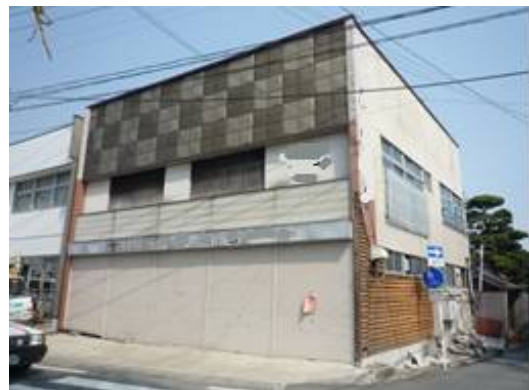
Photo 6.2-14 House with store with large story deformation

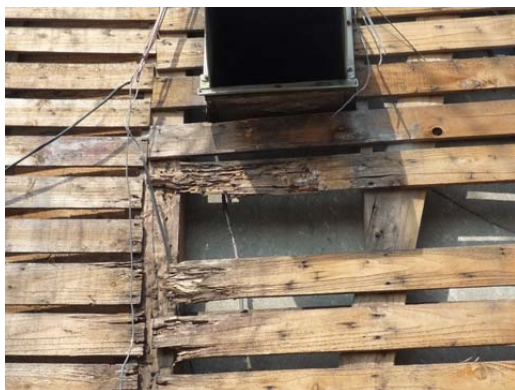
Photo 6.2-15 Deterioration in building of Photo 6.2-14

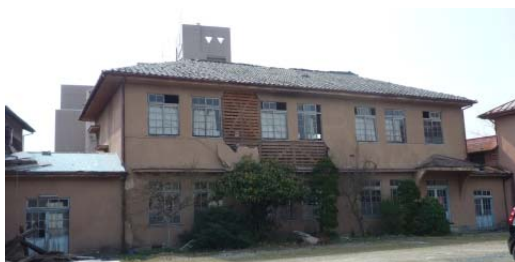
Seismograph at JMA Furukawa (Photo 6.2-16) which recorded seismic intensity 6+ was located in the northeast corner of the Mikkamachi park. There were the former school buildings around it. One of them was not almost damaged (Photo 6.2-17), while the other was damaged on roof tiles and exterior mortar without story drift. In addition to them, a rare damage example (Photo 6.2-18) that only the 2nd story collapsed was observed. On the other hand, a wood school building (Photo 6.2-19) in the west of the Osaki city office seemed not to be damaged in the appearance. Besides these, the house with store with large story drift in 1st story (Photo 6.2-20), those with large story drift in 2nd story (Photo 6.2-21), and 1-story wood house with large story drift caused by the land liquefaction were observed.

Photo 6.2-17 School building suffering damage on roof tiles and exterior walls

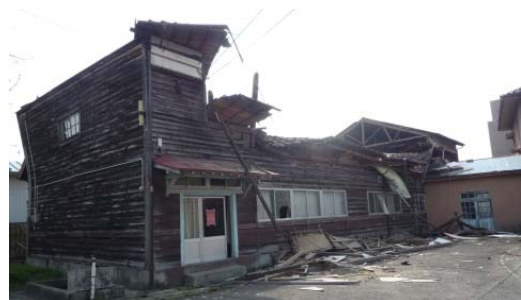
Photo 6.2-18 School building whose 2nd story collapsed

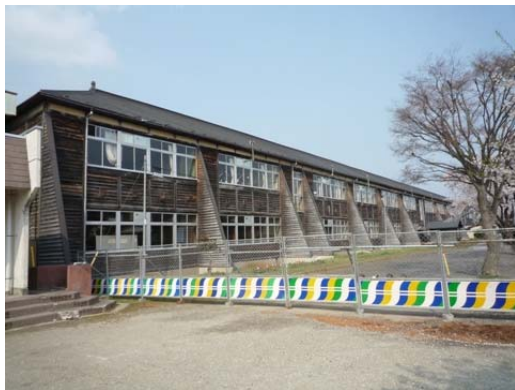
Photo 6.2-19 Seemingly slightly damaged School building

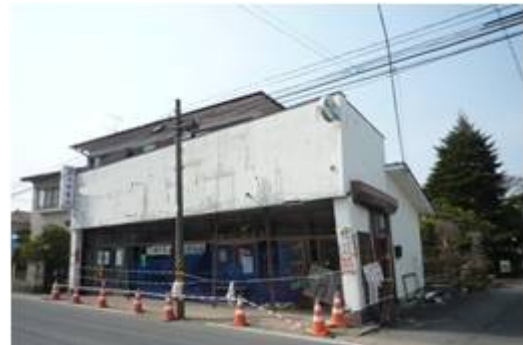
Photo 6.2-20 House with store with large story deformation

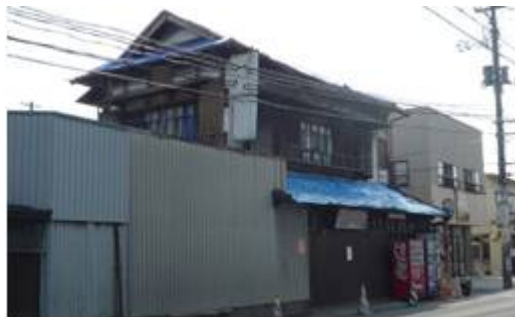
Photo 6.2-21 House with store with 2nd story drift more than that of 1st story

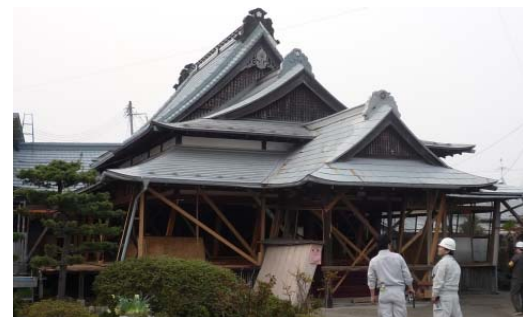
In the northwest of JR Freight Company Furukawa Station, a collapsed steel frame building, an RC structure apartment house with rocking drift caused by the land deformation, and a temple building (Photo 6.2-22) with large story deformation were observed.

Photo 6.2-22 Heavily damaged temple building

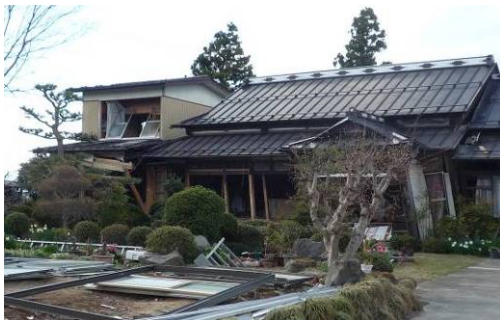
Photo 6.2-23 Largely tilted house

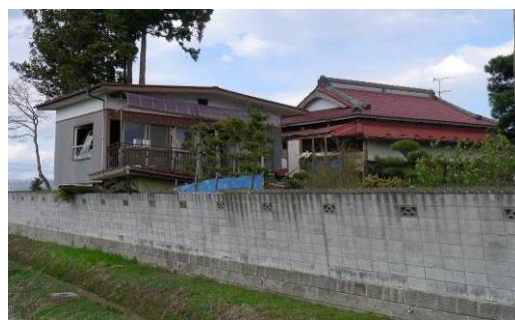
Photo 6.2-24 Collapsed wood house

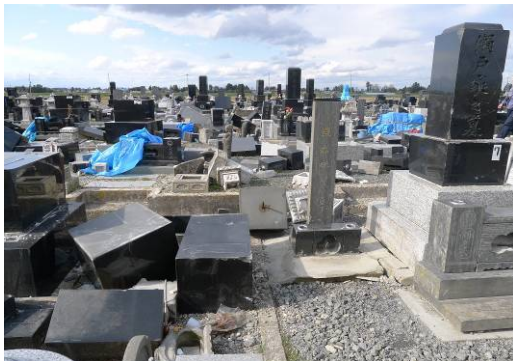
Photo 6.2-25 Tombstones in Hirabari

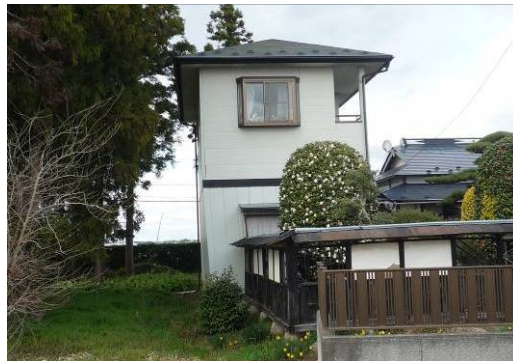
Photo 6.2-26 Tilted two-story house

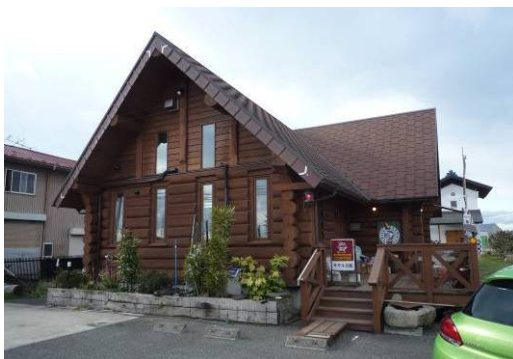
which two-story might be extended. In the southern side of Eaigawa river, there were log house without damage (Photo 6.2-27), wood house which tilted largely at first story (Photo 6.2-28) and tilted shrine building (Photo 6.2-29).

Photo 6.2-27 Log house without damage

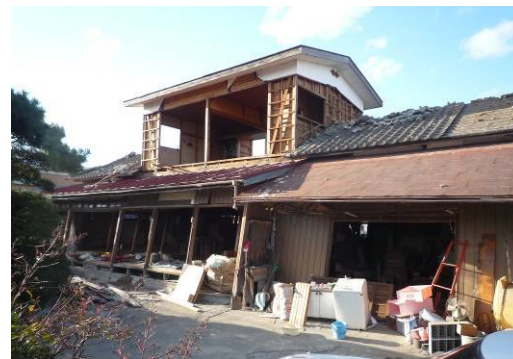
Photo 6.2-28 Largely tilted wood house

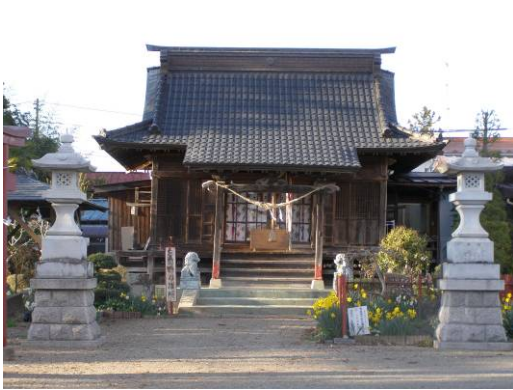
Photo 6.2-29 Damaged shrine

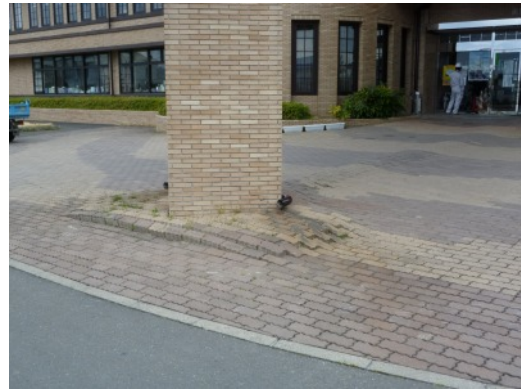
In Nango area, ground deformation was observed in the branch town office (Photo 6.2-30), but there was few damaged houses. Photo 6.2-31 is the tilted wood house in Nango area. The structures in this area were damaged in a certain level during the 2003 northern Miyagi prefecture earthquake. There is a possibility that damaged buildings were retrofitted or rebuilt after the 2003 earthquake, because structures in this area seemed to be new.

Photo 6.2-30 Ground deformation in Nango branch town office

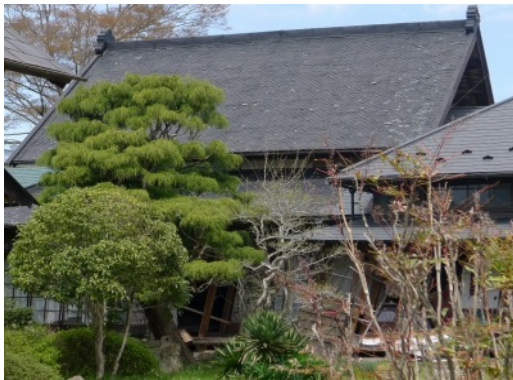
Photo 6.2-31 Heavily damaged house

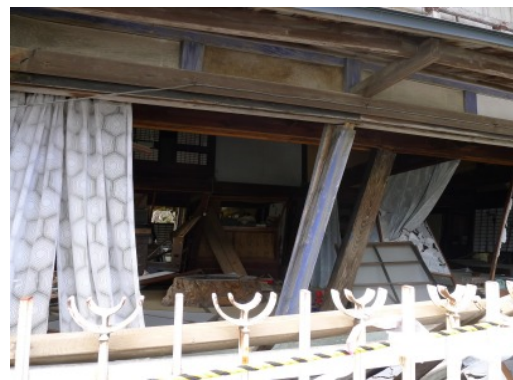
Photo 6.2-32 Inside of the house in Photo 6.2-31

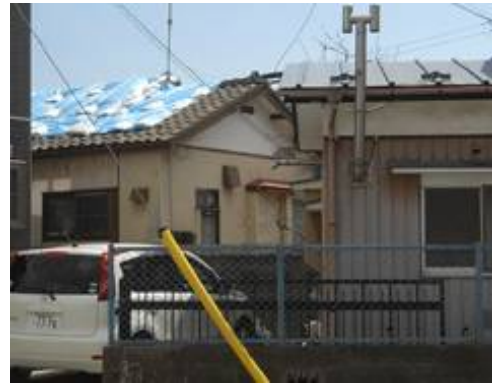
Hiyorigaoka and Izumi-cho in Ishinomaki city is located on a hill (The altitude is 56.4m) at the western side of Kyu-kitakami river, almost all of the buildings are residence without public facilities (Photo 6.2-33). There were not heavily damaged wood houses and a few wood houses of which roof tile damaged (Photo 6.2-34).

Photo 6.2-34 Damaged roof tile in Hiyorigaoka

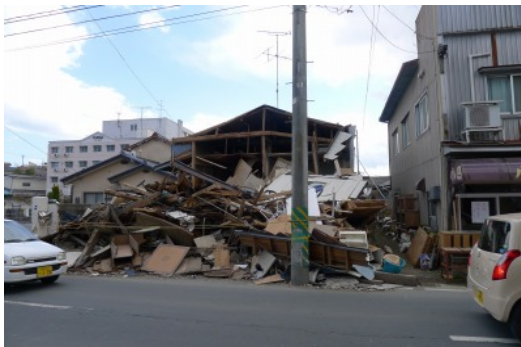
At the both side of the street, there were collapsed wood house by earthquake (Photo 6.2-35) and tilted wood house with store (Photo 6.2-36). It was estimated that the wood houses with store which have less seismic elements at the first story were heavily damaged.

Photo 6.2-35 Collapsed wood house

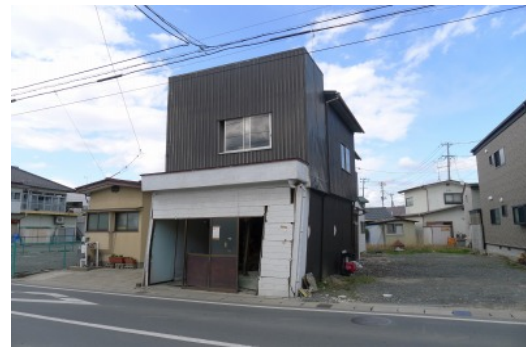
Photo 6.2-36 Tilted wood house with store

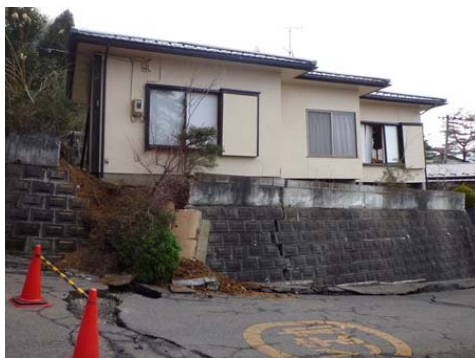
From the results of investigations on Oritate and Seikaen where the damage of the houses were serious, it was found that almost all of the damage of house were caused by ground transformation. Moreover, ground transformation caused retaining wall collapse (Photo 6.2-37, 6.2-38), landslide and damage of houses (Photo 6.2-39). On the other hand, there were some sloping lands in Kaigamori and Asahigaoka where, the number of damage of retaining wall was minor, and damage of roof tile, collapse of concrete block wall and outer wall were observed. In Komatsujima, Aoba ward, drop off the mortar wall and damage of columns and biodeterioration by ants were observed in the house with store (Photo 6.2-40). Moreover, the house with large residual deformation on the 1st floor was observed (Photo 6.2-41). In Mukaiyama, Taihaku ward, collapse of a Japanese-style hotel was observed because of the sudden fall of stone of hillback (Photo

Photo 6.2-37 Damage of retaining wall and houses (Oritate, Aoba ward)

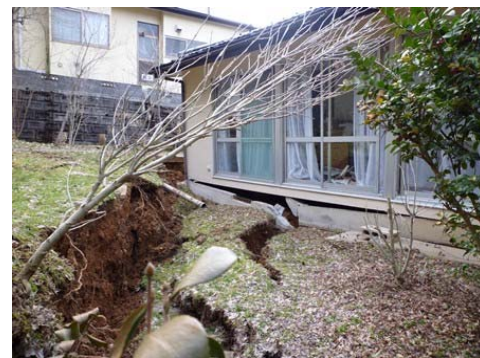
Photo 6.2-38 Damage of house in Photo 6.2-37

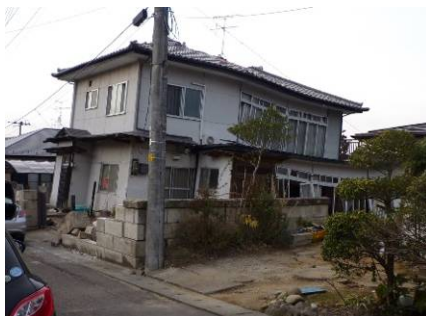
Photo 6.2-39 Damage of house caused by the ground transformation (Oritate)

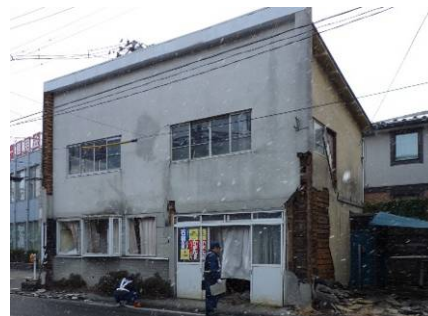
Photo 6.2-40 Drop off the mortar wall (Komatsujima)

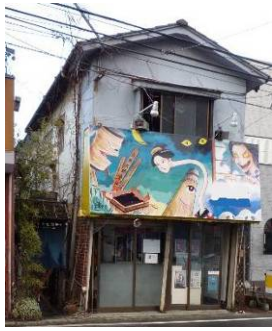
Photo 6.2-41 House with large residual deformation (Komatsujima)

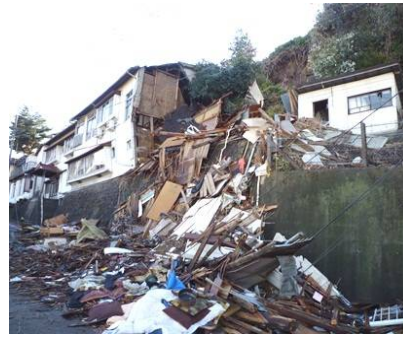
Photo 6.2-42 Collapse of Japanese-style hotel (Mukaiyama)

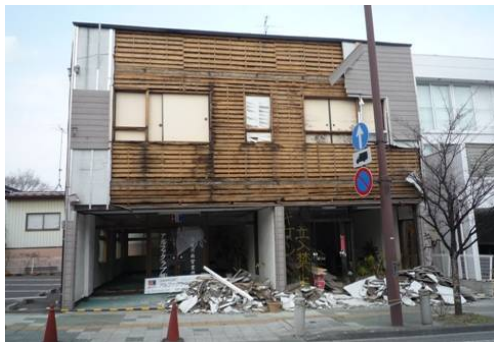
A lot of damaged wood houses were observed around the collapsed RC structure building. Examples are as follows: the failed exterior mortar wall of the 2nd floor in a house with store (Photo 6.2-44), deterioration and damage by *Reticulitermes* on a part of structural member and wood lath of exterior mortar wall (Photo 6.2-45), a wood house whose stair hall was removed and collapsed (Photo 6.2-46), and so on.

Photo 6.2-44 Fallen mortar of wall (Wood house with store)

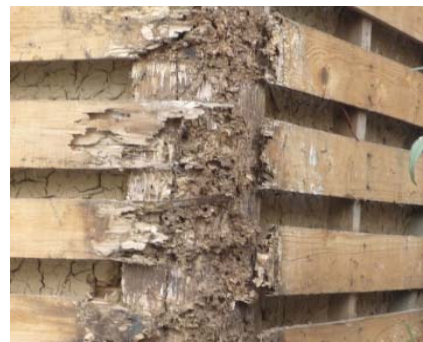
Photo 6.2-45 Deterioration and damage due to termite on column and wood lath of exterior mortar

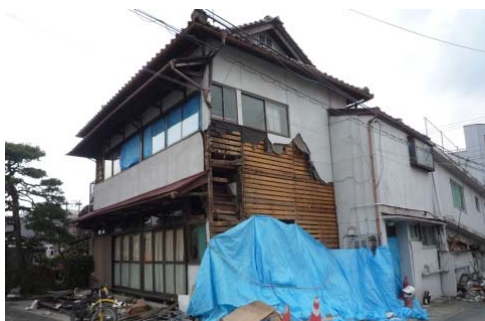
Photo 6.2-46 Collapsed stair hall

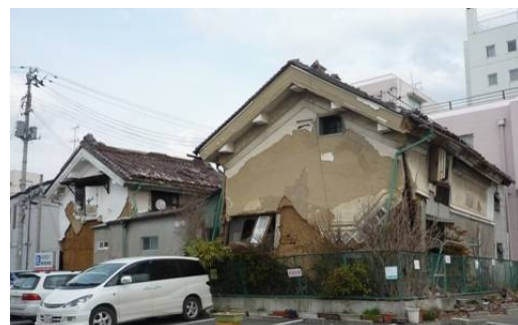
The wood warehouses with mud wall were heavily damaged near the hotel with the window glass broken. For example, the warehouses which deformed much (Photo 6.2-47) and whose roof system collapsed (Photo 6.2-48) were observed. A few wood houses with roof tiles damaged (*e.g.* Photo 6.2-49) were found. On the other hand, roof tiles of temple gate (called as “*Sanmon*”) was damaged, while the main hall of the

Photo 6.2-47 Failed warehouse with mud wall

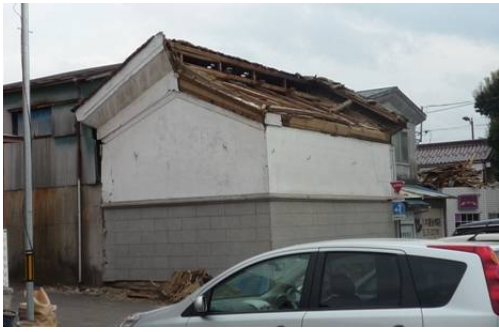
Photo 6.2-48 Fallen roof of warehouse with mud wall

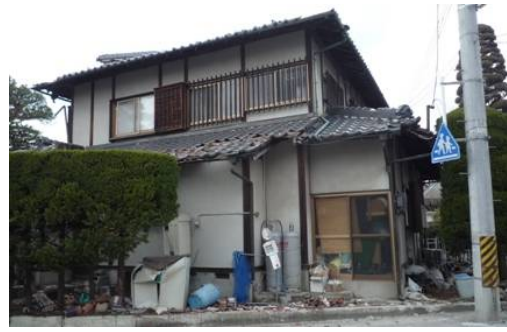
Photo 6.2-49 Damage on roof tile

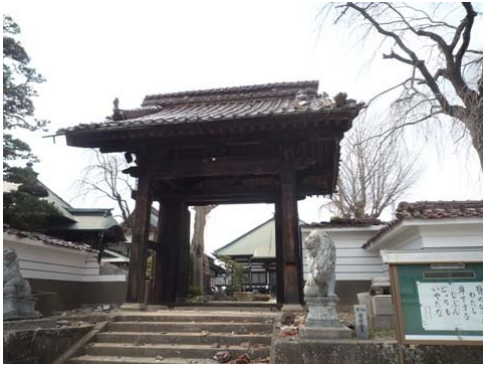
temple was not so damaged (Photo 6.2-50 and 51). The sand eruptions caused by the soil liquefaction and the damage on the roof tiles were seen here and there in Minami-machi, Sukagawa city. In addition, on the web site of the city, the collapsed house was reported (Photo 6.2-52, From the city website).

Photo 6.2-50 Minor damage of temple gate

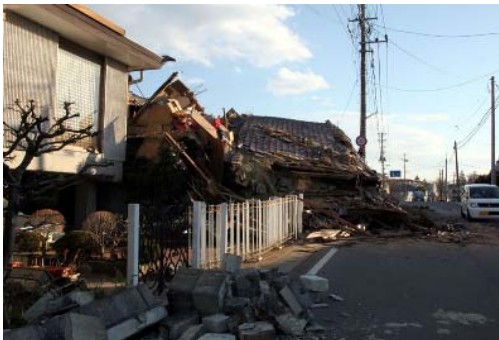
Photo 6.2-52 Collapsed wood house at Minami-machi (From Sukagawa city website)

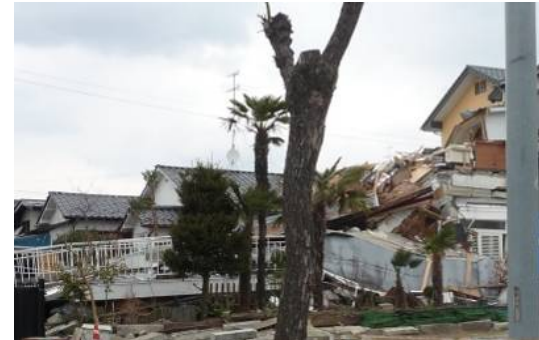
Another collapsed building with uncertain structural type was found (Photo 6.2-53). According to the damage overview seen from the east of Minami-machi (Photo 6.2-54), it was observed that the wood houses with roof covered temporarily with blue vinyl sheet which was guessed to be damaged to roof tiles were many relatively.

Photo 6.2-53 Collapsed building (Unknown structure type)

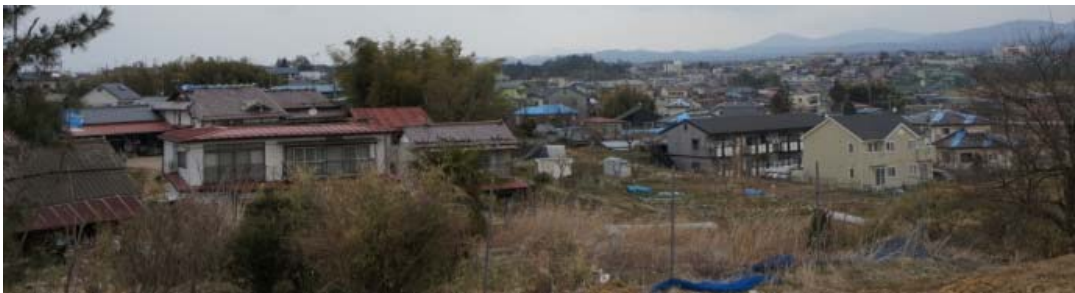
Photo 6.2-54 Damage overview from the east of Minami-machi (Many roofs covered with blue vinyl sheet)

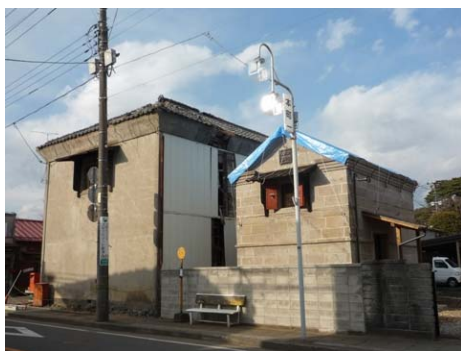
The stone-built warehouse was heavily damaged near the town office (Photo 6.2-55). The exterior stonewall of the former post office was failed (Photo 6.2-56).

Photo 6.2-55 Damage of stone-built warehouses

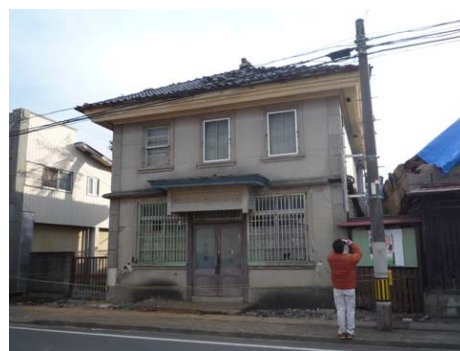
Photo 6.2-56 Damage of old post office

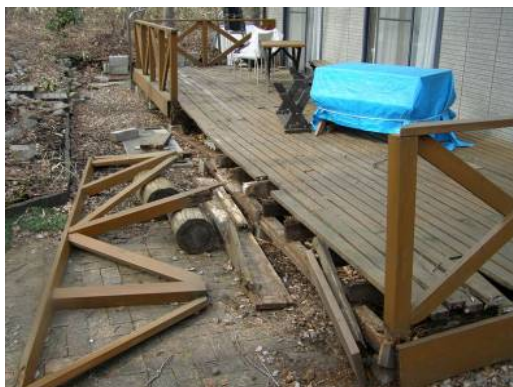
Toyohara-Otsu area is in the north of Nasu Town, and cottages are built along the path on slightly elevated hills. The movement and collapse of the wood deck (Photo 6.2-57) and collapse of the stone exterior were often observed. The several damages on wood houses caused by the slope land or the embankment were observed. The damage on the wood house due to large ground deformation caused by the earthquake motion was also found (Photo 6.2-58). It was confirmed that the metal fasteners were installed in the column end joint and the brace end joint of this house. (Photo 6.2-59). Besides the story drift, the crack of concrete foundation (Photo 6.2-60), the crack and loss of the exterior siding board, the broken window glass, and the failed ceiling of eaves (Photo 6.2-61) were observed.

Photo 6.2-57 Damage of wood deck in Toyohara-Otsu, Nasu Town

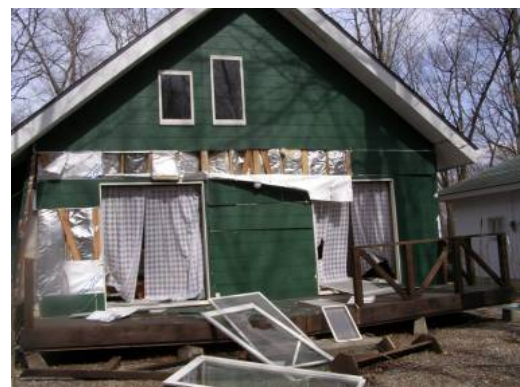
Photo 6.2-58 Heavily damaged wood house

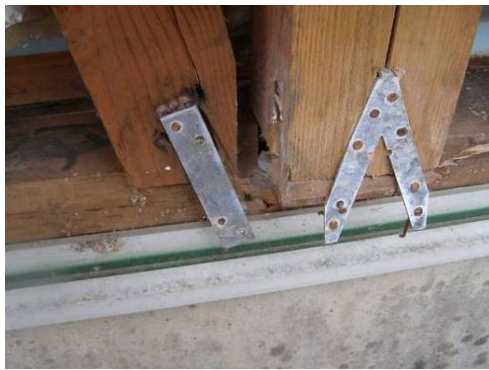
Photo 6.2-59 Metal fastener at the end of column and brace

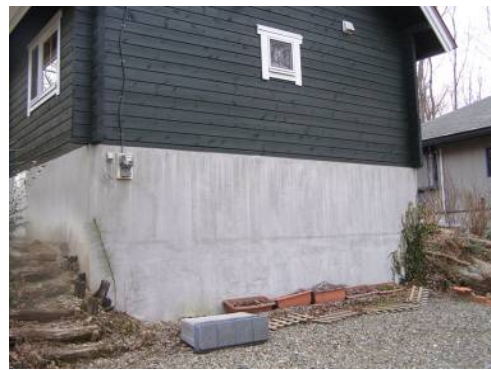
Photo 6.2-60 Crack of foundation

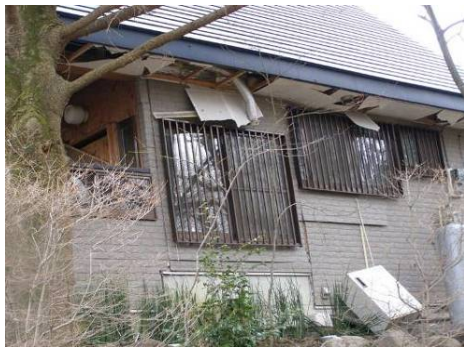
Photo 6.2-61 Failed ceiling of eave

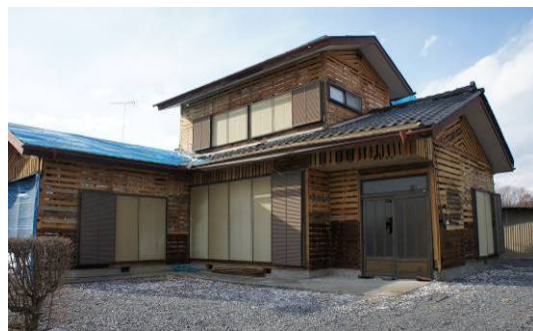
In Nishi-Ohkubo area, the several wood houses whose exterior mortar wall in the 1st floor was almost failed were found (Photo 6.2-62). And, the wood house with large story drift (Photo 6.2-63) and the other one damaged due to deformation of the residential land (Photo 6.2-64) were found.

Photo 6.2-62 Damage of exterior mortar wall

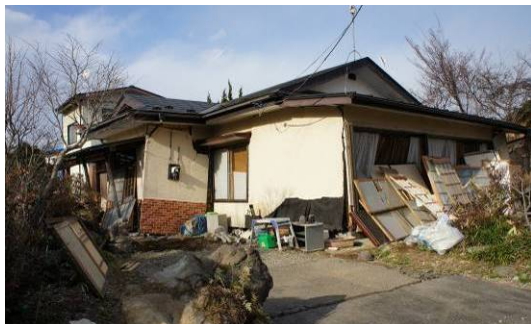
Photo 6.2-63 Wood house with large story drift

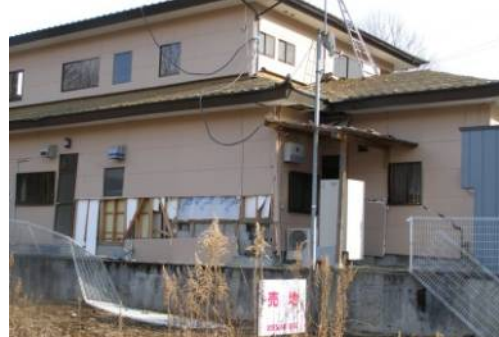
Photo 6.2-64 Damaged house due to deformation of residential land

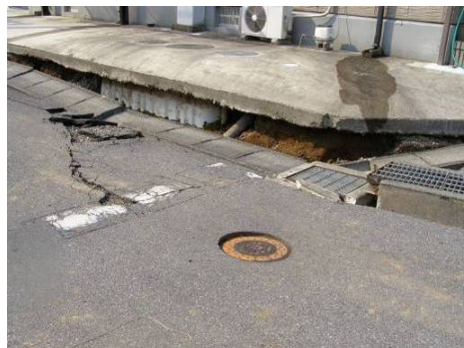
In Lobin-city (Photo 6.2-65), the cracks of fence and retaining wall, the caving of road bed, the ups and downs of the residential land (Photo 6.2-66) and the crack of the foundation concrete (Photo 6.2-67) were often observed. In addition, damage on the roof tile, especially top of the roof, and collapsed concrete block fences were observed.

Photo 6.2-66 Ups and downs of residential land

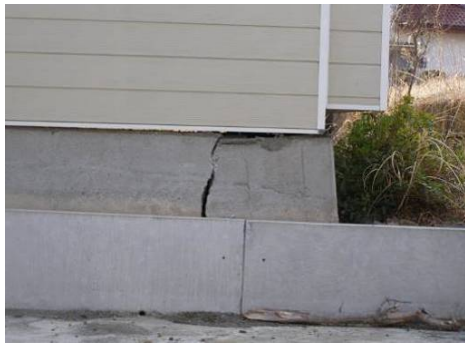
Photo 6.2-67 Crack of foundation

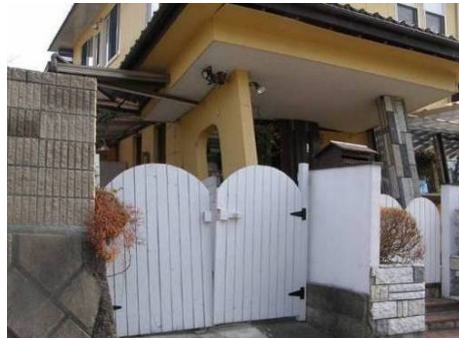
Narita-Happy-Highland at the north of Lobin-city was a developed residential land. Most of the damage on buildings was due to the deformation of the residential land. A wood house with 1/10 radian shear deformation (Photo 6.2-68) was found.

Photo 6.2-68 Wood house with large shear deformation

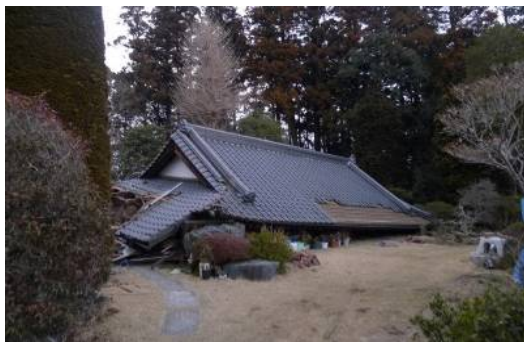
There were a lot of damaged fence made by the Ohyaishi stone. A collapsed farm type house was observed (Photo 6.2-69, 6.2-70). The mortar plastered wall finish of the wood house at the land filled paddy field fell down (Photo 6.2-71).

Photo 6.2-69 Collapsed wood house

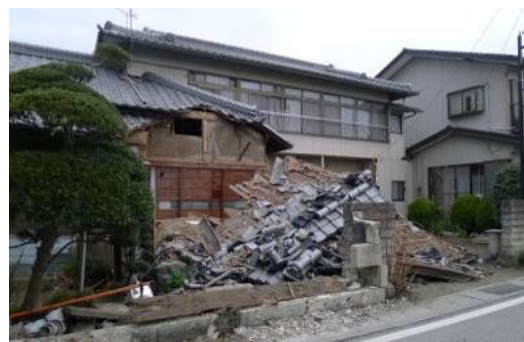
Photo 6.2-70 Breakage of entrance part.

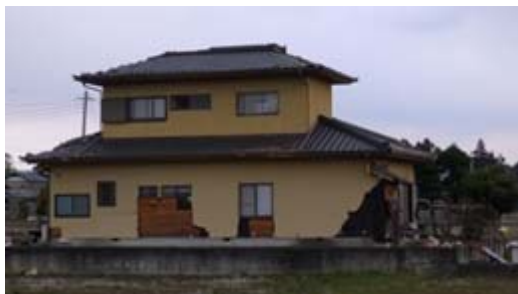
Photo 6.2-71 Falling down of mortar plastered wall

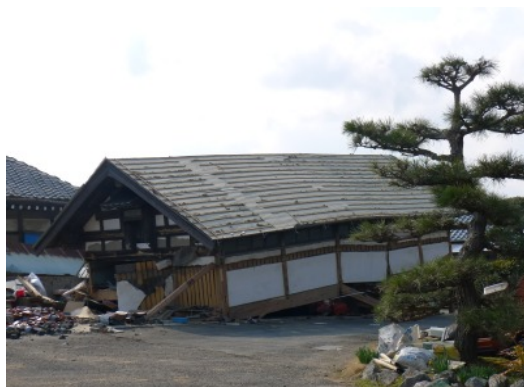
At Kadobeshimogawara in Naka city, there were a lot of collapsed barns (Photo 6.2-72) and heavily damaged nagayamon gates (Photo 6.2-73). A damaged house with store was observed (Photo 6.2-74). A lot of collapsed barns were observed at Kadobeakutsu.

Photo 6.2-72 Collapsed nagayamon gate (Kadobe)

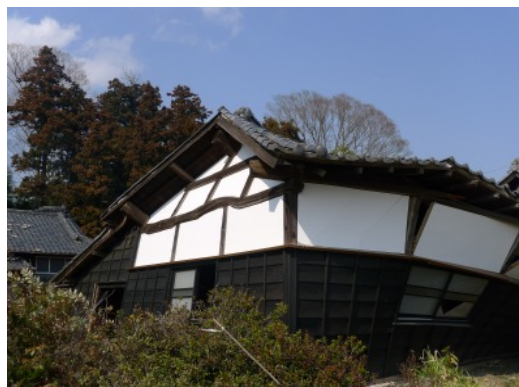
Photo 6.2-73 Tilted nagayamon gate (Kadobe)

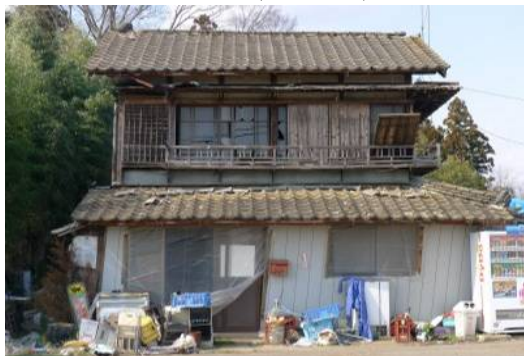
Photo 6.2-74 Damaged house with store (Kadobe)

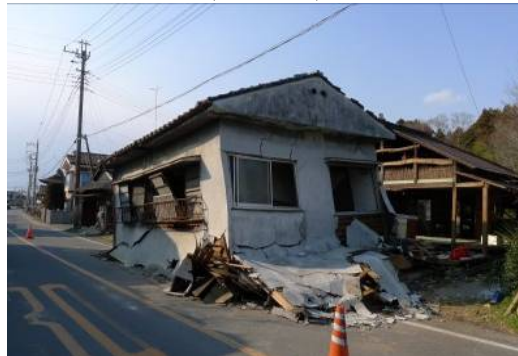
A two story wood house with mortar finish collapsed at the urban area of Urizura in Naka city (Photo 6.2-75).

Photo 6.2-75 Collapsed house (Urizura)

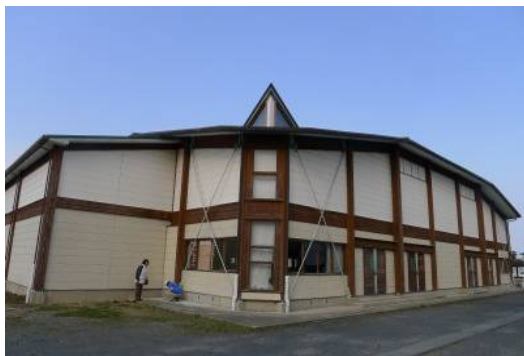
Photo 6.2-76 Wood gymnasium

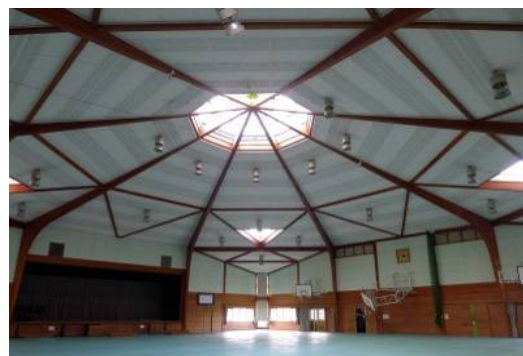
Photo 6.2-77 Inside of the gymnasium

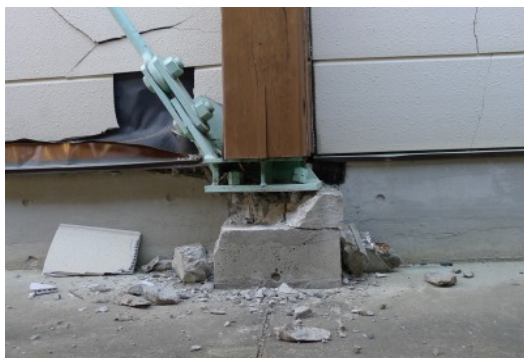
Photo 6.2-78 Breakage of the foundation concrete

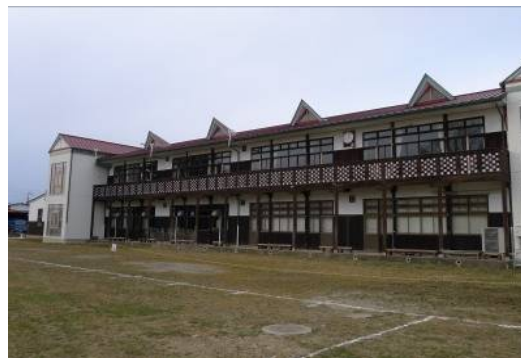
Photo 6.2-79 Wood school building

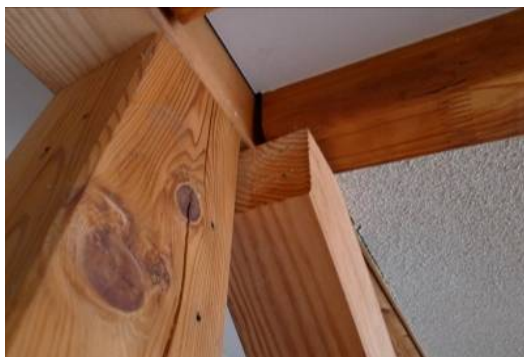
Photo 6.2-80 Slip of the wood brace

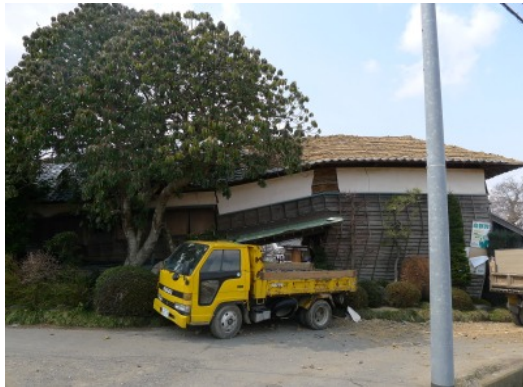
There was a heavily damaged Nagayamon gate at Yoshinuma-cho (Photo 6.2-81). The damaged barns were observed at Aoyagi-cho, Yanagawa-cho, Taya-cho (Photo 6.2-82).

Photo 6.2-81 Heavily damaged Nagayamon gate (Yoshinuma-cho)

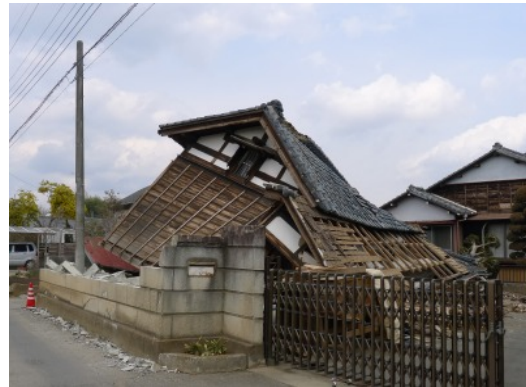
Photo 6.2-82 Damaged barn (Aoyagi-cho)

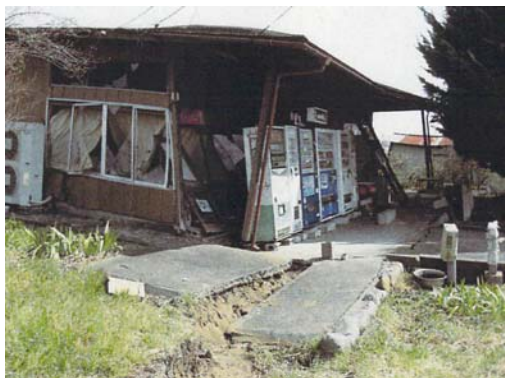
According to the Joso city office, Ibaraki prefecture, structural damage was not observed for houses. An announcement of collapsed house immediately after the earthquake, is thought to be the damage to a wood hut in a resting place. The house built in the side of Lake of crescent was inclined because of the soil liquefaction (Photo 6.2-83, 6.2-84). Although there were several inclined houses because of the soil liquefaction, a lot of damage to the roof tile were observed, and it seemed that the ratio of the damage of the roof tile was comparatively high.

Photo 6.2-83 Damage of resting place (Joja-machi, offered by Joso city office)

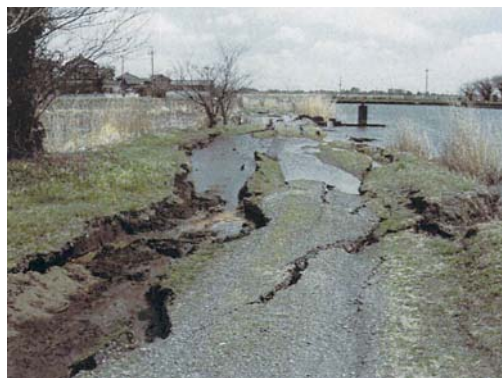
Photo 6.2-84 Damage of ground near the resting place (offered by Joso city office)

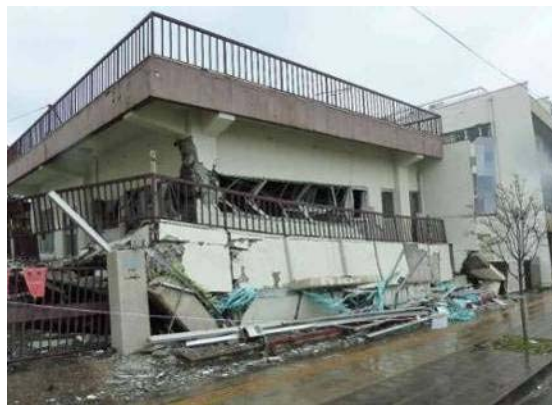
The first story in a two-story RC office building shown in Photo 6.3-1 was completely collapsed in Wakabayashi ward, Sendai city. In addition, the shear failure and the axial deformation of the columns on the second floor of this building caused the buckling of the longitudinal reinforcements and the fracture of the hoops of columns in the first story.

Photo 6.3-1 First-story collapsed building (Wakabayashi ward, Sendai city)

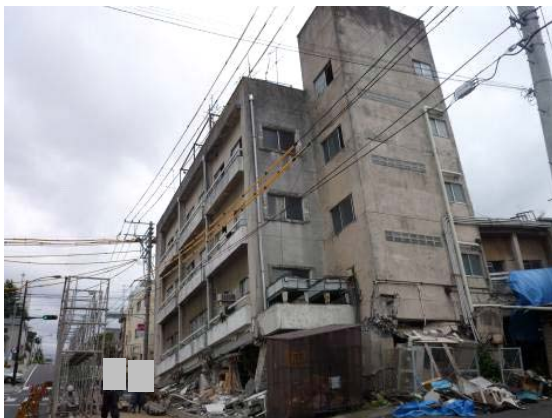
The soft-first story collapse occurred on the four-story RC residential building with a shop in the first floor in Koriyama city, and is attributed to the shear failure of the columns on the first story and the torsional deformation (Photos 6.3-2 and 6.3-3). The RC shear wall on the first story was collapsed out-of-plane with buckling of reinforcing bars.

Photo 6.3-2 First-story collapsed building (Koriyama city)

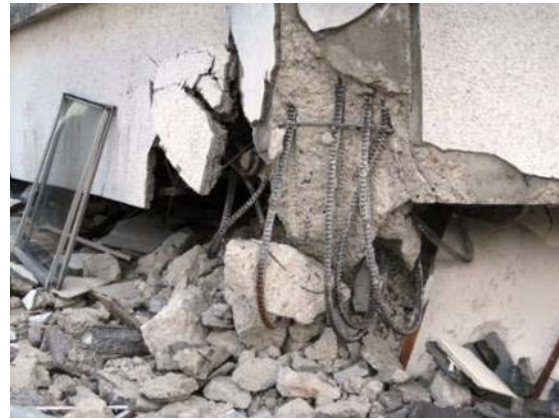
The three-story RC building shown in Photo 6.3-4 was severely damaged on the first story, which was located at the intersection in Sukagawa city, had a few walls on the facade on the first story and many walls on the back of the first story and the second story and higher. The corner columns faced to the intersection were significantly destroyed as shown in Photo 6.3-5. The loss of axial load carrying capacity of the first-story columns caused the drop of the second and higher stories.

Photo 6.3-5 Close-up view of the fallen story

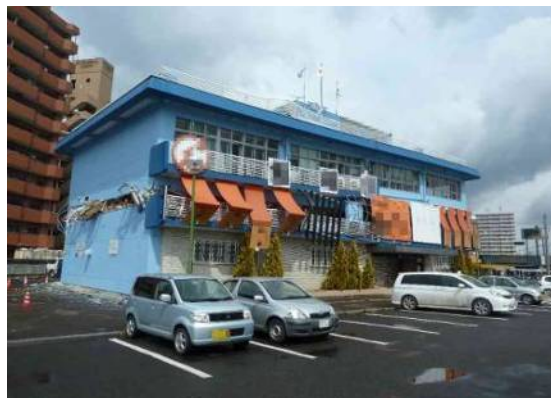
The three-story office building shown in Photo 6.3-6 in Wakabayashi ward, Sendai city partially collapsed on the second story and the building tilted. Only the second story has openings on the wall at the gable side, as shown in the left of Photo 6.3-6. For this reason, it was assumed that the openings were intensively deformed and resulted in shear failure of the short columns formed by the hanging and spandrel walls. The shear failure of the long columns on the third story was observed possibly due to the effect of the collapse of the second story. The damage to the columns and beams on the first story was not seen, while shear cracks were observed on the nonstructural walls.

Photo 6.3-6 Mid-story collapsed building (Wakabayashi ward, Sendai city)

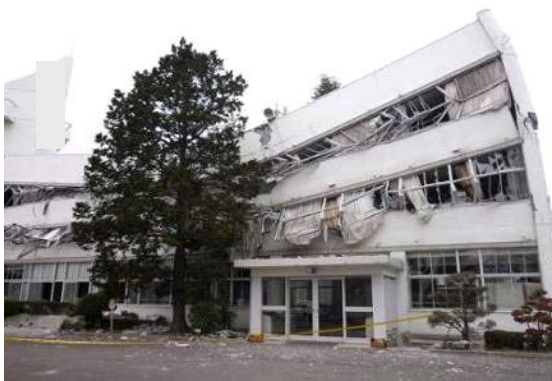
1966 and has a Y-letter shape plan in Fukushima city. The mid-story collapse occurred on the second story, and the part of the third story was heavily damaged. In addition, the shear failure also occurred on the columns in the first story, as shown in Photo 6.3-8. Visual damage was not seen in other school buildings and the gymnasium on the same site. The seismic indices of the structure, I_s on the first and second stories of the building were below the seismic demand index of structure, I_{s0} by the seismic evaluation method ^{6.3-1)}, therefore the seismic retrofit of the building was being planned.

Photo 6.3-7 Mid-story collapsed building (Fukushima city)

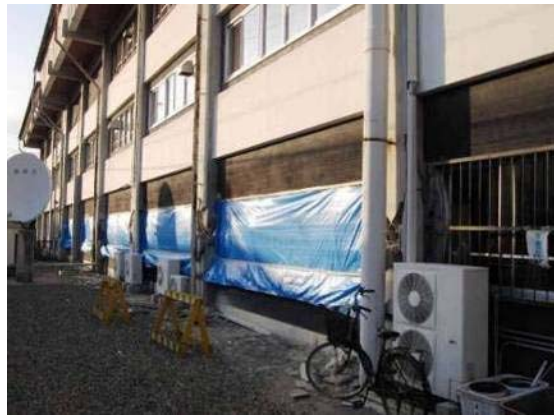
The three-story RC building constructed in 1963 was suffered from the shear failures of columns in Tono city, where the JMA seismic intensity was 5 upper (5+) (Photo 6.3-9). Two extremely short columns on the first-story, four columns on the northern plane of structure and an interior shear wall were failed in shear as shown in Photo 6.3-10, and short columns with spandrel wall, some long columns on the southern plane of structure had shear cracks. The post-earthquake damage evaluation ^{6.3-2)} was conducted for the building in the longitudinal direction. In the result, the building was determined to represent heavy damage (residual seismic performance ratio, $R=57.8\%$). The building had been damaged in the South Sanriku Earthquake in 2003 (JMA seismic intensity 6 lower). For this reason, cover concrete was then recast on the shear-cracked columns, and the existing columns were temporary strengthened with H-shaped steel, as shown in Photo 6.3-11. However, the 2011 Tohoku earthquake affected these columns again.

Photo 6.3-9 Appearance of the damaged building (Tono city)

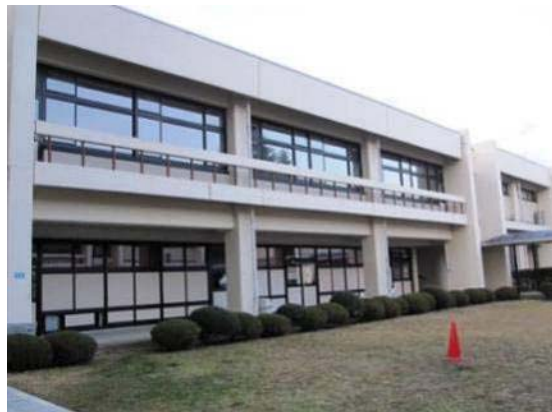
The next case is that the shear failure occurred on the first-story columns in the two-story RC building in Aoba ward, Sendai city (Photos 6.3-12 and 6.3-13). Some columns of the building were intact after the mainshock on March 11, but aftershocks caused shear failure to some of them, as shown on the right of Photo 6.3-13. It was confirmed that the aftershocks accelerated the damage level of this building.

Photo 6.3-12 Appearance of the damaged building (Aoba ward, Sendai city)

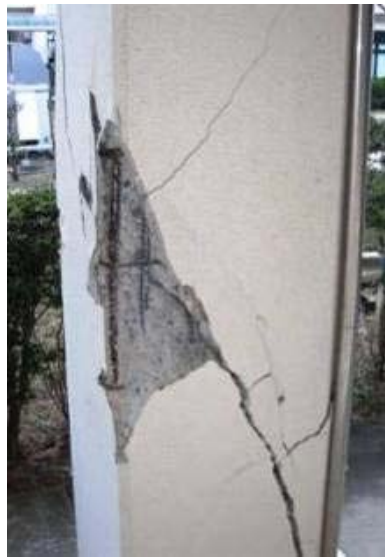
Photo 6.3-13 Shear cracks of first-story columns
