September 2011

**Summary of the Field Survey and Research on
“The 2011 off the Pacific coast of Tohoku Earthquake”
(the Great East Japan Earthquake)**

National Institute for Land and Infrastructure Management (NILIM)
Ministry of Land, Infrastructure, Transport and Tourism, Japan

Building Research Institute (BRI)
Incorporated Administrative Agency, Japan

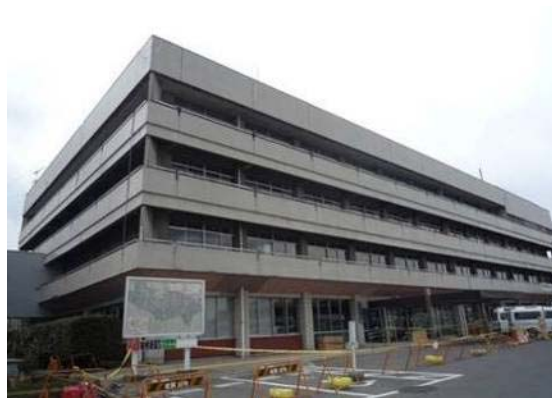
Photo 6.3-14 shows the four-story RC building that was constructed in 1970 in Sukagawa city. The columns with the spandrel wall on the first story were heavily damaged in shear and shorten in the axial direction as shown in Photo 6.3-15. The same damage was seen on the second-story exterior columns. Some of the reinforcing bars of the damaged columns that were raised from the foundation are anchored with a 180-degree hook near the mid height of story. It is considered that the shear failure began at the point. Two shear walls were severely damaged, which are arranged in the center core of the building to resist mainly horizontal forces. In particular, the second-story core wall was failed in shear in both of the span and longitudinal directions, and the longitudinal reinforcements in the boundary column of shear wall were heavily buckled as shown in Photo 6.3-16.

Photo 6.3-14 Appearance of damaged building (Sukagawa city)

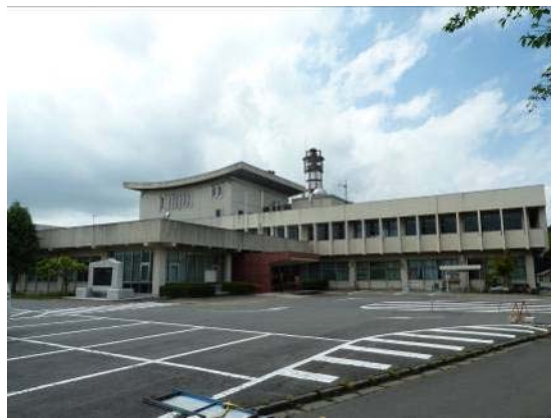
The three-story RC building constructed in 1964 on a hill in Kasama city shown in Photo 6.3-17 suffered also damage. Cracks in the ground were observed around the building. As seen in the photo, the RC structure on the first story was severely damaged. Shear failure occurred on many exterior columns, which were made shorter in clear height by the hanging and spandrel walls without structural slit, as shown in Photo 6.3-18. In addition, the failures of the shear walls with openings were observed (Photo 6.3-19).

Photo 6.3-17 Appearance of damaged building (Kasama city)

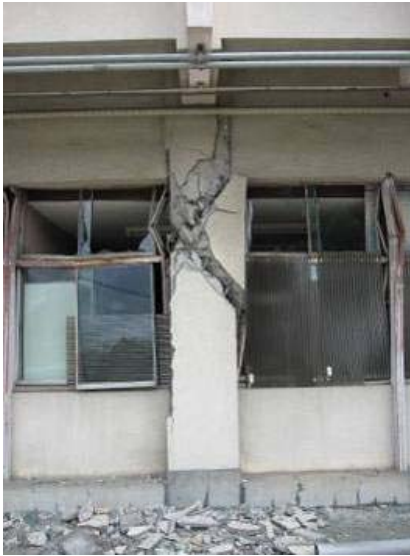
Photo 6.3-18 Shear failure of column

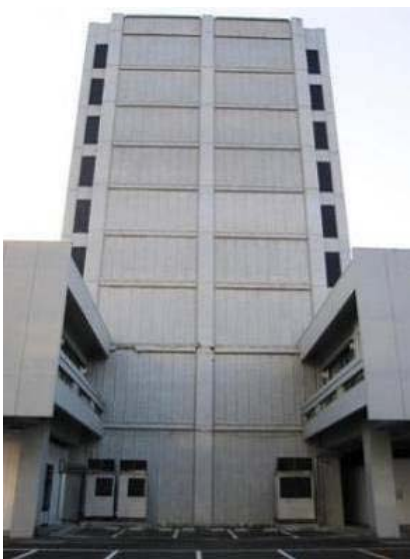
The building that consists of nine-story SRC and two-story RC structures in Aoba ward, Sendai city suffered from the earthquake (Photo 6.3-20). In the high-rise building, the multi-story shear wall of the gable side was subject to flexural failure at the third floor. Crushing of concrete and buckling of the longitudinal reinforcements was observed at the bottom of the boundary column of shear wall, as shown in Photo 6.3-21. This building was also damaged by the Miyagiken-oki Earthquake in 1978 and had been retrofitted.

Photo 6.3-20 Appearance of damaged building (Aoba ward, Sendai city)

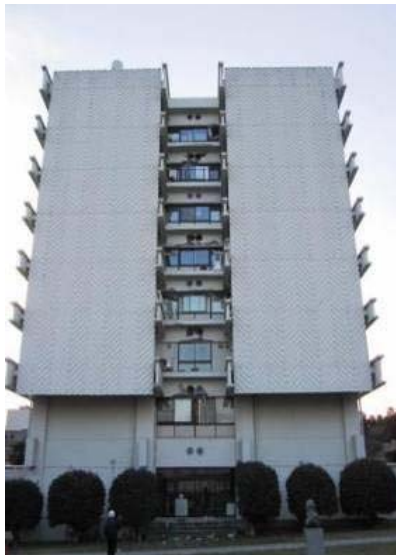
The shear failure or bond splitting failure occurred on the link beam connecting coupled shear walls from low-rise to high-rise stories on the eight-story RC building in Aoba ward, Sendai city, as shown in Photo 6.3-27. The link beams have two openings at the center of them, and were damaged around these parts (Photo 6.3-28).

Photo 6.3-27 Appearance of damaged building (Aoba ward, Sendai city)

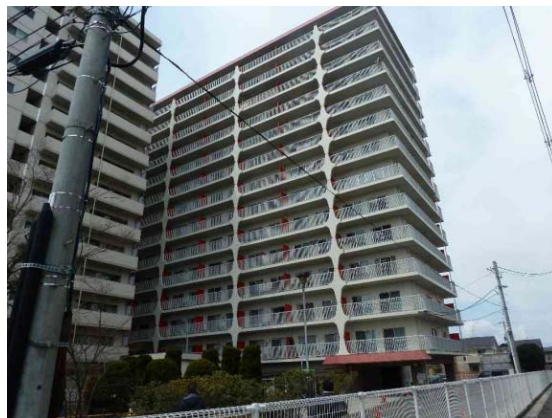
The fourteen-story RC building shown in Photo 6.3-29 was settled down and was tilted about 1/70 radian, which was one of two residential buildings located in L-shape with expansion joint in Miyagino ward, Sendai city. The shear cracks on the nonstructural walls over every story and some parts of mullions occurred in both buildings as shown in Photos 6.3-30 and 6.3-31, which damage was classified as B-2. Though the other building without inclination had same shear cracks on the nonstructural walls from first to sixth story in the Miyagiken-oki Earthquake in 1978 and had been repaired with concrete replacement, almost same damage was happened on the similar part.

Photo 6.3-29 Appearance of tilted building (Miyagino ward, Sendai city)

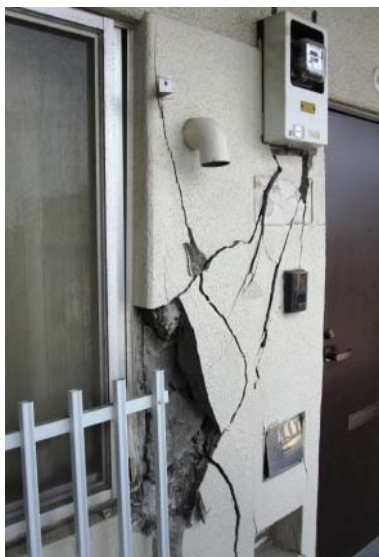
Photo 6.3-30 Shear cracks on nonstructural wall

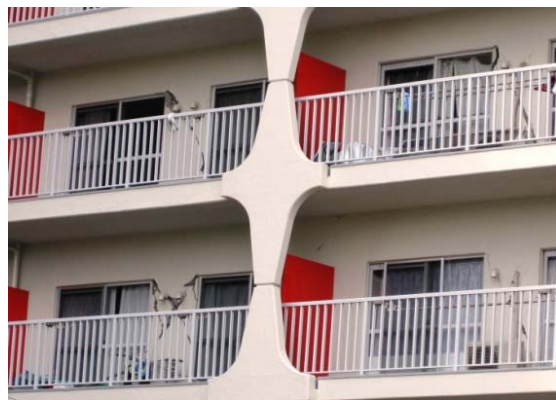
Photo 6.3-31 Shear cracks on mullion

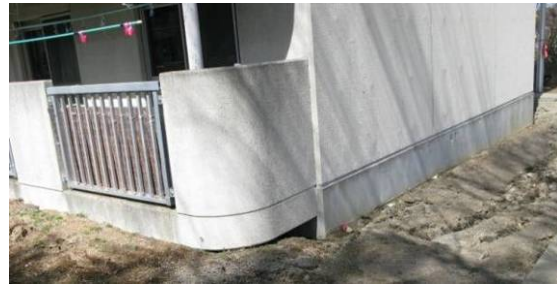
Photo 6.3-32 shows a residential building that sank and leaned in the longitudinal direction in Shirakawa city. The balcony, of which height above ground level was about 77cm, went down to ground surface in the gable side, as shown in Photo 6.3-33.

Photo 6.3-33 Sunken balcony

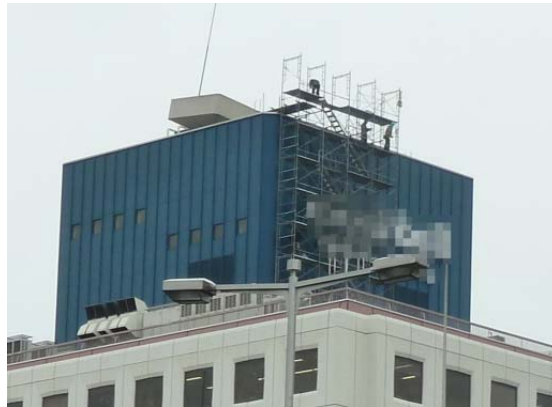
The damage on penthouses was observed everywhere, like tilting of it in Aoba ward, Sendai city, as shown in Photo 6.3-34. The clock tower attached to the five-story RC building constructed in 1954 was destroyed at the bottom of it, despite the building was hardly damaged in Fukushima city (Photos 6.3-35 and 6.3-36).

Photo 6.3-34 Damaged penthouse (Aoba ward, Sendai city)

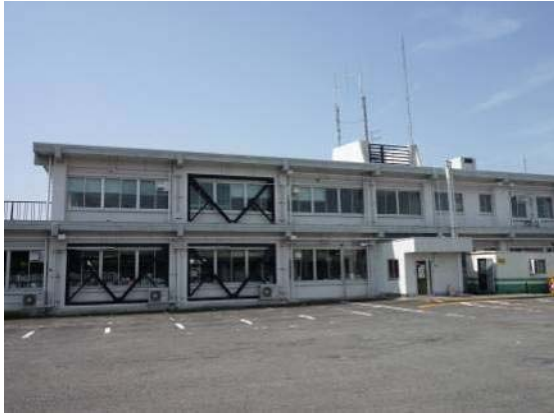
Photo 6.3-37 shows the two-story RC office building constructed in 1969 in Hitachiomiya city. The building has been retrofitted with framed steel braces in the longitudinal direction in 2003, because the seismic index of structure, I_S on the first story of the building was below the seismic demand index of structure, I_{S0} by the seismic evaluation method ^{6.3-1)}. Meanwhile, the building in the span direction was not retrofitted, as a consequence of that the seismic index of structure in the direction satisfied the seismic demand index of structure. The steel braces are eccentrically installed to the center axis of the beams and columns.

Photo 6.3-37 Appearance of damaged building (Hitachiomiya city)

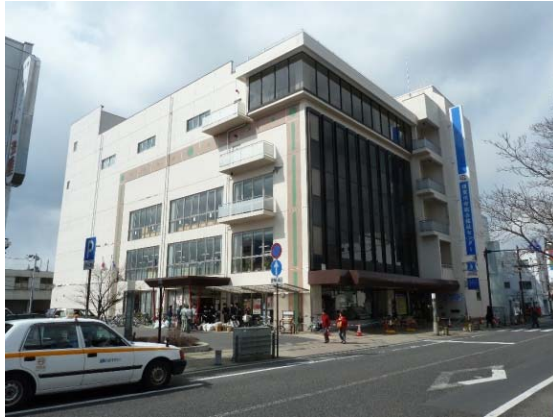
The separation of cover concrete at the bottom of wing wall was observed on the five-story RC building constructed in 2007 in Sukagawa city, as shown in Photos 6.3-39 and 6.3-40. In this report, that case is classified as the damage of nonstructural elements, because the wing wall is generally designed as the nonstructural element, which is not expected to resist the external force.

Photo 6.3-39 Appearance of damaged building (Sukagawa city)

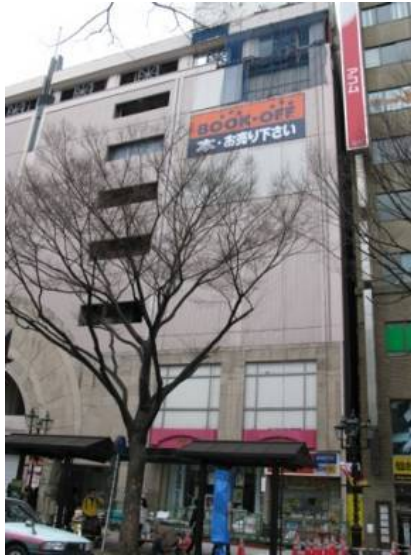
Photo 6.3-47 Damaged building with AAC panels (Aoba ward, Sendai city)

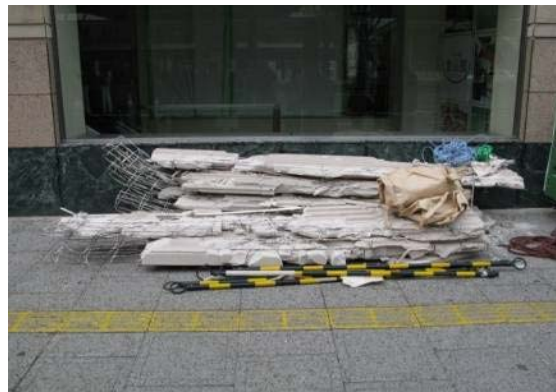
panel on the upper floor in the eight-story building fell away, and Photo 6.3-49 is the case where the tile on exterior wall was dropped, in Aoba ward, Sendai city.

Photo 6.3-48 Dropped AAC panels

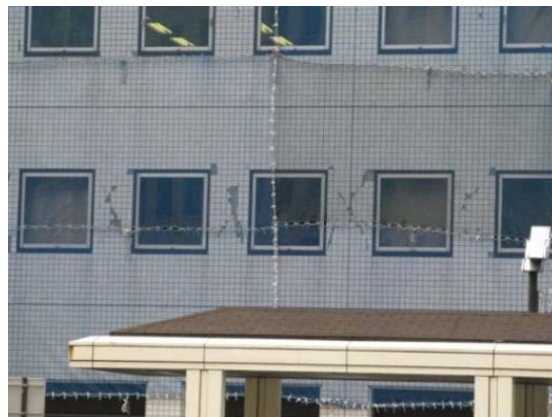
Photo 6.3-49 Damage of tile on exterior wall

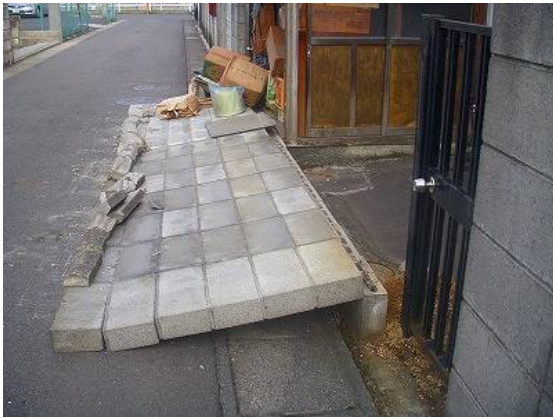
The collapse of concrete block wall and stone masonry wall are well known as earthquake damage caused by strong seismic motion. The damage of that type was often observed in the field investigation, as shown from Photo 6.3-50 to Photo 6.3-53.

Photo 6.3-50 Collapse of concrete block wall (Koriyama city)

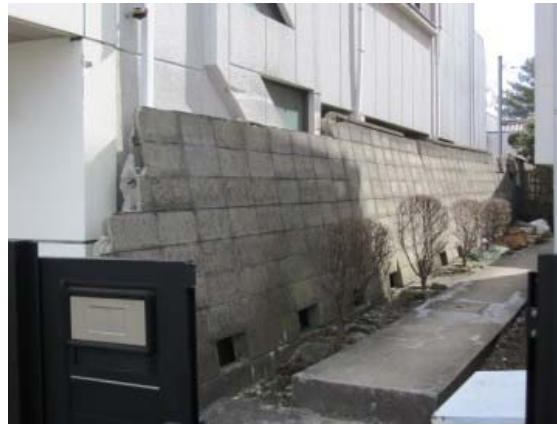
Photo 6.3-51 Collapse of concrete block wall (Sukagawa city)

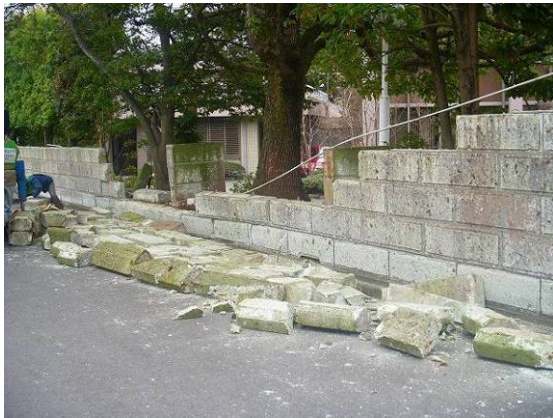
Photo 6.3-52 Collapse of stone masonry wall (Fukushima city)

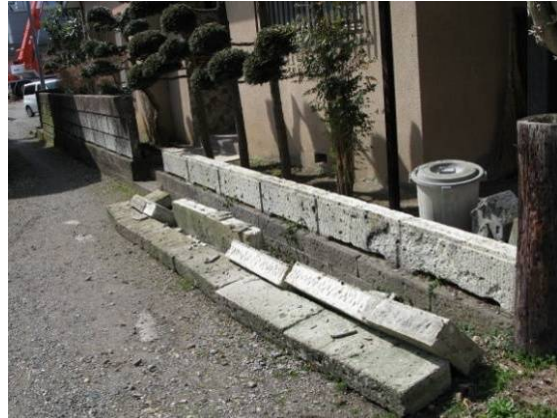
Photo 6.3-53 Collapse of stone masonry wall (Shirakawa city)

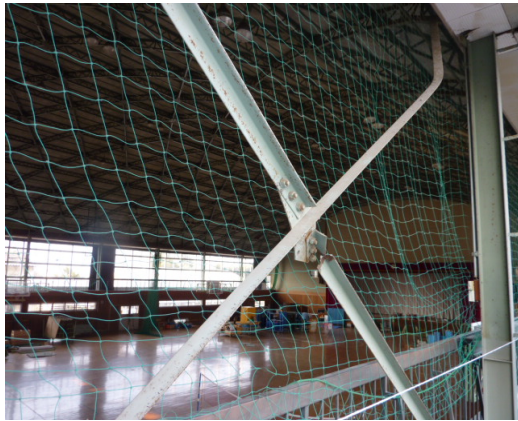
Buckling of brace member (Photo 6.4-1) and fracture of brace joint (Photos 6.4-2 ~ 6.4-4) were observed. Angle section was often used for many brace members, but circular hollow section steel (Photo 6.4-3) was also used for brace members. Fractured sections include steel plate inserted into steel pipe, end of bracing member and section loss part by bolt hole. These types of the damage are classified into the severe damage category based on the damage evaluation standard^{6.4-4)}. The number of the gymnasiums of this type is 3. The gymnasiums constructed under the previous seismic code that were severely damaged by the Mid Niigata Prefecture Earthquake in 2004 had accounted for about 30% of the total^{6.4-1)~6.4-3)}. It is impressed that a rate of the gymnasiums severely damaged by the 2011 Tohoku earthquake was lower than by the Mid Niigata Prefecture Earthquake in 2004.

Photo 6.4-1 Buckling of brace

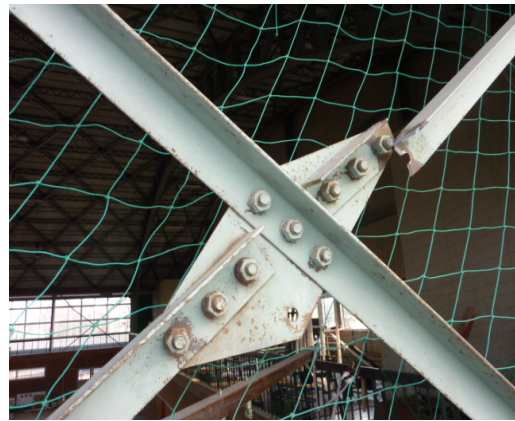
Photo 6.4-2 Net section fracture at bolt hole

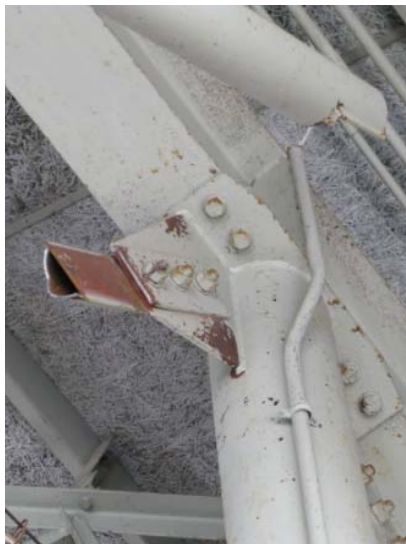
(a) Fracture at column top

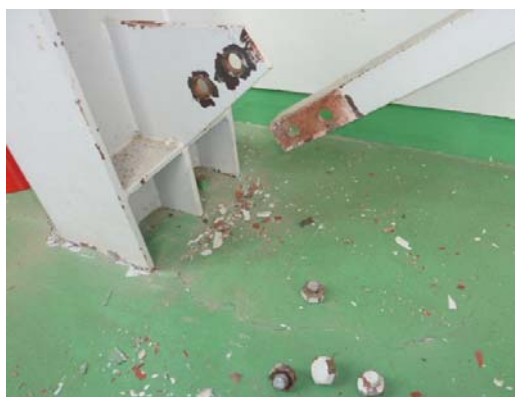
Photo 6.4-4 Fracture of bolts

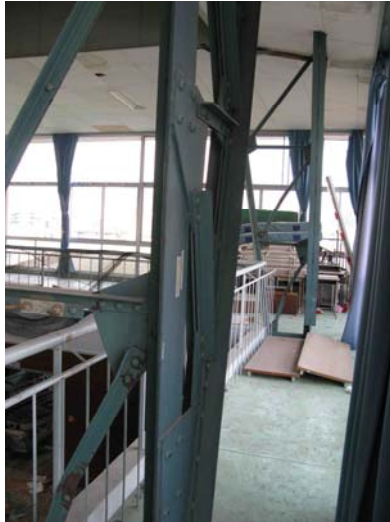
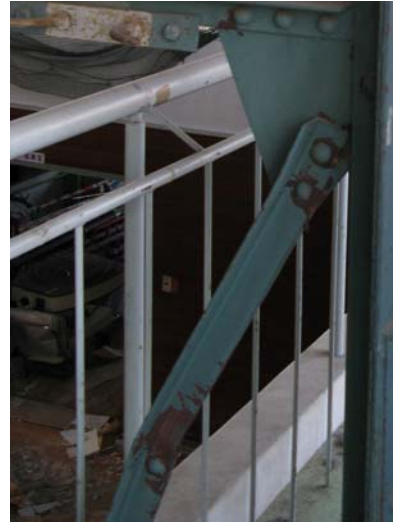
In one of the investigated gymnasiums, buckling of diagonal members in some latticed columns was observed (Photo 6.4-5). Damage of column buckling caused in steel frames for span direction had not been observed under the damage investigations of the Mid Niigata Prefecture Earthquake in 2004^(6.4-1)~6.4-3).

(a) Latticed column

(b) Buckling of diagonal member

Photo 6.4-5 Buckling of diagonal member of latticed column

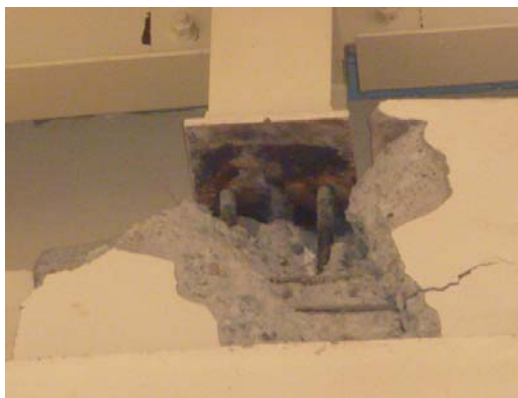
In the investigated gymnasiums, exposure of anchor bolts due to spalling of the concrete at connection (bearing support part) between the RC column and steel roof frame (Photos 6.4-6 and 6.4-7), spalling of finish mortars on the RC column at the roof bearing support part, and pullout of hole-in anchors (Photo 6.4-8) were often observed.

Photo 6.4-6 Spalling of concrete

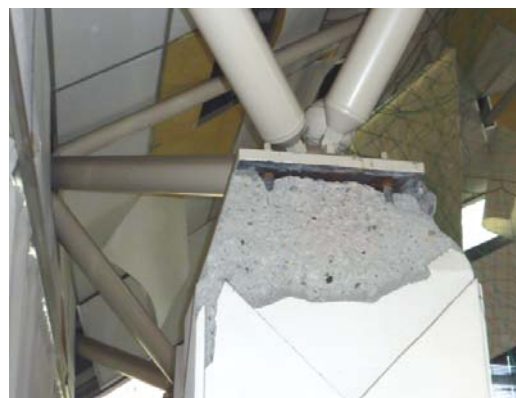
Photo 6.4-7 Spalling of concrete

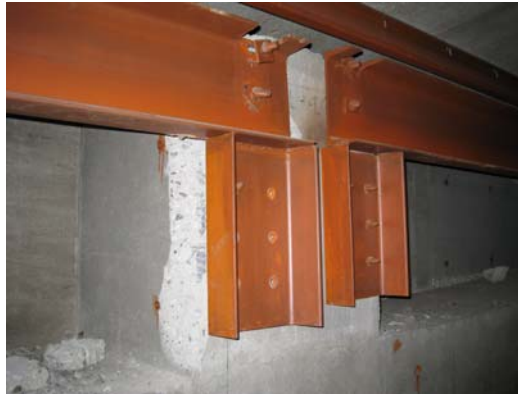
Photo 6.4-8 Pullout of hole-in anchors

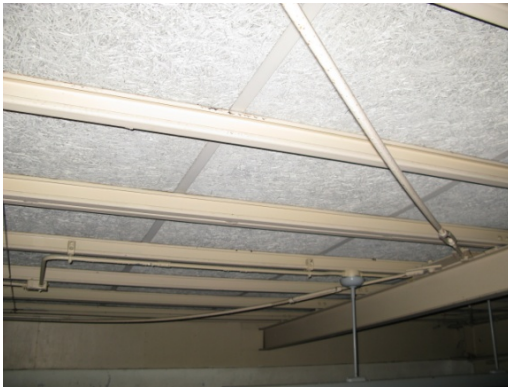
Roof horizontal braces were damaged in two high school gymnasiums and five elementary and junior high school gymnasiums. Such damage mainly occurred at horizontal braces with turnbuckles; obvious deflection of the horizontal brace (Photo 6.4-9) and fracture at thread and fracture of bolt connections were observed (Photo 6.4-10).

Photo 6.4-9 Deflection of horizontal braces

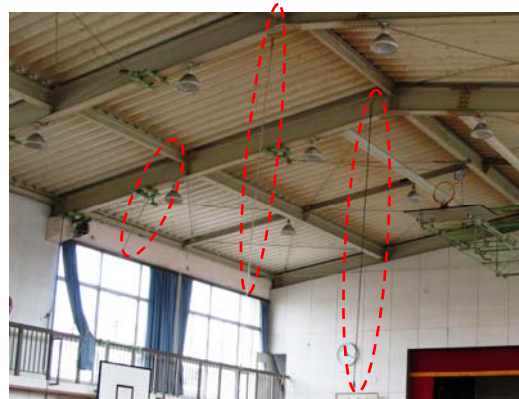
Photo 6.4-10 Fracture of horizontal braces

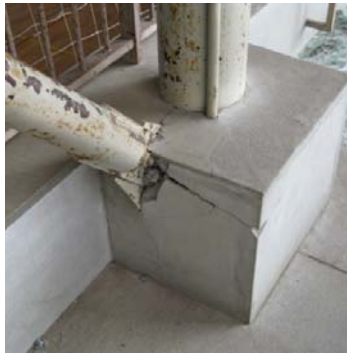
Damage of cracking of the column base concrete and mortar in the gallery of some gymnasiums was observed (Photo 6.4-11). Concrete and mortar of steel column base at a ground level was also cracked (Photo 6.4-12). However, almost all of these cracking are classified into minor or slight damage.

Photo 6.4-11 Cracking of column base concrete

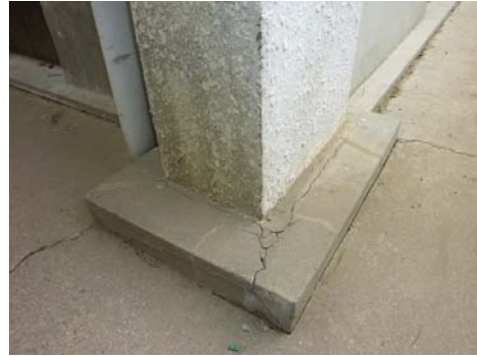
Photo 6.4-12 Cracking of column base concrete

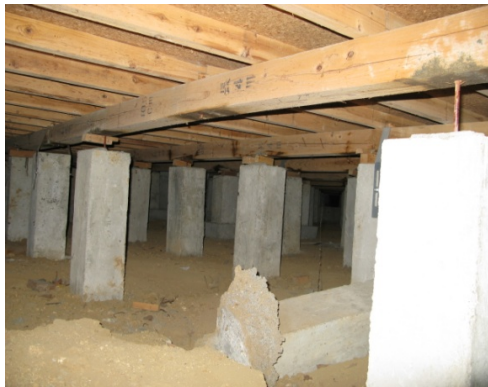
As the other types of the structural damage, the following damage was observed; (a) overturning of floor strut (Photo 6.4-13), (b) tilting of concrete block self-standing wall and (c) peeling of paint of beam members which was observed near the top of the V-shaped roof beams or arch beams (Photos 6.4-14 and 6.4-15). In terms of the peeling of paint, it is uncertain whether yielding of the beams occurred or not.

Photo 6.4-13 Overturning of floor strut

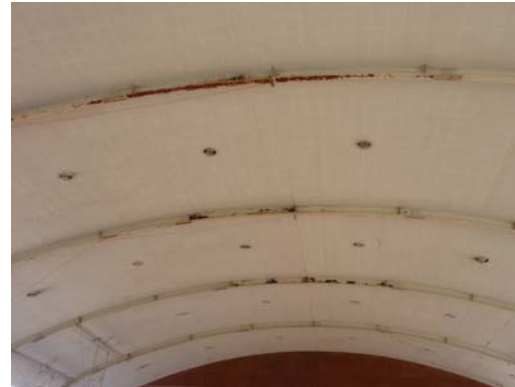
Photo 6.4-14 Peeling of paint of beams

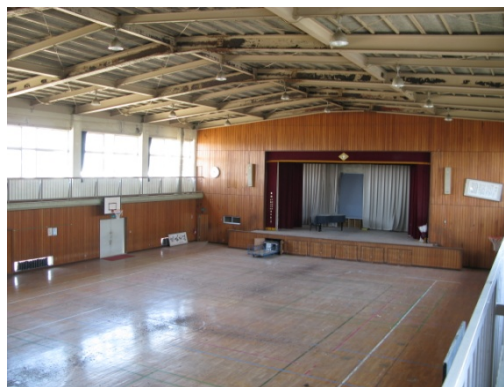
Photo 6.4-15 Peeling of paint of beams

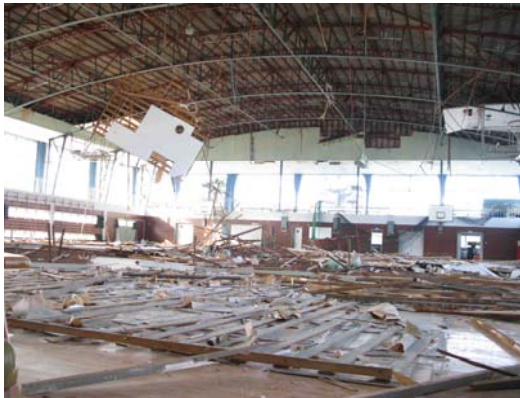
The types of nonstructural damage of gymnasiums include dropping of ceilings and lighting equipment (Photos 6.4-16 ~ 6.4-18), breakage of windows (Photo 6.4-19), dropping of exterior walls (Photo 6.4-20), dropping of interior walls and eave soffit (Photo 6.4-21). In particular, the severe damage such as dropping of extensive ceiling in the high school gymnasiums was observed more than in the elementary and junior high school gymnasiums.

Photo 6.4-16 Dropping of extensive ceiling components

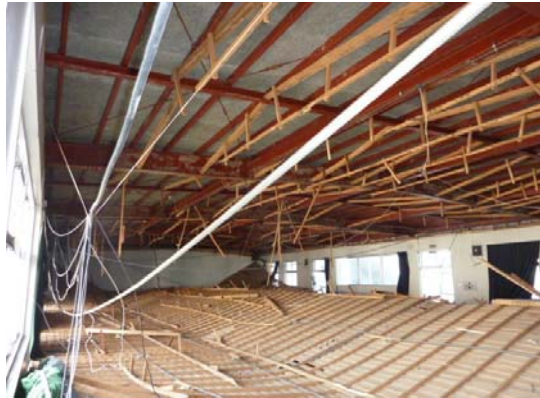
Photo 6.4-17 Dropping of extensive ceiling components

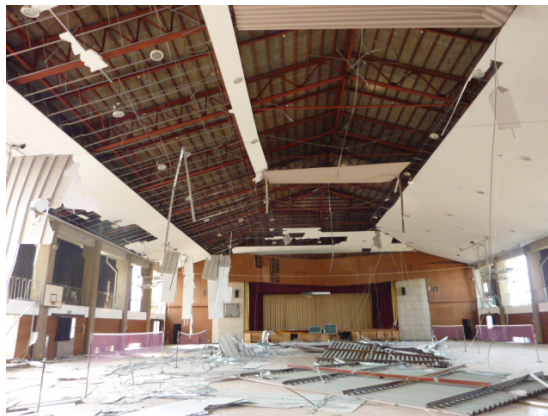
Photo 6.4-18 Dropping of extensive ceiling components

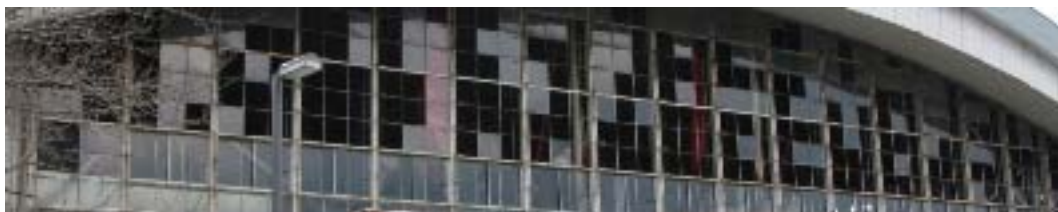
Photo 6.4-19 Breakage of windows

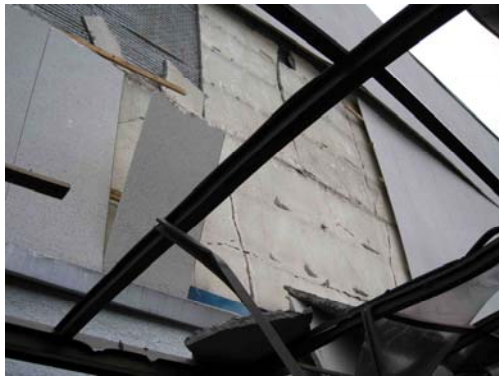
Photo 6.4-20 Falling of exterior finish components

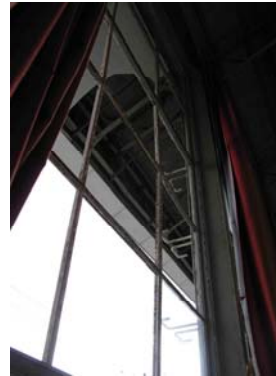
Photo 6.4-21 Falling of eave soffit

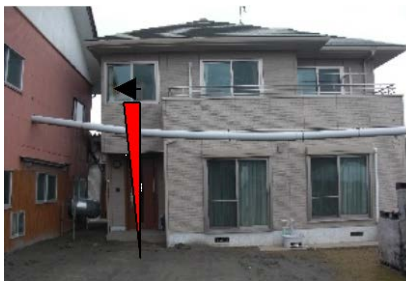
Photo 6.5-2 House tilted 5.0/100

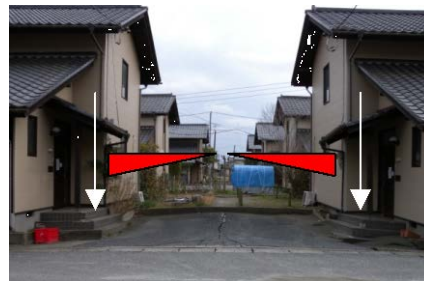
In Hinode, large-scale damage occurred in the area of about 200 m by 200 m along the Hitachi-tone River. Boiled sand, uplift of buried structures, and subsidence or tilting of utility poles, which were caused by liquefaction, were seen everywhere on the site. Many houses facing to the road subsided 20 to 30 cm from the front sidewalk (Photo 6.5-3). Foundation cracks or gaps were not observed.

Photo 6.5-3 Subsidence of two houses enclosing vacant land

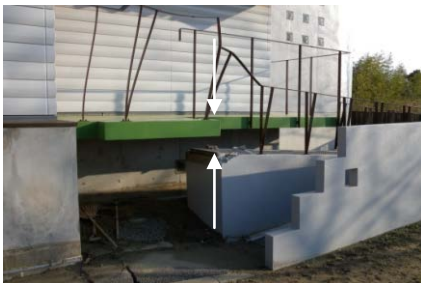
Photo 6.5-4 Slope difference in level

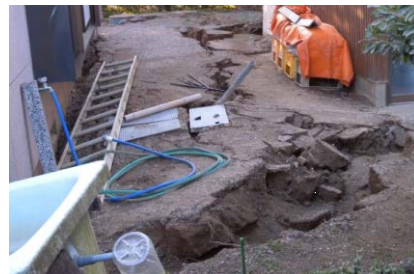
ground and caused about 30 cm of difference in level from the ground (Photo 6.5-5). Cracking or crack fissures on the foundations were not visually observed.

Photo 6.5-5 Crack in the site

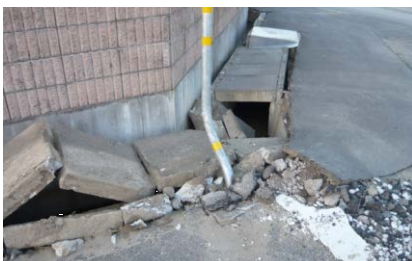
Photo 6.5-6 Damage of side ditch

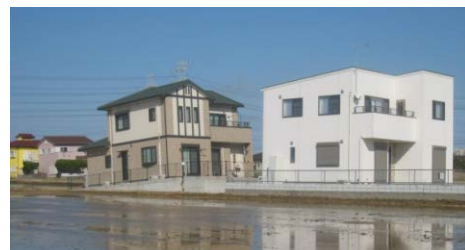
Fukashiba is located in the western part of Kamisu city and on the opposite side of Horiwai along Route 124. In this area, many houses were damaged due to ground deformation and embankment deformation. Most of the damage patterns of the houses seem to have included their movement, subsidence and tilting without structural damage on their upper structures or foundations (Photo 6.5-7).

Photo 6.5-7 Damage situations by liquefaction

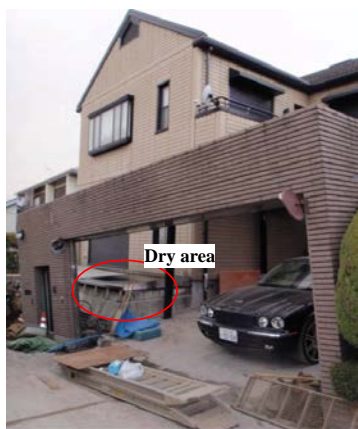
In Mihama, subsidence and tilting were observed in houses that have a dry area in the basement (Photo 6.5-8). An angle of tilting of the house was about 3 degrees. It is considered that the basement was uplifted and another remaining parts of the house was subsided. Around the house, in-site of house was totally covered with boiled sand by liquefaction, and a foundation of fence at site boundary was deformed. In addition, a carport in one building was ruptured and moved (Photo 6.5-9). A unit of the carport and the building was separated and moved about 50 cm due to the movement of the ground associated with liquefaction.

Photo 6.5-8 Tilted house

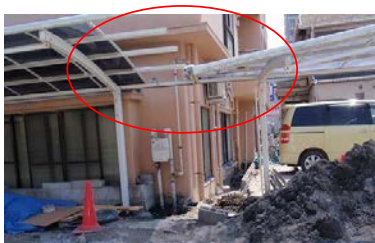
Photo 6.5-9 Moved carport

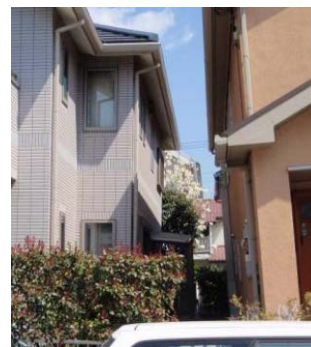
Significant tilting and subsidence of houses was observed at a zone in Benten (Photo 6.5-10). In another zone, the ground subsided by liquefaction, there were damage to which the road waved and a 10 cm of difference in level was generated between a side ditch and the road. These types of damage were concentrated on an extension line of the boundary between the sites of tilted houses. Inhabitants told us that there was an old river on a straight line where the damage was concentrated.

Photo 6.5-10 Settled and tilted house

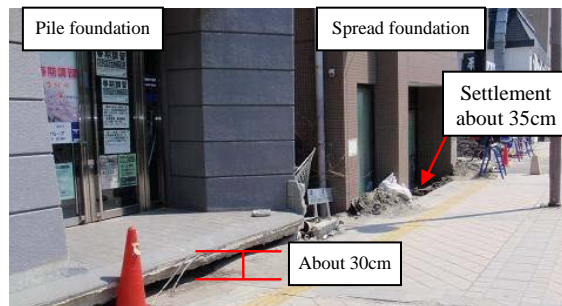
In Irifune, a difference in settlement between adjacent buildings on spread and pile foundations was observed. The building on spread foundation settled about 35 cm from the front sidewalk, while the case of building on pile foundation was about 30 cm of difference in level from the front sidewalk (Photo 6.5-11). Other settled and tilted buildings were dotted.

Photo 6.5-11 Difference in damage due to support mechanisms

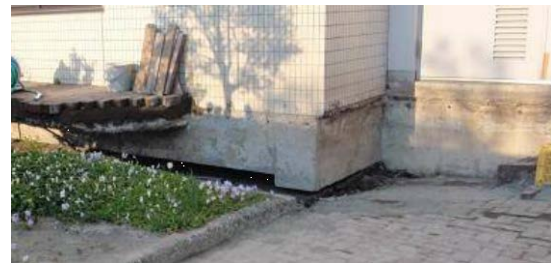
In Hinode, the ground subsidence was observed (Photo 6.5-12). This building is considered to have a pile foundation. A relative gap between the building and ground was about 50 cm. Building lifeline was damaged due to ground subsidence and displacement.

Photo 6.5-12 Building with subsidence of surrounding ground

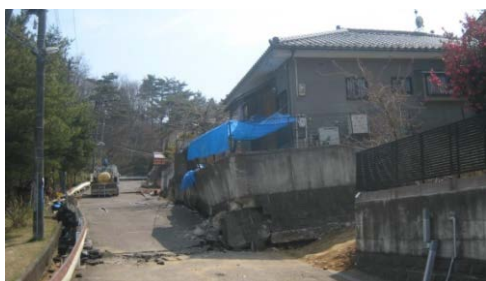
Photo 6.5-13 Damage to retaining wall and house by sliding and ground deformation

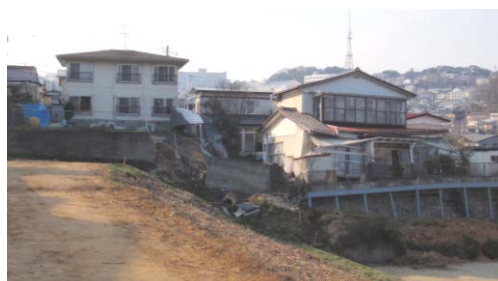
Photo 6.5-14 Group of houses damaged by sliding and ground deformation

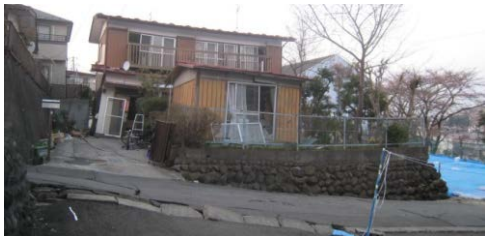
Photo 6.5-15 Damage to houses by sliding and ground deformation

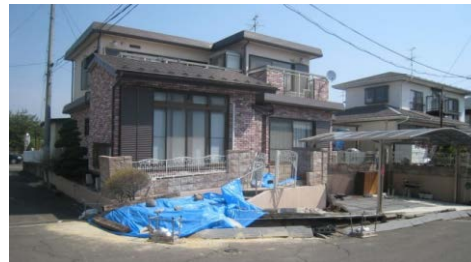
This is a housing area where a hill was developed. Fissures on the slope of the hill and near the top of the hill, and damage to housing foundations and retaining walls by deformation of the reclaimed area by banking, were observed in the area. The slope in 1-chome, Midorigaoka had been significantly collapsed under the 1978 Miyagi-oki earthquake. A level of ground deformation on the slope under the 2011 Tohoku earthquake was lower than that during the 1978 earthquake. Near at the top of the hill, ground deformation of the reclaimed area by banking caused fracture of the embankment retaining wall, damage to house foundations (Photo 6.5-16) and push-out of the retaining wall on embankment.

Photo 6.5-16 Houses damaged near the top of hill

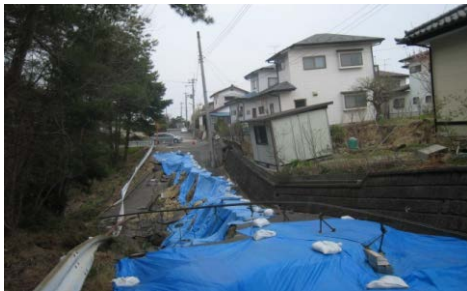
Photo 6.5-17 Fracture of embankment retaining wall and houses tilting by land sliding on the slope of hill end

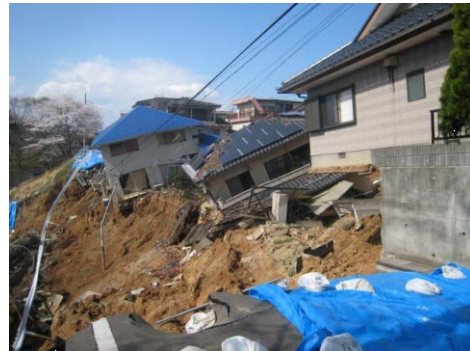
Photo 6.5-18 Land sliding of slope on the southwest of hill and sliding houses

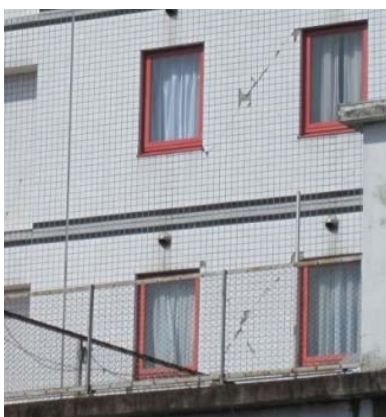
Detachment of ceramic wall tiles was often observed at buildings of RC nonstructural exterior walls. Types of the detachment are classified according to existence or nonexistence of crack on the damaged RC wall.^{6.6-1) 6.6-2)} In Photo 6.6-1, ceramic wall tile detached from RC exterior wall. Cracks were observed on the damaged RC wall. Photo 6.6-2 shows detachment of ceramic wall tiles installed on a cylindrical RC wall above the building entrance (within a circle). No crack was externally observed on the undersurface RC wall. A net was placed over the damaged area to catch falling tiles.

Photo 6.6-1 Detachment of ceramic wall tiles from damaged RC exterior wall

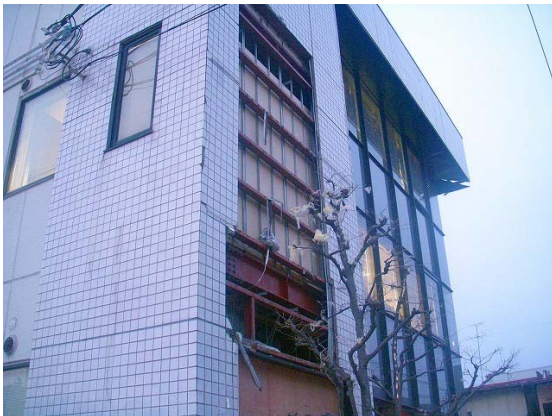
Damage to cement mortar and metal lath exterior walls was often observed in steel buildings. Photo 6.6-3 shows detachment of cement mortar and metal lath exterior wall in a 3-story building. Damage to the window glass was not observed, but cement mortar and metal lath fell from the exterior wall (shown in Photo 6.6-3) and from the parapet on another side. Photo 6.6-4 shows an one-story steel building in which cement mortar and metal lath detached from an exterior wall and from an eaves soffit. Photo 6.6-5 shows a damaged gable end wall of a gymnasium. This wall consisted of two layers. The undersurface wall was cement mortar and metal lath exterior wall. The surface one was exterior boards nailed to furring installed on the undersurface wall. Both were damaged and fell by the earthquake.

Photo 6.6-3 Falling of cement mortar and metal lath wall

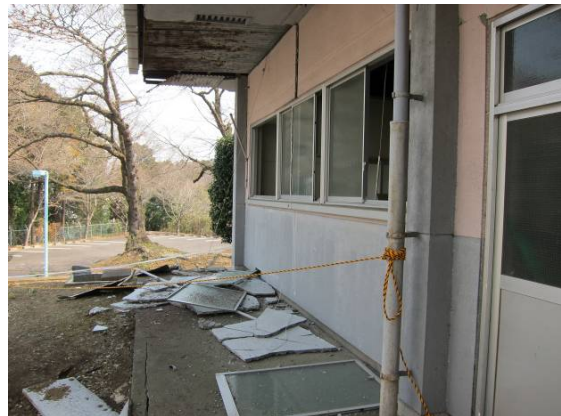
Photo 6.6-4 Falling of cement mortar and metal lath from eaves soffit

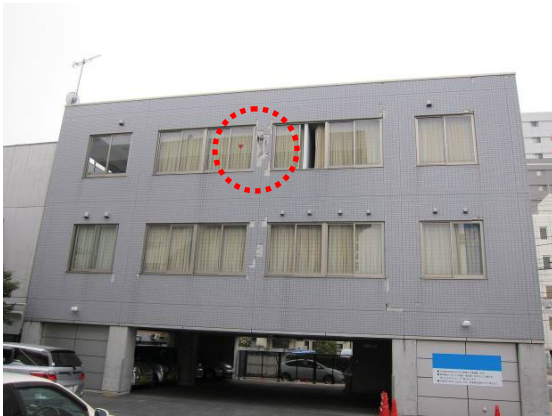
Photo from 6.6-6 to 6.6-7 shows damage to AAC panel exterior walls. Photo 6.6-6 shows falling of finishing ceramic wall tiles on AAC panels and broken light-weight aerated concrete in a 3-story building. Ceramic wall tiles on all faces of the exterior walls detached and the corners of the AAC panels were chipped. AAC panel was broken and internal iron wires were exposed at the circular broken line in the photo. AAC panels fell from another side. The construction method of the AAC panel exterior wall was not

Photo 6.6-6 Falling of ceramic wall tiles and breakage of AAC panels

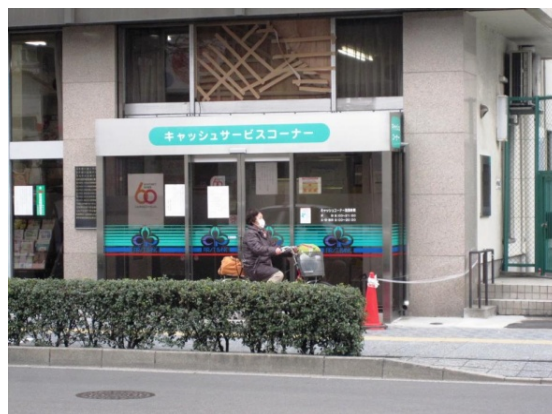
Photo 6.6-8 shows broken window glasses in the upper area of a windbreak room on the ground level of a 5-story building. Exterior wall ceramic wall tiles fell from another side.

Photo 6.6-8 Broken window glass

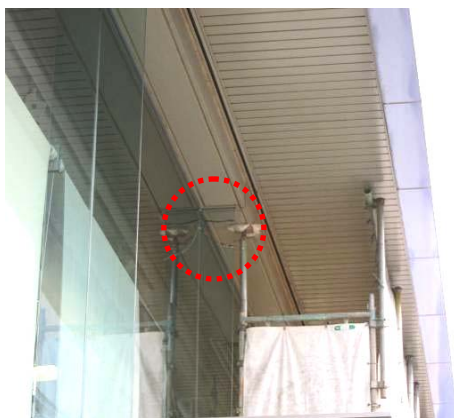
Photo 6.6-12 shows a damaged glass wall system at the 1st floor of a 6-story building. A glass mullion was broken in an area circled by a broken line (steel pipe adjacent to the broken glass were installed after the earthquake for the repair work).

Photo 6.6-12 Breakage of glass mullion of glass wall system

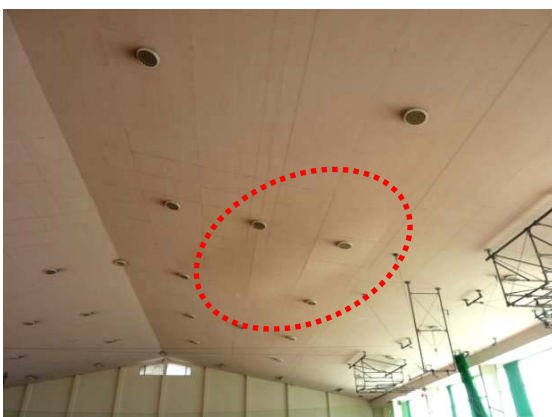
Photo 6.6-19 shows a damaged metal furring suspended ceiling in a gymnasium. Significant visual damage was not observed, but the ceiling board sagged near the center of pitched ceiling marked with a red dotted oval line in the photo. This was possibly due to the displacement of ceiling members in the plenum. Cement mortar finish of interior wall above the stage was flaked as shown in Photo 6.6-23, and the exterior boards were broken at the gable end wall. No damage to the structure was not observed.

Photo 6.6-19 Sagging of metal furring suspended ceiling

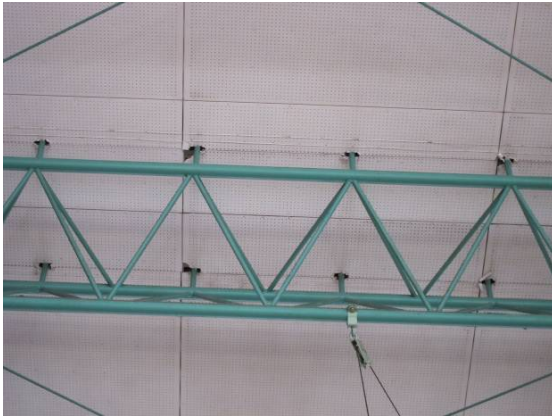
Photo 6.6-21 shows damaged ceiling boards at the connection with the structure of a gymnasium. It was reported that one window glass was broken. No damage to the structure was observed.

Photo 6.6-21 Damage to metal furring suspended ceiling at the connection

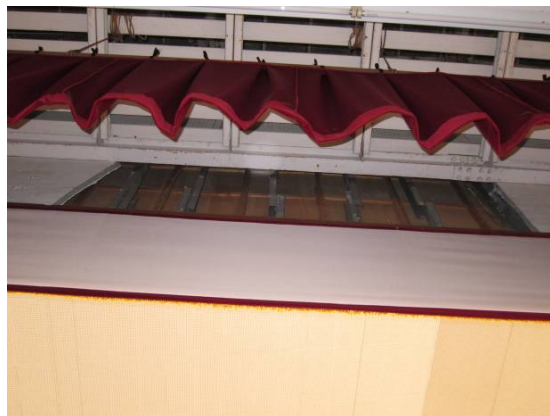
Photo 6.6-23 shows damaged walls above the stage in the gymnasium shown in Photo 6.6-19. Cement mortar finishes on the studs were broken and fell. Damage to the walls above the stage was observed also in some gymnasiums such as shown in Photo 6.6-15 or Photo 6.6-17.

Photo 6.6-23 Falling of cement mortar finish above stage

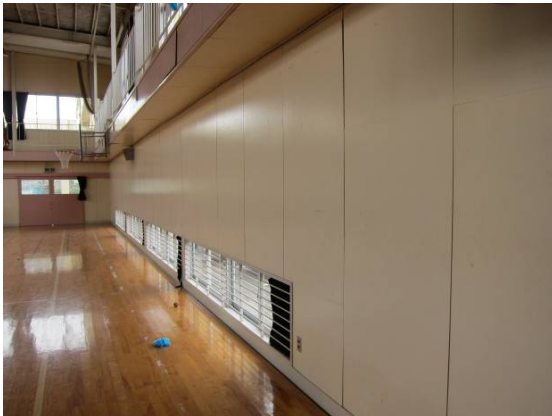
Photo 6.6-24 shows a lift of the nail fixing interior wall boards to the studs in the arena of gymnasium.

Photo 6.6-24 Loosen nails fixing board

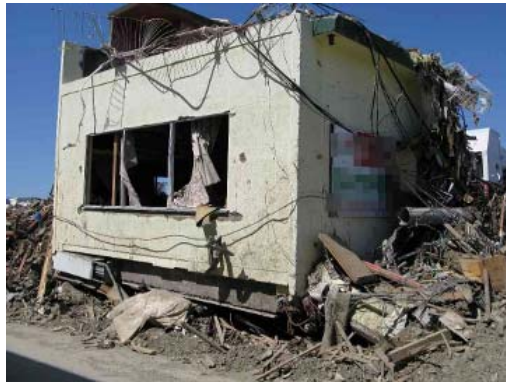
A case where column capitals and bases on the first floor in a building were subject to bending failure and subsequently to story collapse was seen in 2-story buildings (Photo 7.2-1).

These buildings have column-to-beam frames. The first floor has a relatively small number of walls, but many concrete block walls are placed on the second floor. The first and second floors of the building in Photo 7.2-1 are used as shop and dwelling, respectively. The relevant buildings are estimated to have structural characteristics of low strength and stiffness on the first floor. As an opening on the second floor is not large, it is assumed that the second floor suffered a large tsunami wave pressure and the shear force acting on the first floor exceeded the lateral load-bearing capacity, resulting in the collapse of the building. Story collapse of the first floor has not been observed in 3-story or higher buildings in the investigations. In 3-story buildings, in general, reinforced concrete walls are often used for the first floor. Therefore, the strength of the first floor of 3-story buildings is considered to have been larger than that of 2-story buildings.

Photo 7.2-1 Story collapse of a 2-story reinforced concreted building

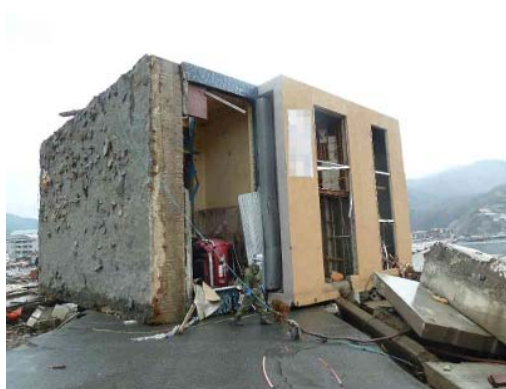
Overturning was observed in 4-story or lower buildings. In all overturned buildings, the maximum inundation depth exceeded their height. Overturning types include building that fell sidelong (Photo 7.2-2) and buildings that turned upside down. Most of the overturned buildings are of mat foundation. In some overturned buildings on pile foundation, piles were pulled out.

Photo 7.2-2 Overturning of a 3-story reinforced concrete building

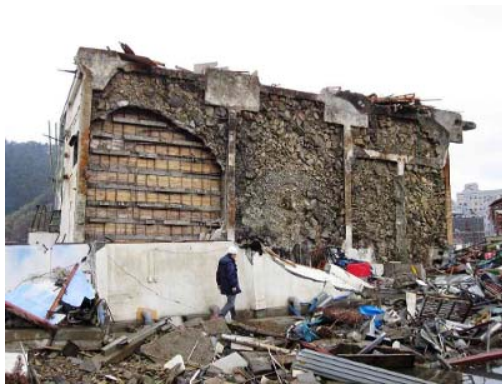
Most of the overturned buildings were moved from their original positions. It is estimated that large buoyancy acted on the buildings. Moved and overturned buildings left no dragged traces on the ground. One of the buildings moved over a concrete block fence with about 2m height on an adjoining land without destroying the fence (Photo 7.2-3). The building seems to have floated up by buoyancy. Some of the 2-story apartment houses with the same shape that were overturned were washed away and missing. A buoyancy and large horizontal force seem to have acted on these buildings.

Photo 7.2-3 A 2-story reinforced concrete building that moved over the fence and overturned

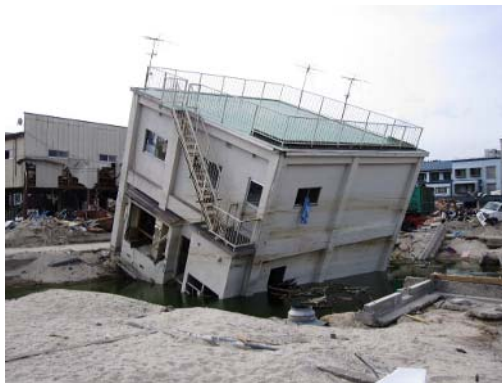
When tsunami acted on a building, a strong stream was generated around the corner of the building, resulting in many large holes on the ground that were bored by scouring. In one case, a building on mat foundation fell into a hole bored by scouring (Photo 7.2-4).

Photo 7.2-4 A 2-story reinforced concrete building that was tilted by scouring

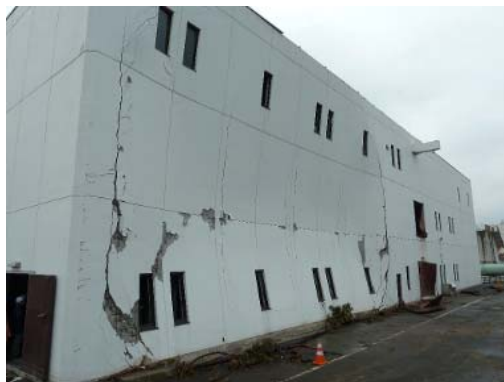
A case where such wall reinforcement was fractured is often seen in wall members with single layer bar arrangement. In one damaged building (Photo 7.2-5), a 300 mm-thick shear wall with double layer bar arrangement and a support span of more than 10 m and without the second and third floor slabs was bent inside by tsunami wave pressure. However, a shear wall in an area (Photo 7.2-5 Back of the building, right-hand side), where there is a floor on the second story and a support span is not long in the same building, was not bent.

Photo 7.2-5 Out-of-plane fracture of reinforced concrete shear wall without floor

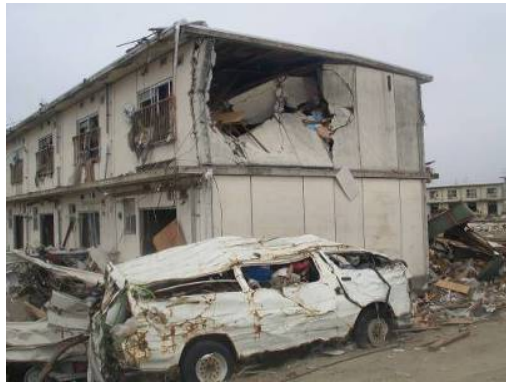
Debris impact was seen in most of the non-structural members such as window and ceiling materials. The number of cases of clear damage to skeletons was not large, but in one observed case, a multi-story wall in an apartment house was probably bored by debris impact (Photo 7.2-6).

Photo 7.2-6 Wall opening generated by debris impact

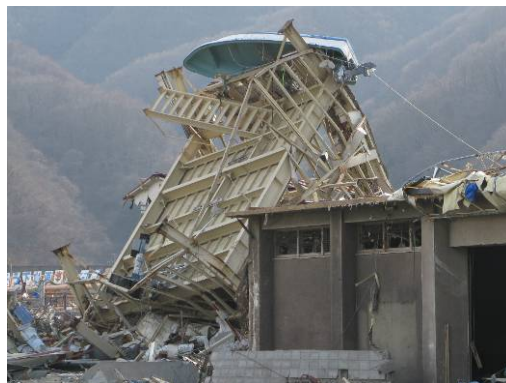
A typical case of building movement and washout is that a building moved and flew due to the fracture of anchor bolts and/or base plates at steel exposed column bases and the fracture of a weld between the column and the base plate (Photo 7.2-7). In most cases, a foundation and some column bases were left in a site, but the body of a building was moved beyond the site or missing.

Photo 7.2-7 Steel building overturned by fracture of column base anchor bolts

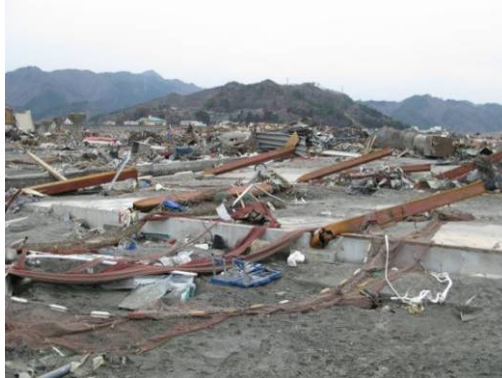
In most cases, welds between diaphragms with lower flanges and the first-floor columns were fractured and the sections of the columns were exposed. In one building, flanges of the second-floor H-shaped beams were torn. Based on the deformation states

near the column bases, it is estimated that a tensile force acted on the first-floor columns, and then the first-floor capital connections were fractured after the first floor was greatly tilted to the same extent as the inclination of the remaining columns.

Photo 7.2-8 First-floor columns falling in the same direction

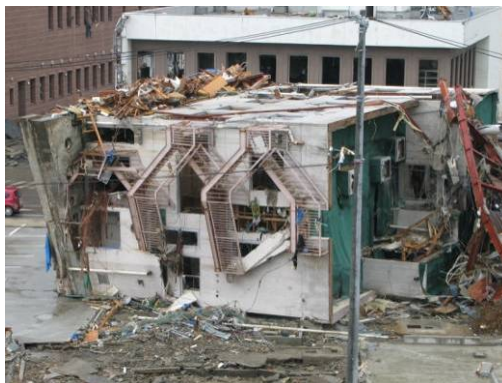
One case, in which a whole building including foundation is overturned, was confirmed. Most of the AAC panels of claddings were left (Photo 7.2-9).

Photo 7.2-9 Overturning of a 3-story steel building

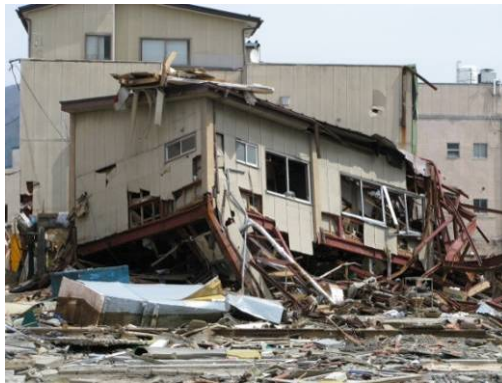
Skeleton collapse including story collapse of the first floor was seen in a 2-story steel building (Photo 7.2-10). Partial collapse of a warehouse was also seen on the coast.

Photo 7.2-10 Story collapse of first floor in a 2-story steel building

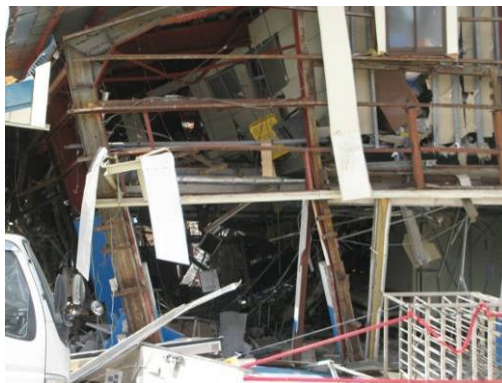
Slight tilting was often observed with remaining their skeletons in steel buildings. In one case (Photo 7.2-11), a gabled roof frame building did not collapsed despite large residual deformation.

Photo 7.2-11 Tilted gabled roof frame

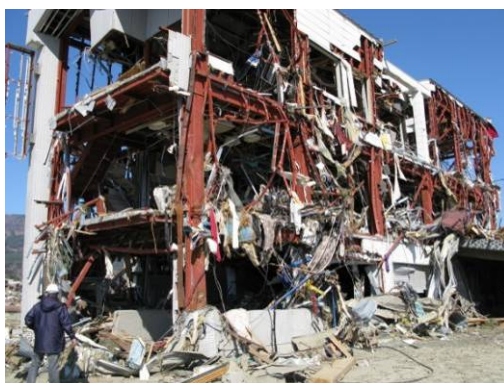
Cladding materials such as AAC panel were almost fully fractured and washed away, and then a steel frame as a skeleton was remaining. This case was often observed (Photo 7.2-12). It is considered that an external force that acts on the skeleton became small due to early washout of the cladding materials. In the remaining building, slight tilting of the skeleton, member deformation on the face affected by tsunami, or members locally damaged possibly by debris impact, were observed.

Photo 7.2-12 A remaining 3-story steel building

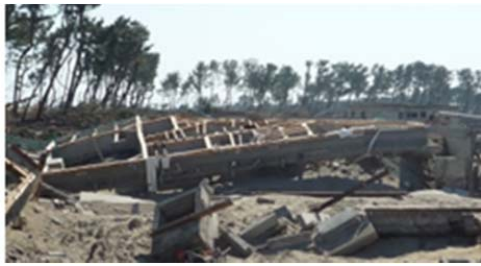
In the area with over 5 m flood water depth, most of the wood houses in the inundated area were washed away by the tsunami. How the houses were washed away; as for the case which the whole house including foundations was washed away (Photo 7.4-1), the case which only foundations were left (Photo 7.4-2), the case which sills and foundations were left (Photo 7.4-3), the case which sills, foundations and floor boards were left (Photo 7.4-4), and so on, were observed. There were several cases that the hold down fastener was failed, as shown in Photo 7.4-5. The foundations or wall of bath room made by concrete block often remained in, as shown in Photo 7.4-2.

Photo.7.4-1. Foundations washed away.
