September 2011

**Summary of the Field Survey and Research on
“The 2011 off the Pacific coast of Tohoku Earthquake”
(the Great East Japan Earthquake)**

National Institute for Land and Infrastructure Management (NILIM)
Ministry of Land, Infrastructure, Transport and Tourism, Japan

Building Research Institute (BRI)
Incorporated Administrative Agency, Japan

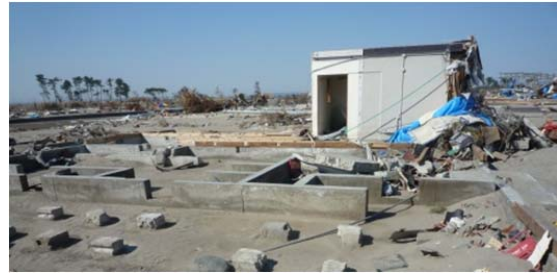
In the area with over 5 m flood water depth, most of the wood houses in the inundated area were washed away by the tsunami. How the houses were washed away; as for the case which the whole house including foundations was washed away (Photo 7.4-1), the case which only foundations were left (Photo 7.4-2), the case which sills and foundations were left (Photo 7.4-3), the case which sills, foundations and floor boards were left (Photo 7.4-4), and so on, were observed. There were several cases that the hold down fastener was failed, as shown in Photo 7.4-5. The foundations or wall of bath room made by concrete block often remained in, as shown in Photo 7.4-2.

Photo.7.4-2. Only foundation remained.

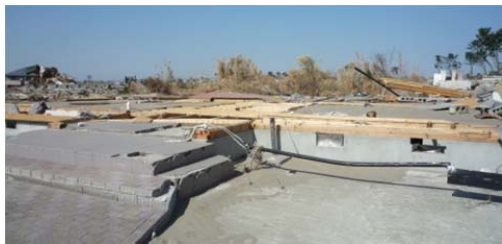
Photo.7.4-3. Foundations and sills remained.

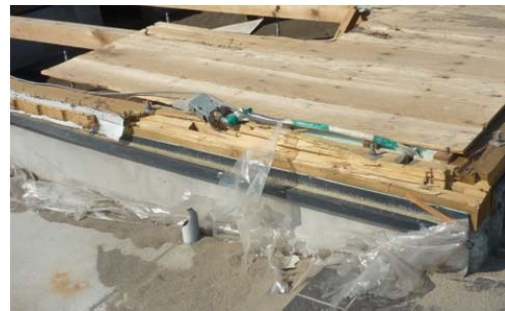
Photo.7.4-4. Sills, foundations and floor boards remained.

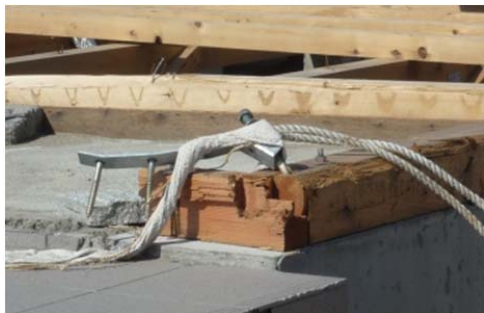
Photo.7.4-5. Failed hold down fastener.

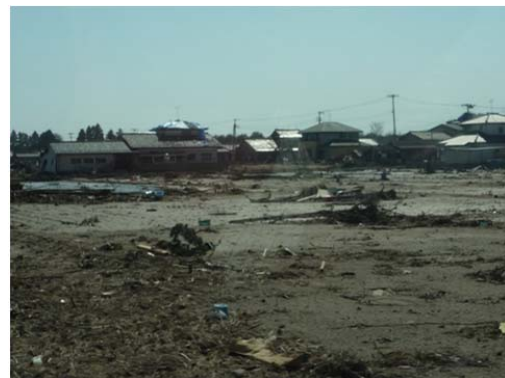
Photo.7.4-6. Many wood houses remained.

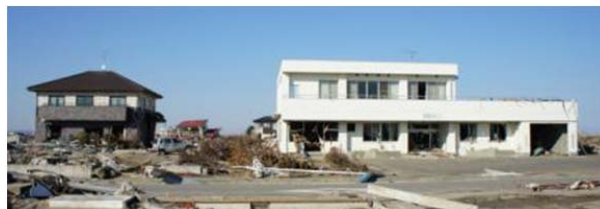
Photo.7.4-7. Wood house remained in the downstream of RC building in Arahama, Wakabayashi ward, Sendai city.

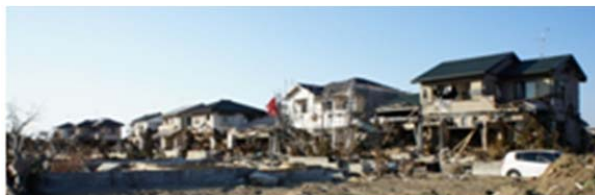
A line of wood houses remained were confirmed in Arahama-shin, Wakabayashi ward, Sendai city, as shown in Photo 7.4-8. The front survived house of the line was non-wooden. The flood water depth in this area was estimated at the level about 4-5 m. On the other hand, wood house which didn't have survived buildings in the direction where the tsunami came avoid being washed away, but suffered heavy damage, as shown in Photo 7.4-9. Several such houses were confirmed in each surveyed area, and they were built by the construction methods with many metal fasteners.

Photo 7.4-8. A line of wood houses remained in Arahama-shin, Wakabayashi ward, Sendai city.

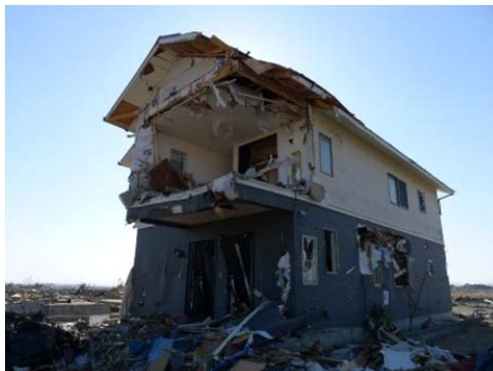
Photo 7.4-9. Remained house which didn't have survived buildings in the direction where the tsunami came in Arahama-shin, Wakabayashi ward, Sendai city.

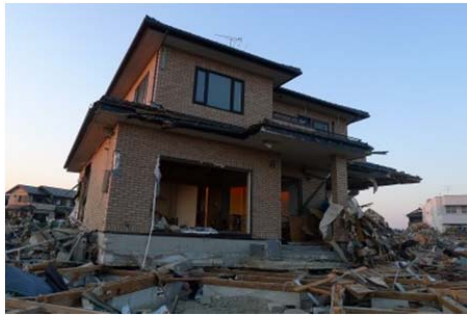
Photo 7.4-10. Wood house ([1]) that was carried away with the base in Yuriage, Natori city.

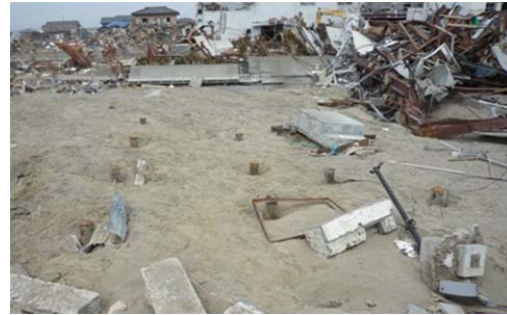
Photo 7.4-11. Steel tube pile left at the the original position ([2]) of photo 7.4-10.

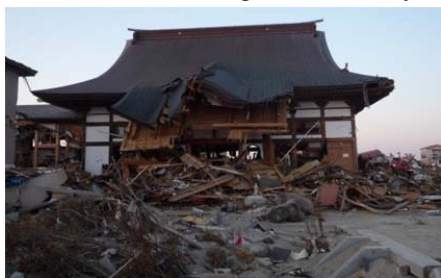
Photo 7.4-12. Heavily damaged temple ([3]) building in Yuriage, Natori city.

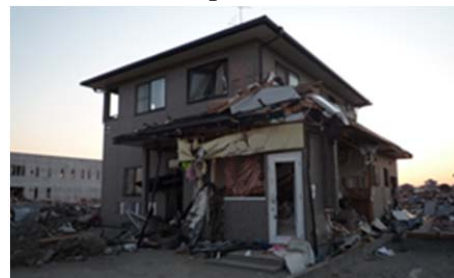
Photo 7.4-13. Wood house with store ([5]) remained in the downstream of the survived buildings in Yuriage.

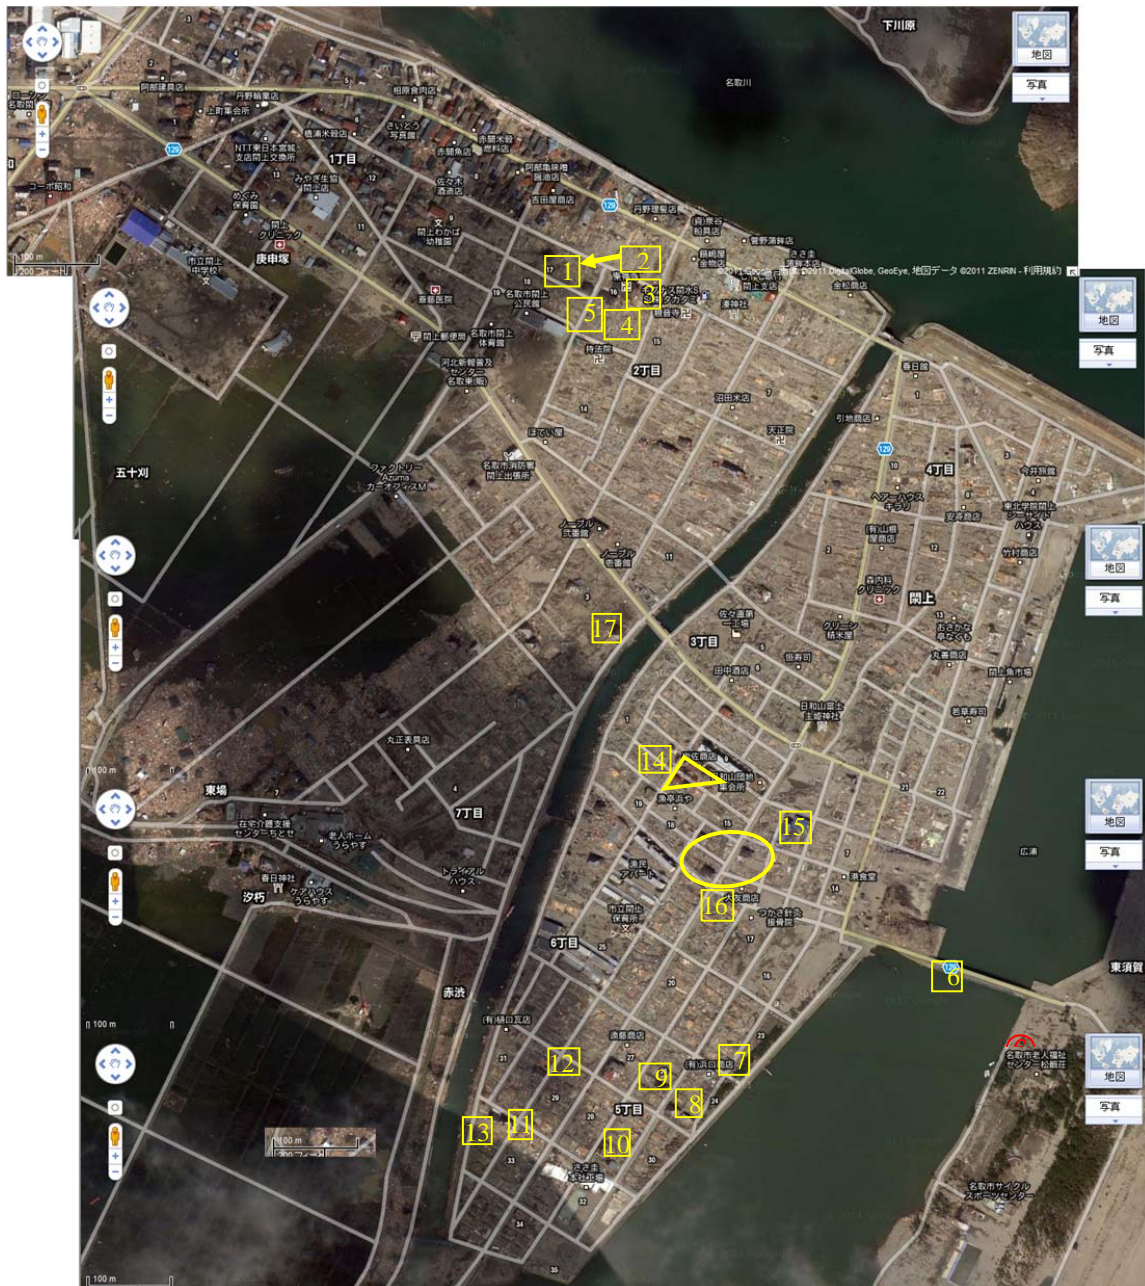
Fig. 7.4-2. Aerial photograph and the location related to surveyed buildings in Yuriage, Natori city.

Wood buildings also suffered crushing damage due to tsunami, as shown in Fig. 7.4-2. What parts of buildings remained, for example foundation, sill, and so on, were as same as mentioned in (1). Figures in rectangles in Fig. 7.4-2 show the locations of buildings mentioned in the followings. The wood house (Photo 7.4-10:①) united with the foundation and carried away. In the original position of it, steel tube piles remained as shown in Photo 7.4-11(②). Because a temple building (Photo 7.4-12:③) and a steel-frame house (④) were damaged heavily and remained, tsunami wave force was reduced to some extent, and the neighboring wood house with store avoided being carried away, as shown in Photo 7.4-13 (⑤). It might be possible for the survived low-rise building to make wave force reduce.

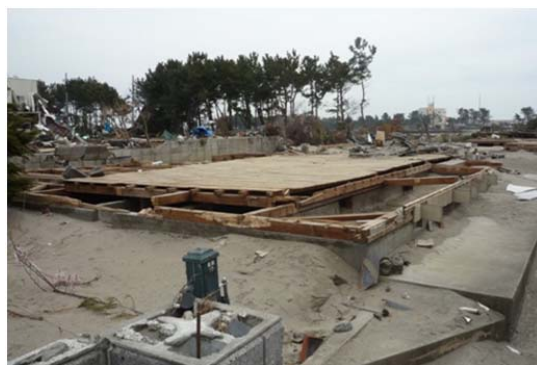
Photo 7.4-15. Fallen Protect forest and wood house (8) washed away in Yuriage, Natori city.

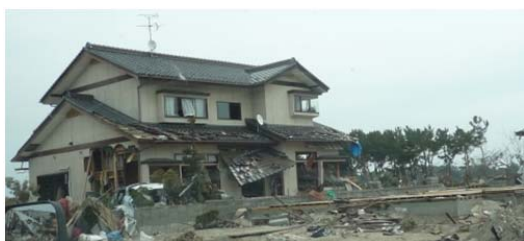
Photo 7.4-16. Protect forest and wood house (9) remained in Yuriage.

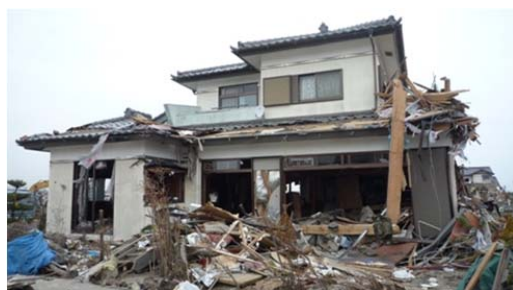
Photo 7.4-17. Wood house (10) remained without the effect of protect forest.

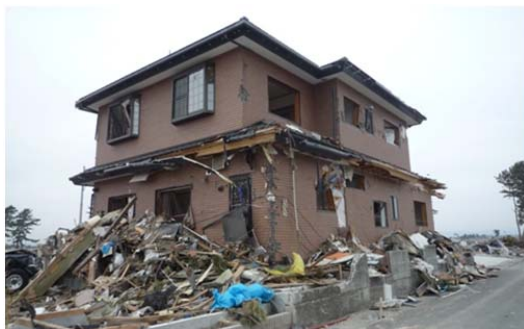
Photo 7.4-18. Japanese conventional post and beam wood house (11) remained alone.

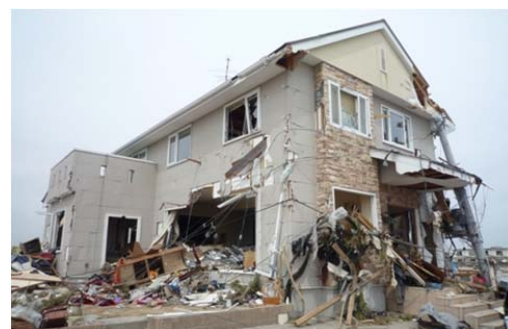
Photo 7.4-19. Light frame construction wood house (12) remained alone

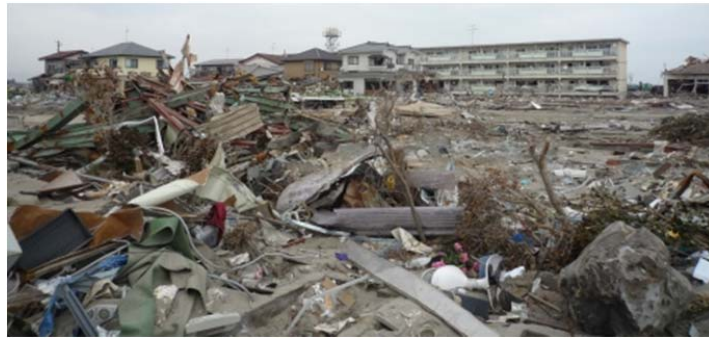
Photo 7.4-20. Group of wood houses (14) which were not washed away in the downstream of a RC apartment house in Yuriage

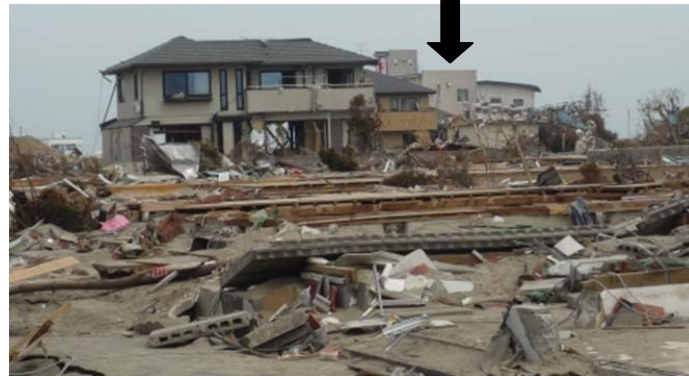
Photo 7.4-21. Wood house (15) which were not washed away selectively in the downstream of a factory building.

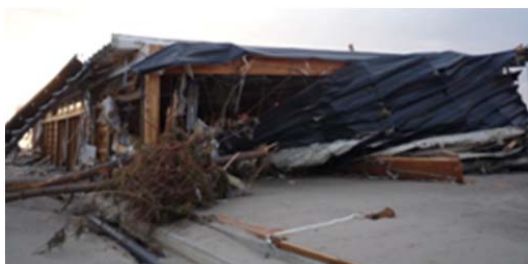
Photo 7.4-22. Glulam frame structure remained in Arahama, Watari town.

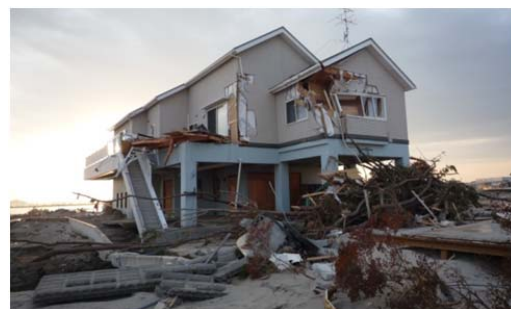
Photo 7.4-23. Mixed structure which has 1st story of RC structure and wooden 2nd story.

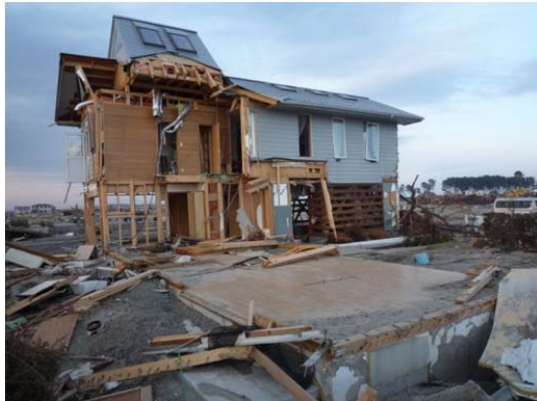
Photo 7.4-24. L-shaped wood house whose part was washed away in the east of Arahama port.

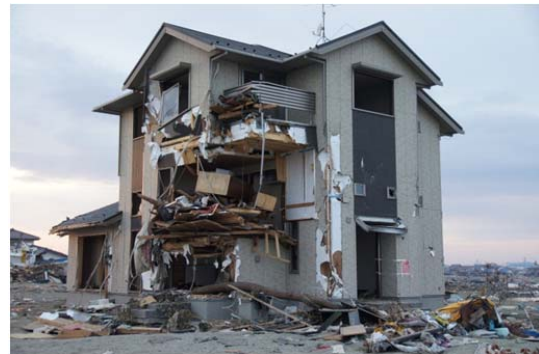
In the north area of the Arahama port, the 3-story wood house (Photo 7.4-25) remained. It might be the reason why the lateral strength of 1st story in 3-story building was larger than that in 2-story building.

Photo 7.4-25. 3-story wood house remained in the north of Arahama port.

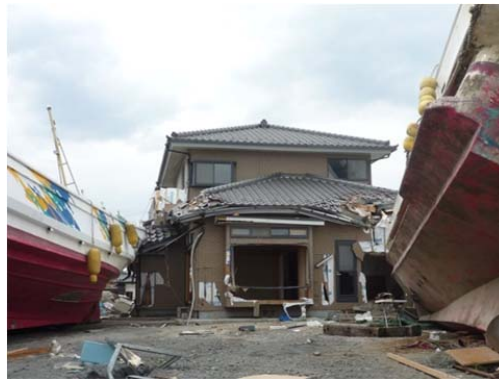
In the west area of the Arahama port, it was confirmed that the wood house (Photo 7.4-26) was crashed by two ships but remained. It was the reason why the wave pressure was low and the structural performance of the house high because the house was relatively new.

Photo 7.4-26. Wood house remained in spite of ship crashing in the west of Arahama port.

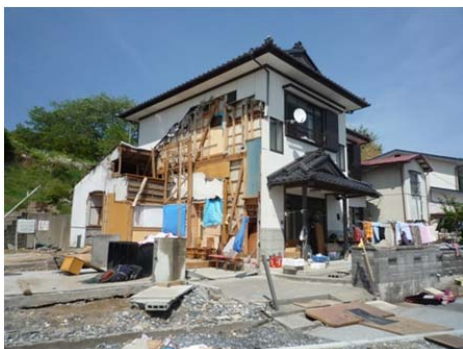
Photo 7.4-27. Wood house (1) remained under the flood water depth of over 7 m in Akasaki-cho, Oofunato city.

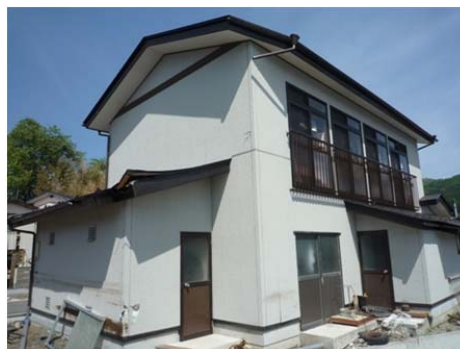
Photo 7.4-28. Wood house (3) without damage under the flood water depth of over 7 m in Akasaki-cho, Oofunato city.

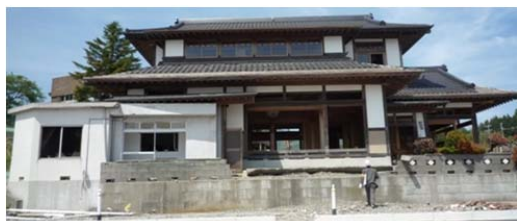
Photo 7.4-29. Japanese traditional wood house (5) which was not carried away under about 5 m flood water depth in Akasaki-cho, Oofunato city.

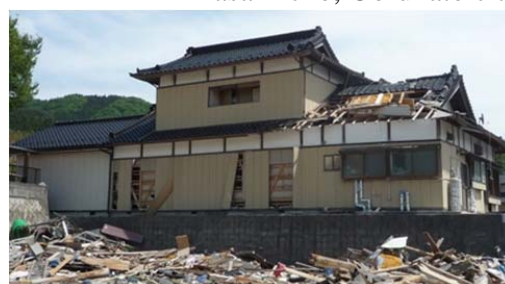
m, in spite of partial failure of walls. Near this house, the wood house (Photo 7.4-30:^[6]) remained under about 6 m flood water depth in spite of partial failure in the roof system. It was considered that this failure caused by the floating materials. There was a house (^[7]) remained in the next, but a house which was guessed to have many hole down fasteners (^[8]) washed away. The house with hold down fastener may not avoid being washed away by the tsunami.

Photo 7.4-30. Wood house (6) which was not carried away in spite of damage on 1st floor roof system in Akasaki-cho, Oofunato city.

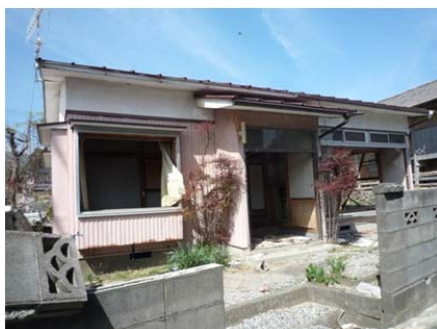
At the location where we went up the slope land from these houses, a light steel-frame house (^[9]) remained in under the about 5 m flood water depth. In the next of this house, the 1-story old wood house (Photo 7.4-31:^[10]) whose structural specification was not so good, but the anchor bolts were installed remained. In addition, a warehouse with mud walls (Photo 7.4-32:^[11]) was remained and an old wood house without anchors (Photo 7.4-33:^[12]) turned and moved horizontally. Because the wood house under about 5 m flood water depth were almost washed away in plain areas, it might be possible for the slope land to make lateral force caused by tsunami a little smaller.

Photo 7.4-31. Survived house (9) which seemed to have comparatively slight structural specifications in Akasaki-cho, Oofunato city.

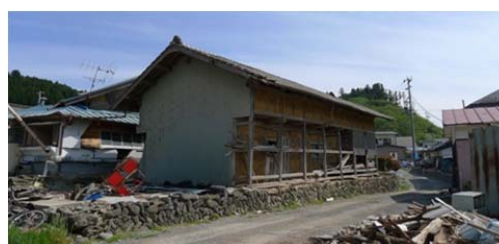
Photo 7.4-32. Survived soil warehouse (10) which seemed to have comparatively slight structural specifications in Akasaki-cho, Oofunato city.

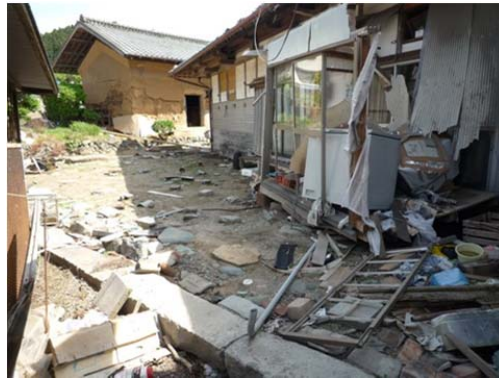
Photo 7.4-33. Survived old house (12) which rotated and moved horizontally in Akasaki-cho, Oofunato city.

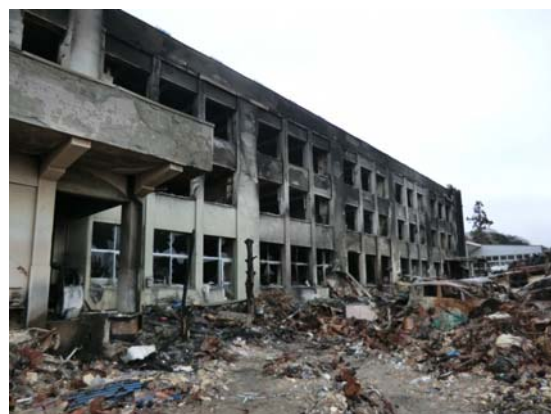
Photo 8.2-1 Tsunami fire at an elementary school (Ishinomaki city, Miyagi prefecture)

Photo 8.2-1 shows a fire scene of an elementary school building located at about 1 km from the coast. Almost all of the 3-story school building had been burnt by the flame flared up from cars, combustible debris and oil and so forth that drifted and accumulated by tsunami in the schoolyard in front of the building.

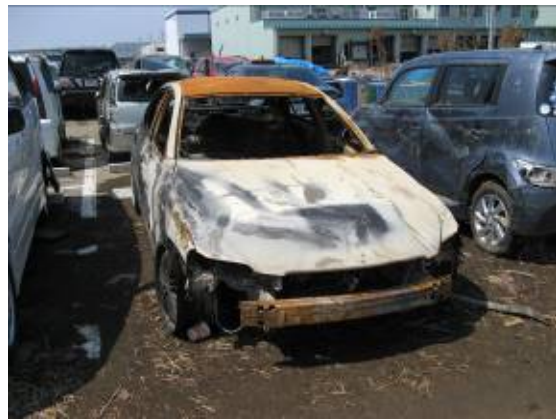
Building at a port is one of the most damaged buildings by tsunami with not only tidal wave but also debris, cars and ships and so forth drifted by tsunami (Photo 8.2-2 and 8.2-3). Several hundred automobiles which have been parked in a parking zone, being drifted to a port warehouse by the tsunami, caused fire at the place where it accumulated.

The cause of the fire is unclear, but it is assumed that the car collided severely each other, the gasoline tank of the cars were damaged, and sparked by malfunction of the electrical system by the seawater. There was no spread of fire in the interior of the building, only the external wall has been damaged by fire.

Photo 8.2-3 Vehicle fire due to tsunami at a parking lot (Iwanuma city, Miyagi prefecture)

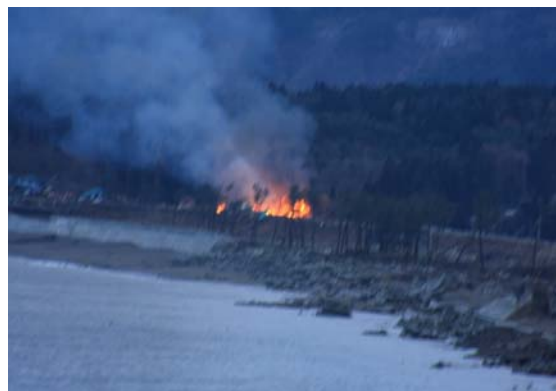
Photo 8.2-4 shows the fire at a coastal village after several hours of tsunami invasion. The fire continued for

Photo 8.2-4 Fire at a site of 8 buildings due to tsunami (Noda-village, Iwate prefecture), Courtesy of Noda-village

over 12 hours. Firefighters could not access to the site because the road had been destroyed by the tsunami.

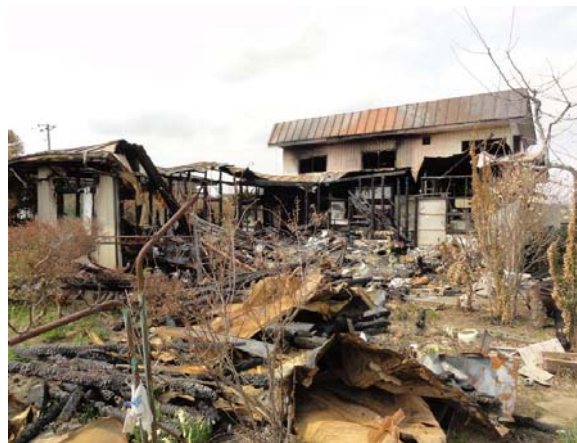
Photo 8.3-3 shows another house fire case in which two wooden houses were completely burnt out and three houses were partly burnt. The cause of fire is assumed to be misuse of candlelight for lighting in the midst of power failure on the night of the next day of the mainshock.

Photo 8.3-3 Fire scene at a house (Oushu city, Iwate prefecture)

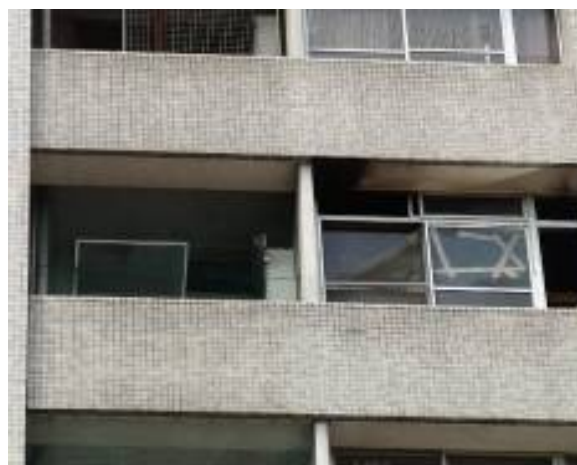
For a condominium fire, one case has been investigated: the fire broke out when electricity supply has been recovered at the night of the next day of the mainshock. The fire broke out on the 7th floor of a 17-story medium scale condominium. The residents of the room of fire origin were absent at the time, but some neighbors were aware of the fire and informed the fire station. Because of early suppression by firefighters, there was no spread of fire to the upper floor and the next rooms (Photo 8.3-4).

Photo 8.3-4 Fire scene at a condominium (Sendai city, Miyagi prefecture)

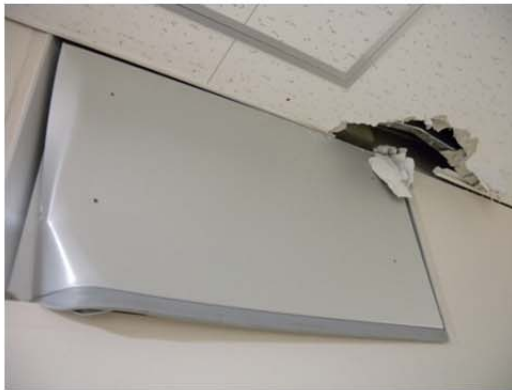
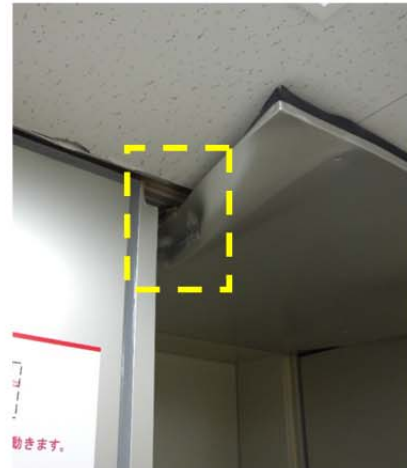
Photo 9.2-2 Damage near the boundary between isolated and non-isolated floors

- According to the person in charge of the building, no furniture was turned over and no structural damage was observed.
- However, some damage was observed at the cover-panels of fire protection and the expansion joints near the boundary between isolated and non-isolated floors (Photo 9.2-2). It seems that parts of expansion joints were not well operated due to the large displacement of SI floor during the earthquake.
- The ground surrounding the building partially subsided around 10 cm.

(a) Damage to the panel

(b) Damage to the expansion joint

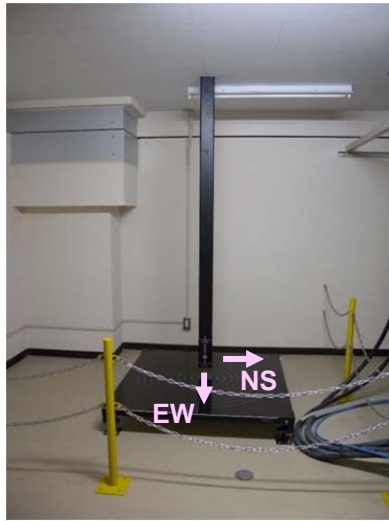
From the trace on the scratch board installed on the SI floor (Photo 9.2-3), the maximum displacement was estimated as around 18 cm at the mainshock on 11 March, 2011 and around 10 cm at an aftershock on 7 April, 2011 (Photo 9.2-4).

Photo 9.2-3 Scratch board installed on the SI floor

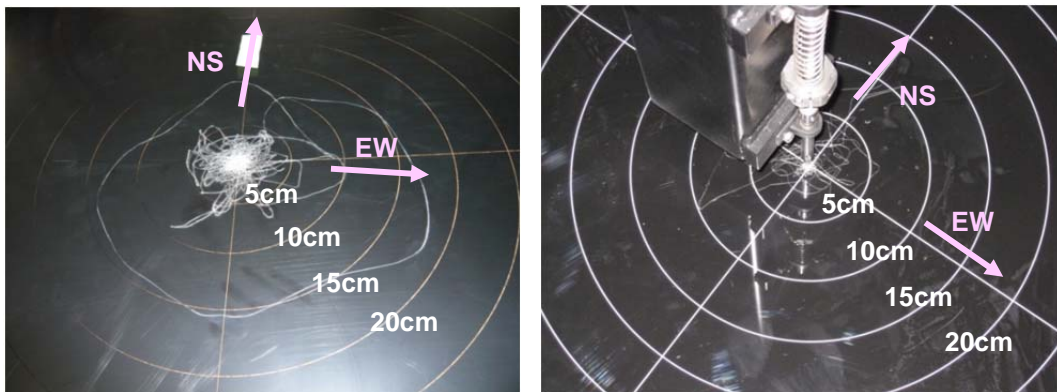
(a) Trace at the mainshock on 11 Mar. (b) Trace at an aftershock on 7 Apr.

Photo 9.2-4 Trace of displacement of SI floor during earthquake

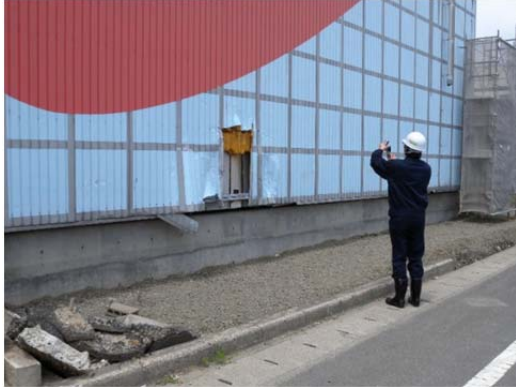
Since the building is located near the Sendai-Shiogama bay, tsunami reached the building and the SI floor was submerged under water. The building also suffered the damage to outer walls by the collision of floating debris (Photo 9.2-6). Observation results are summarized as follows:

Photo 9.2-6 Damage due to debris

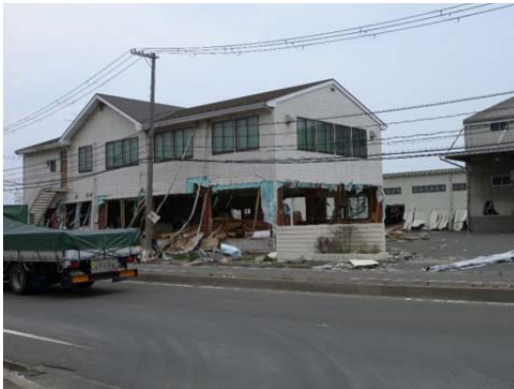
- b) Tsunami height was estimated ~4.0 m from the trace of water on the wall (Photo 9.2-7) and damage situation of surrounding buildings (Photo 9.2-8). There is no information about the direction and impact force of tsunami.

Photo 9.2-8 Tsunami damage to surrounding buildings

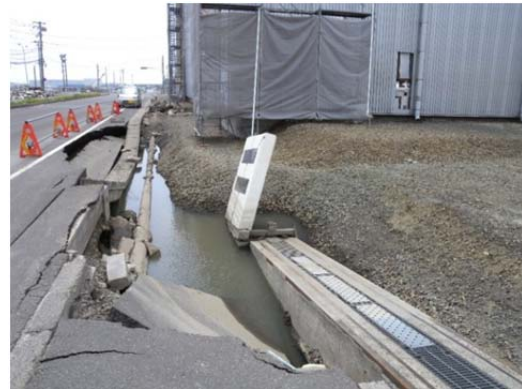
- c) The ground was excavated in northeast corner of the building around 1.0 m depth, probably because of the water flow from the building at the moment of tsunami (Photo 9.2-9).

Photo 9.2-9 Excavation of ground

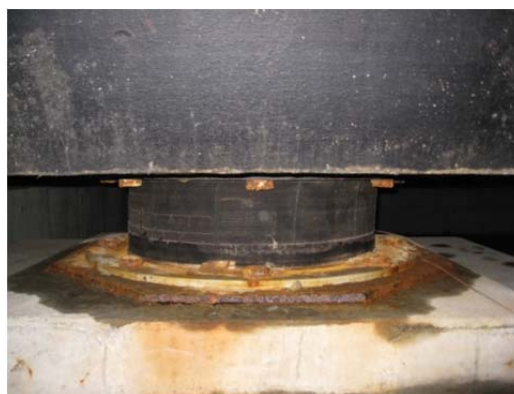
- d) From visual inspection, there was no harmful scratch or inflation of the rubber of HRB, however, severe rust was observed at the steel plates and bolts (Photo 9.2-10).

Photo 9.2-10 Rust of High-damping rubber bearing

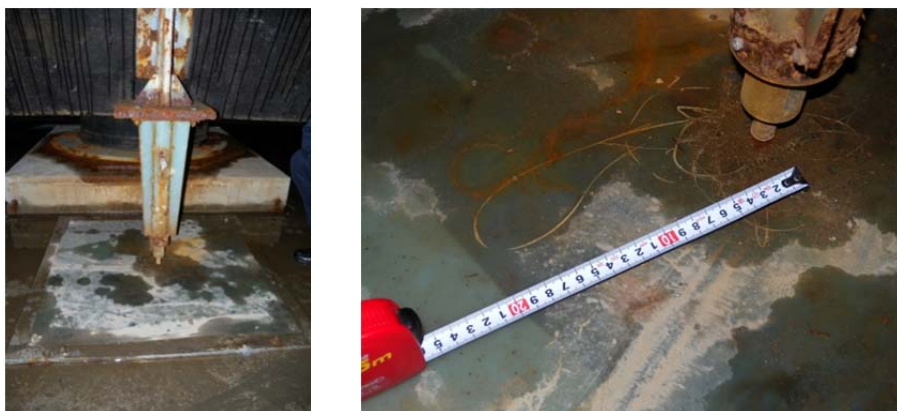
From the trace on the scratch board in the SI floor, the maximum displacement

was estimated as around 21 cm at the mainshock (Photo 9.2-11).

Photo 9.2-11 Trace of displacement of the SI floor on the scratch board

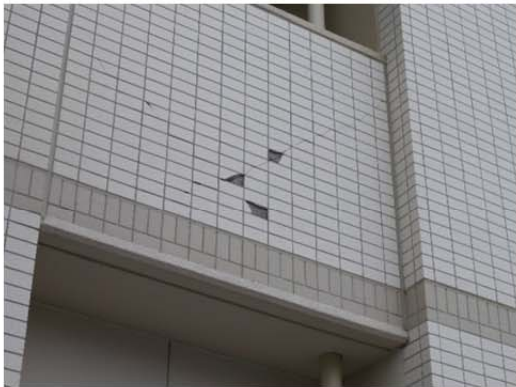
- a) According to the person in charge of the building, no furniture was turned over and no structural damage was observed inside of rooms. However, the damage to the expansion joint was observed.
- b) Drop of the ceramic tiles on outer wall (Photo 9.2-13) and shear crack on the wall in

Photo 9.2-13 Drop of ceramic tiles

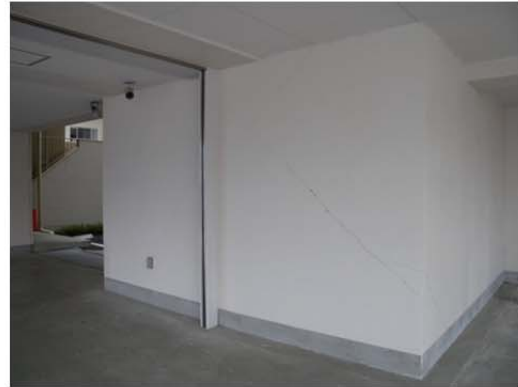
the first floor parking space (Photo 9.2-14) were observed. The subsidence of ground ~ 10 cm was observed around the building.

Photo 9.2-14 Shear crack on the wall

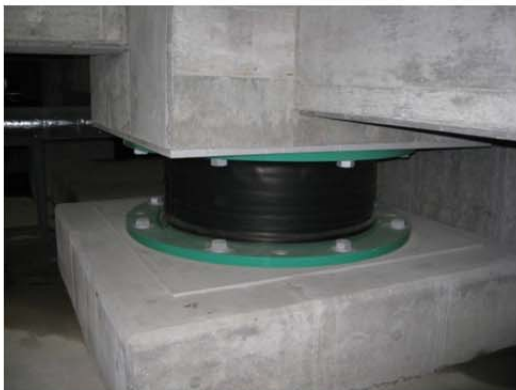
- c) No damage was found to RBs by visual inspection (Photo 9.2-15), however, paint of USDs was peeled off (Photo 9.2-16) and many cracks were found on LDs (Photo 9.2-17).

Photo 9.2-15 Natural rubber bearing

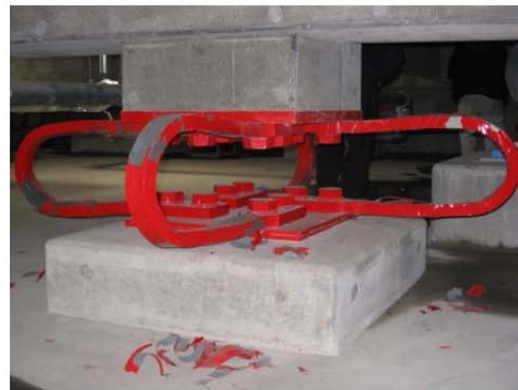
Photo 9.2-16 U-shaped steel damper

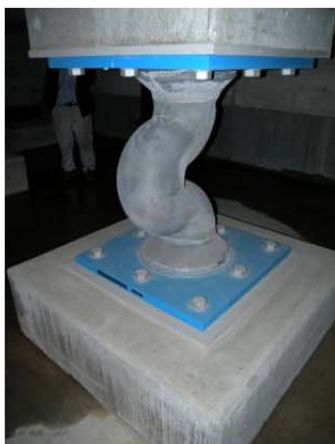
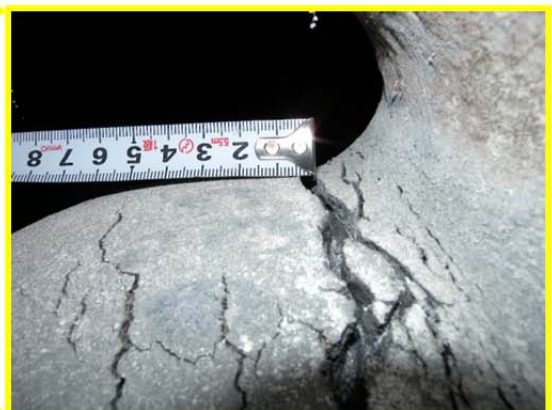
Photo 9.2-17 Lead damper and cracks on the surface

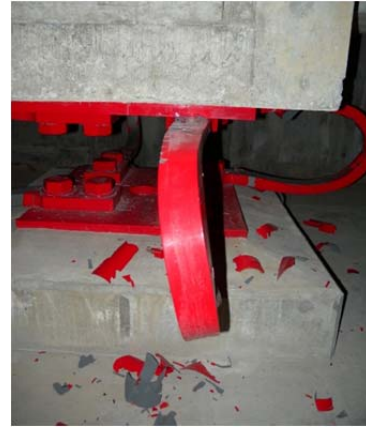
- According to the person in charge of the building, no furniture was turned over and no structural damage was observed.
- Because of the movement of the SI floor during the earthquake, the bolts of steel dampers became loose and the paint on the dampers was peeled off widely. Furthermore, a large amount of residual deformation of steel was remained (Photo 9.2-19).

(2) Deformation of steel

Photo 9.2-19 Deformation of U-shaped steel damper

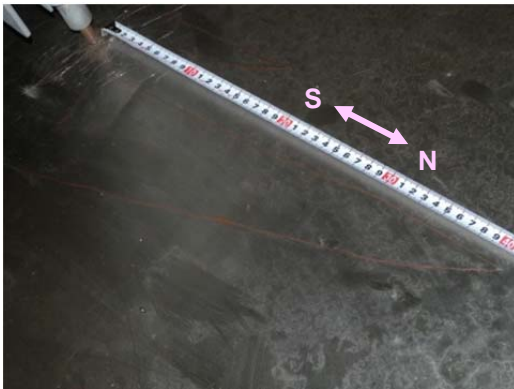
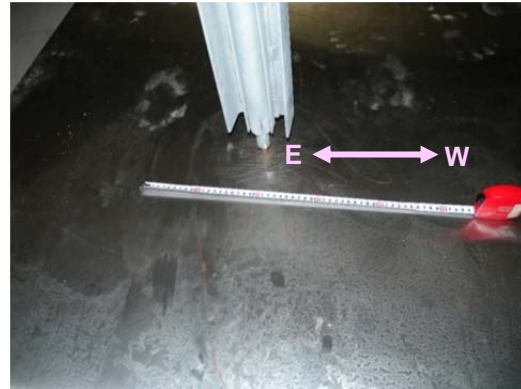
According to the scratch board in the SI floor, the maximum displacement was estimated as around 40 cm northward (Photo 9.2-20). The displacement was also confirmed from the trace of scratch found at the expansion joint outside of the building.

(a) Around 40 cm northward

(b) Around 15 cm eastward
and 22 cm westward

Photo 9.2-20 Trace of displacement of the SI floor on the scratch board

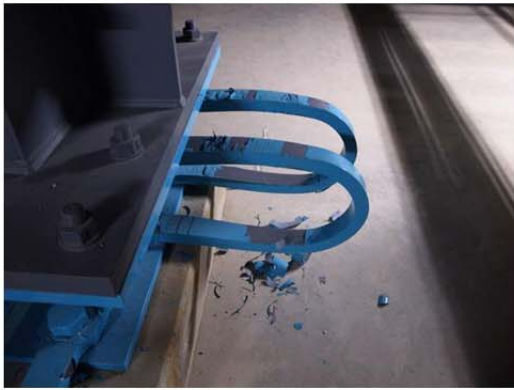
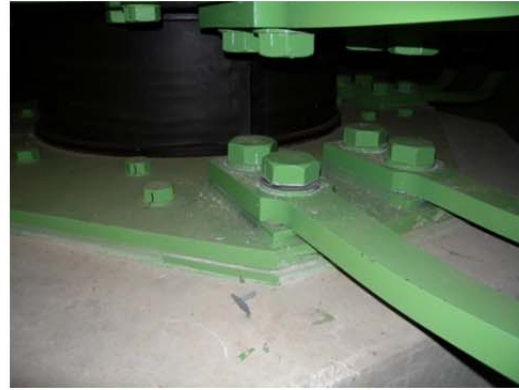
- a) According to the person in charge of the building, up-down shaking happened together with horizontal shaking during the earthquake. On the 6th floor, contents inside of the rooms such as refrigerators and shelves are moved or turned over, and the fire protection steel door moved to open and hit against the ceiling by vertical shaking causing the damage to the lamp covers. Above the 4th floor, PC monitors turned over.
- b) In the penthouse, anti-vibration rubber of a power generator was moved and the bottom part of a water tank was broken.
- c) Because of the movement of the SI floor during the earthquake, the bolts of the steel dampers became loose and the paint on the dampers was peeled off (Photo 9.2-22).
- d) The ground around the building subsided ~20 cm.

Photo 9.2-22 Peeling off of paint and loose of the bolts of U-shaped steel dampers

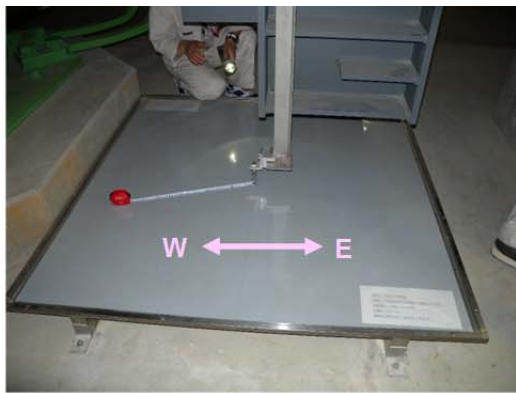
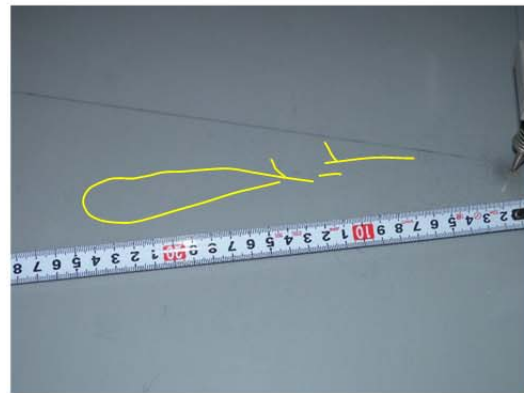
From the trace on the scratch board in the SI floor, the maximum displacement was estimated as around 25 cm westward (Photo 9.2-23). The displacement was also confirmed from the trace of displacement of the ESB (Photo 9.2-24).

Photo 9.2-23 Trace of displacement of the SI floor on the scratch board

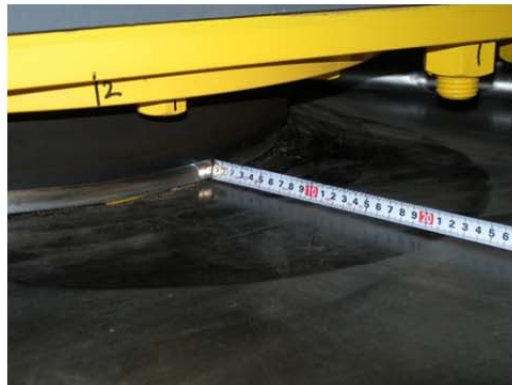
Photo 9.2-24 Trace of displacement of elastic sliding bearing
