## 2. Field scanning records

## 2.1. Antakya city and Hatay Airport Road

### 2.1.1. Viaduct on D817 near Saraykent, Antakya city

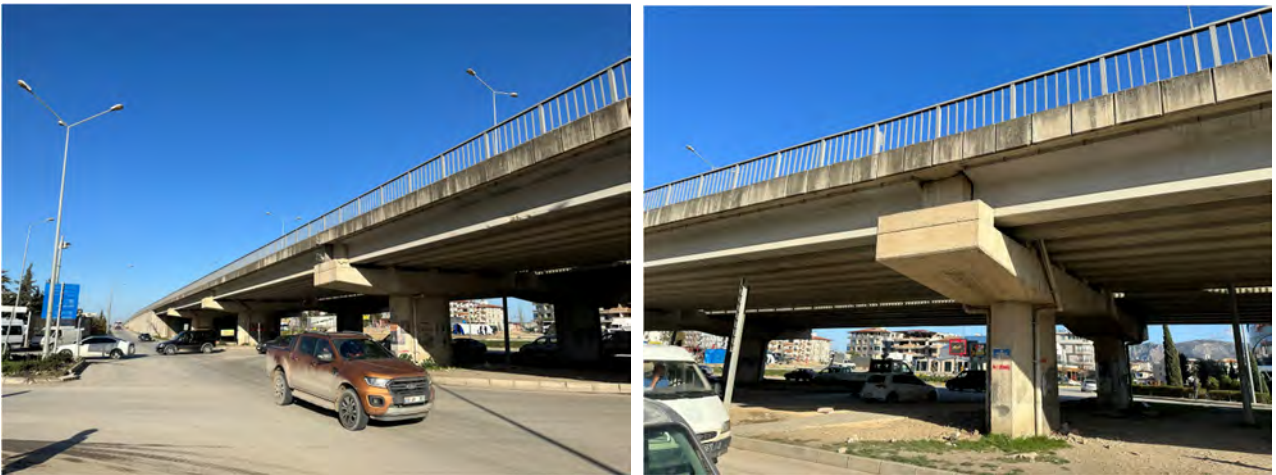
**Figure 2.1-2.** Viaduct on D817 near Saraykent, Antakya city

As shown in **Figure 2.1-2**, the bridge superstructure is divided for each direction and comprises of concrete I-girder beams with no end diaphragms. The floor slabs are continuous over intermediate piers.

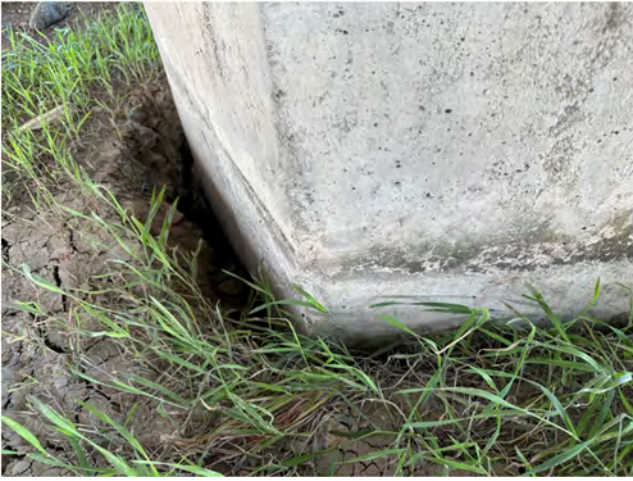
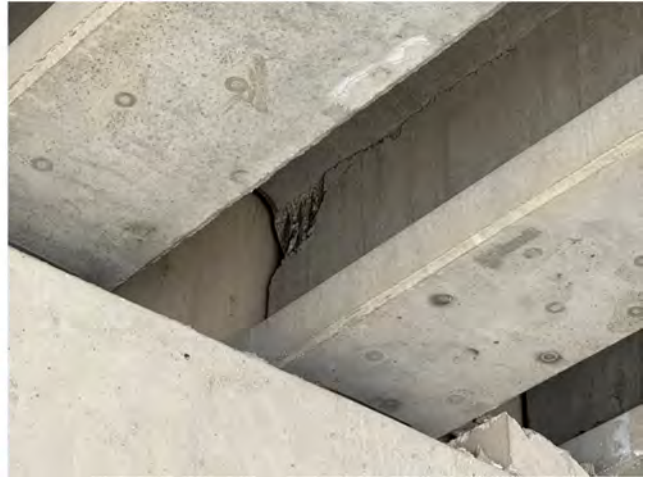
**Figure 2.1-5.** Pier state at ground level and girder-end state above same pier

On all piers, shear keys, link slabs, and girder ends were damaged (Figure 2.1-4), whereas no damage was found on the piers (Figure 2.1-5).

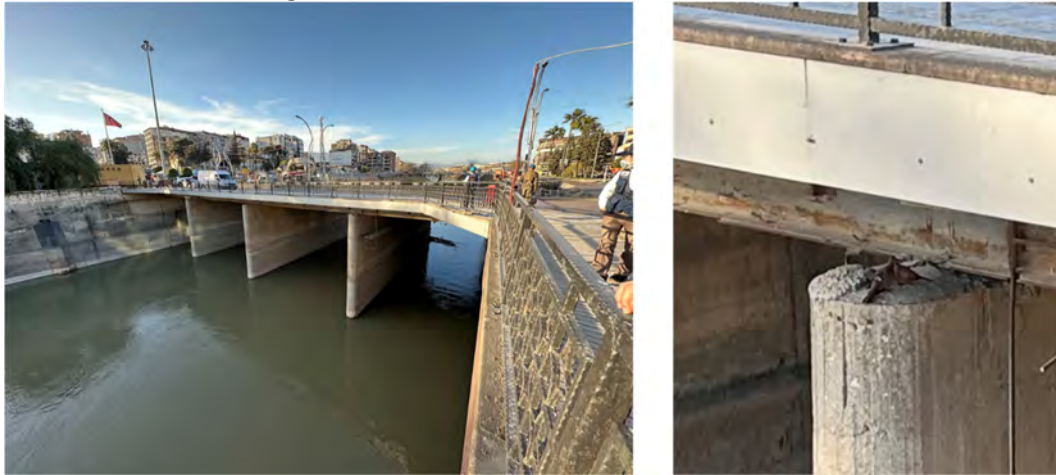
**Figure 2.1-10.** Bridge #3

Bridge #3 is a continuous steel girder with short spans. The conditions around the bearing were uncertain from the observation distance (**Figure 2.1-10**).

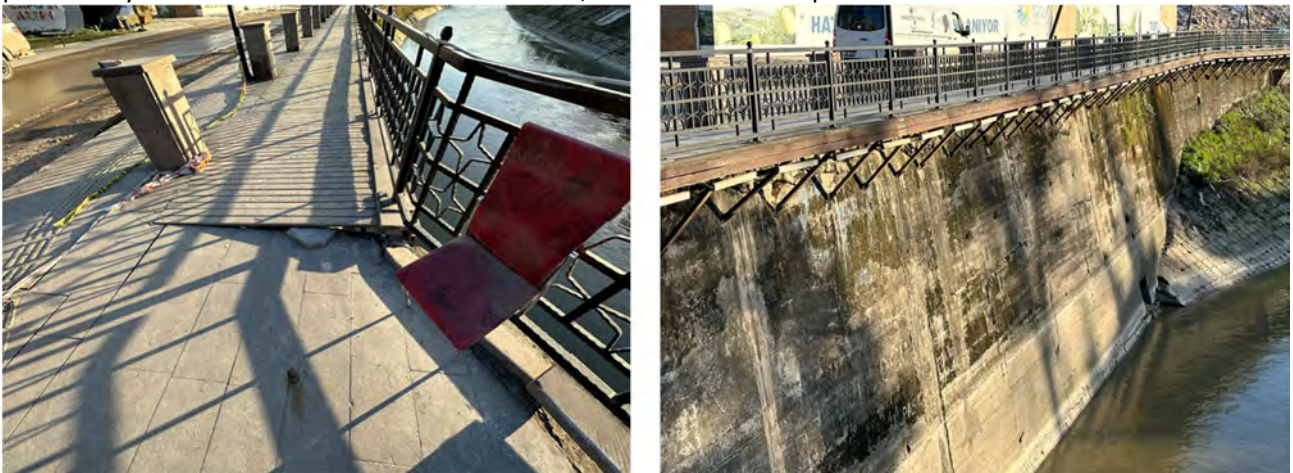
**Figure 2.1-12.** Pedestrian deck along river near Bridge #3

The sidewalk along the river had an overhanging structure (**Figure 2.1-12**). This overhanging structure, particularly the struts embedded in the concrete, was difficult to inspect.

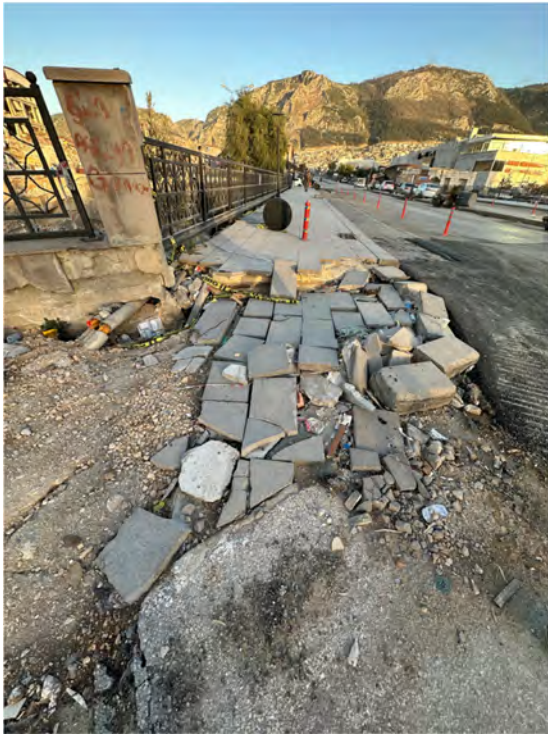
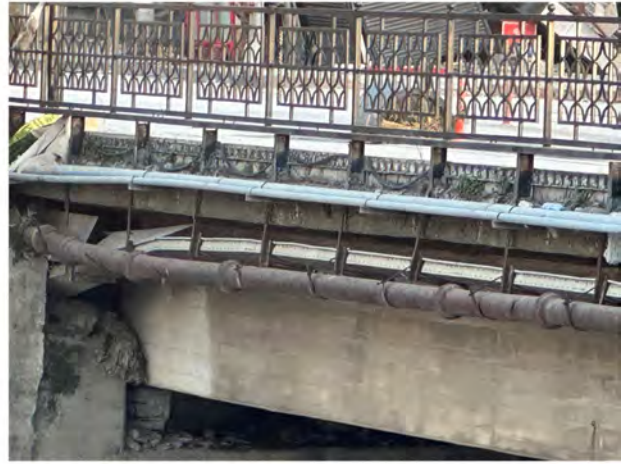
Figure 2.1-15. Bridge abutment and backfill of Bridge #4

Figure 2.1-15 indicates that the backfill behind the abutment moved forward and subsided.

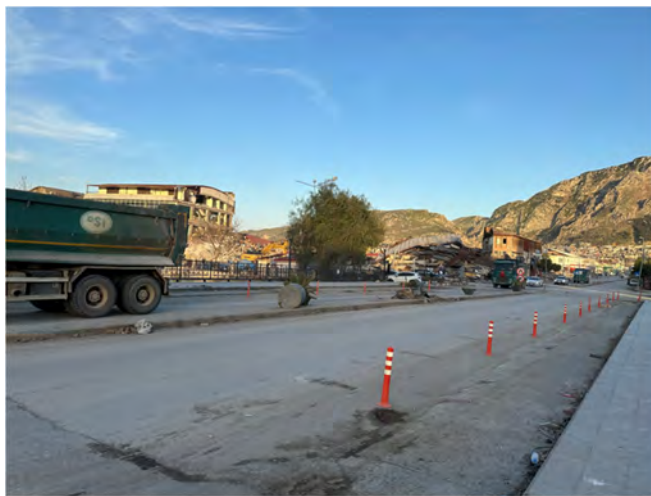
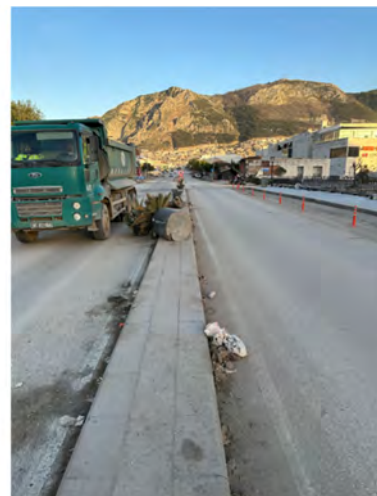
Figure 2.1-16. Surface of Bridge #4

As shown in Figure 2.1-16, plants on the bridge turned over and surrounding buildings collapsed.

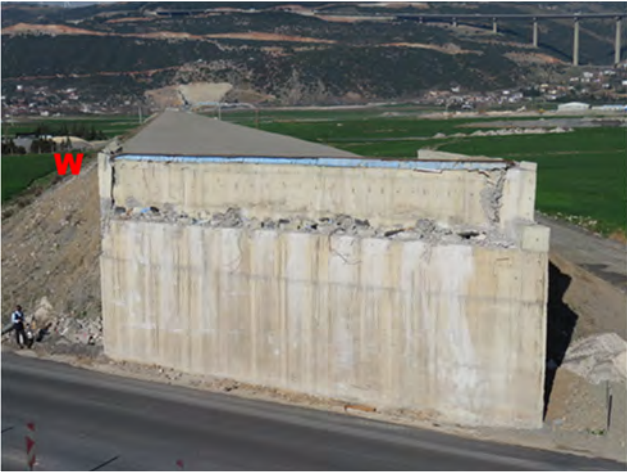
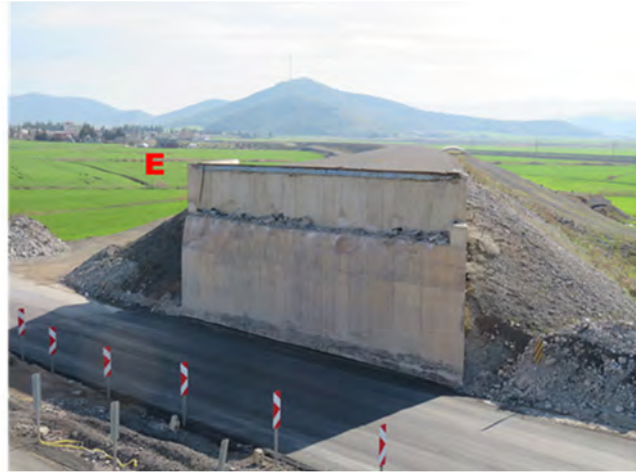
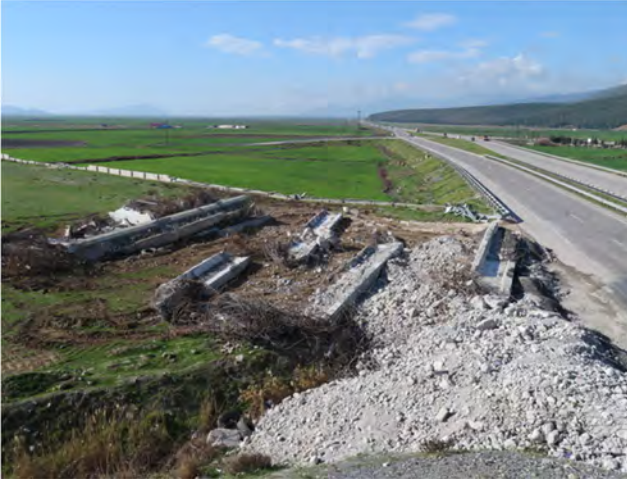
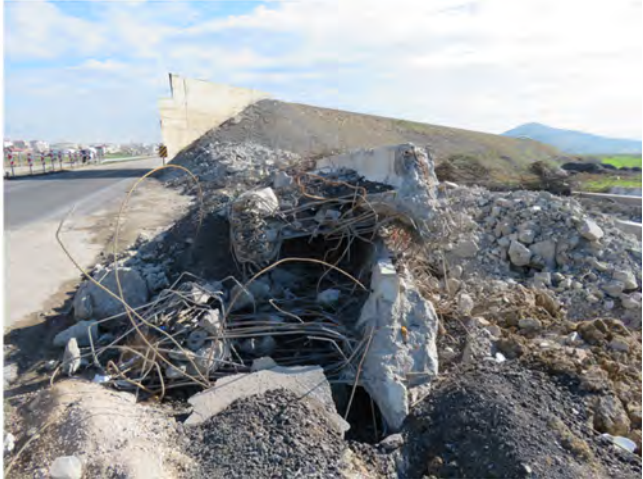
**Figure 2.2-3.** Abutments and removed girders

The bridge spans over the four-lane D825 highway, as shown in **Figure 2.2-2**. As shown in **Figure 2.2-3**, the fallen superstructure was removed and placed on the south side of the western abutment. It is believed to have been a skewed single-span concrete girder bridge.

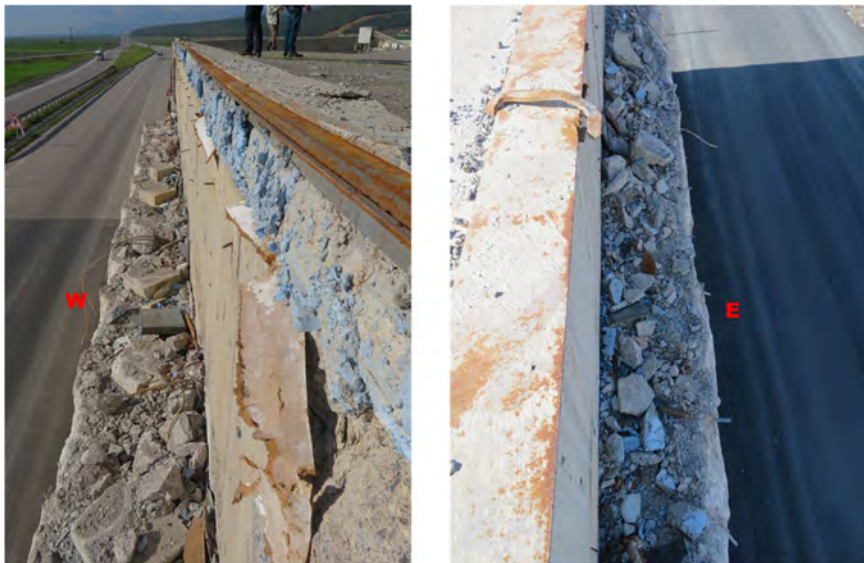
Figure 2.2-6. Comparison of bridge seatings in west and east-side abutments

Figure 2.2-6 shows that concrete and rubber blocks remained on the west side and appeared to be part of the bearings or the shear keys. However, no information was available on whether they remained in the same condition immediately after the disaster or were affected by the superstructure removal work.

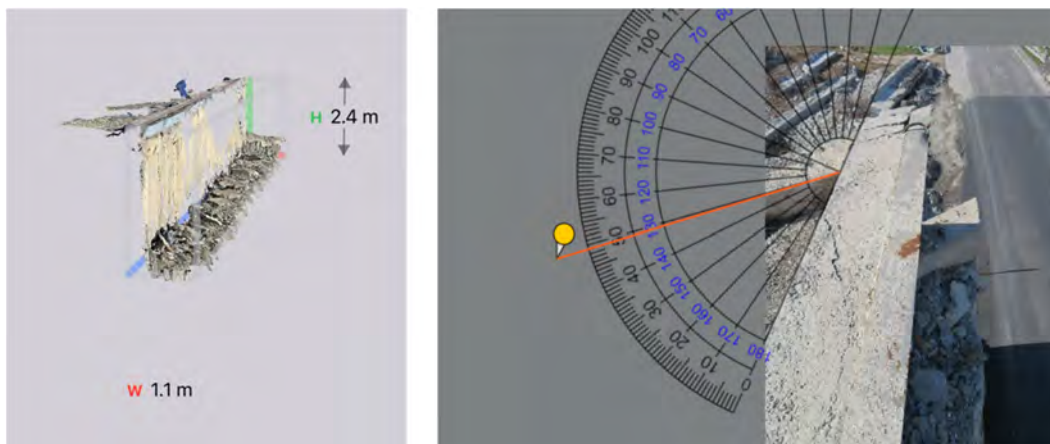
Figure 2.2-7. Measurements of seating length and skew angle

Figure 2.2-7 shows the measurement results of the seating length and skew angle of the west-side abutment estimated from the photos. The seating length and the skew angle were approximately 1.1 m and 50°, respectively.

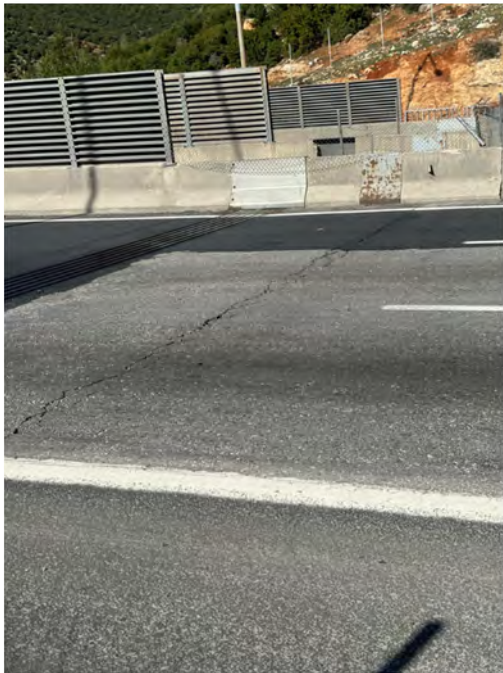
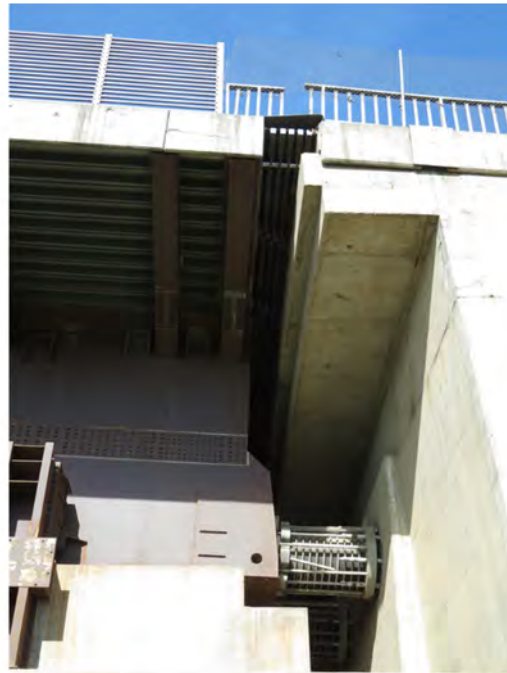
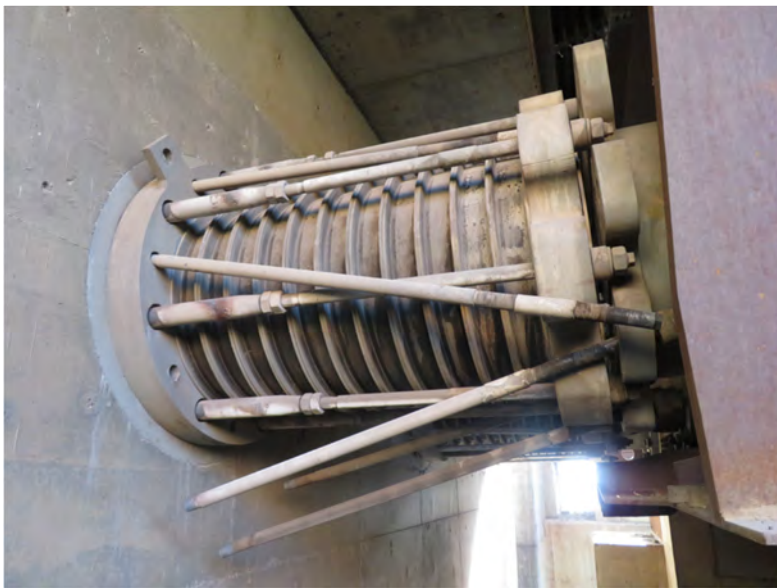
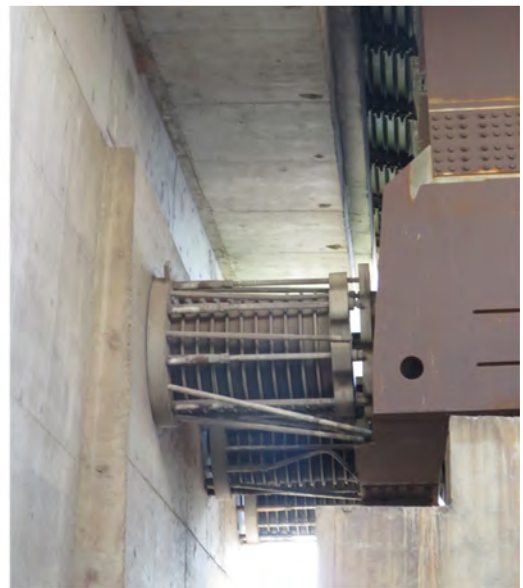
**Figure 2.3-10.** Examples of damage observed around Gaziantep-side abutment

As shown in **Figure 2.3-10**, cracks were present in the pavement behind the Gaziantep-side abutment. The parapet wall was misaligned over the expansion joint. In addition, cylindrical members installed between the girders and the parapet were damaged. This is considered to have prevented the girders from directly colliding with the abutment.

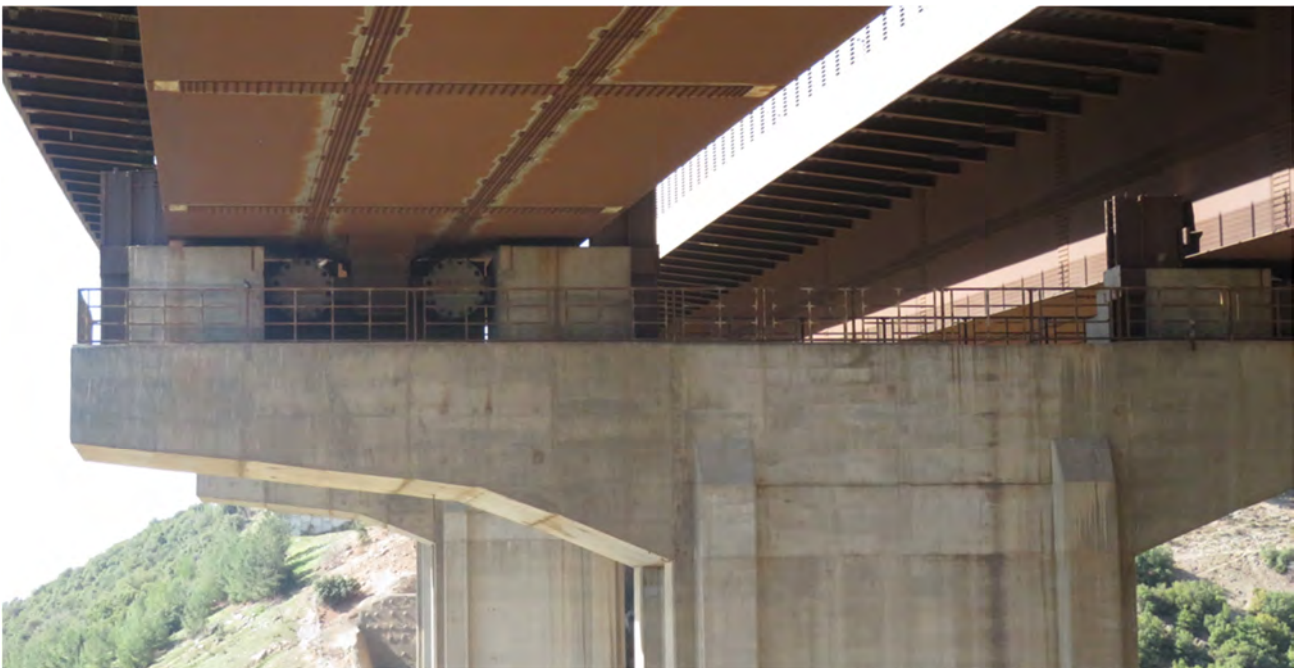
**Figure 2.3-13.** Arrangement of structural parts on piers

**Figure 2.3-13** shows the arrangement of the structural parts around the pier bearings. Concrete blocks were arranged. Displacement-restraining steel cantilevers were placed on the seat, which can support the side of the box girder web in case. Cylindrical parts were placed underneath the steel box girder. It was unclear how these three parts, namely, the concrete blocks, steel cantilevers, and cylindrical parts, worked together to prevent excessive girder movement in the longitudinal or perpendicular direction to the bridge axis.

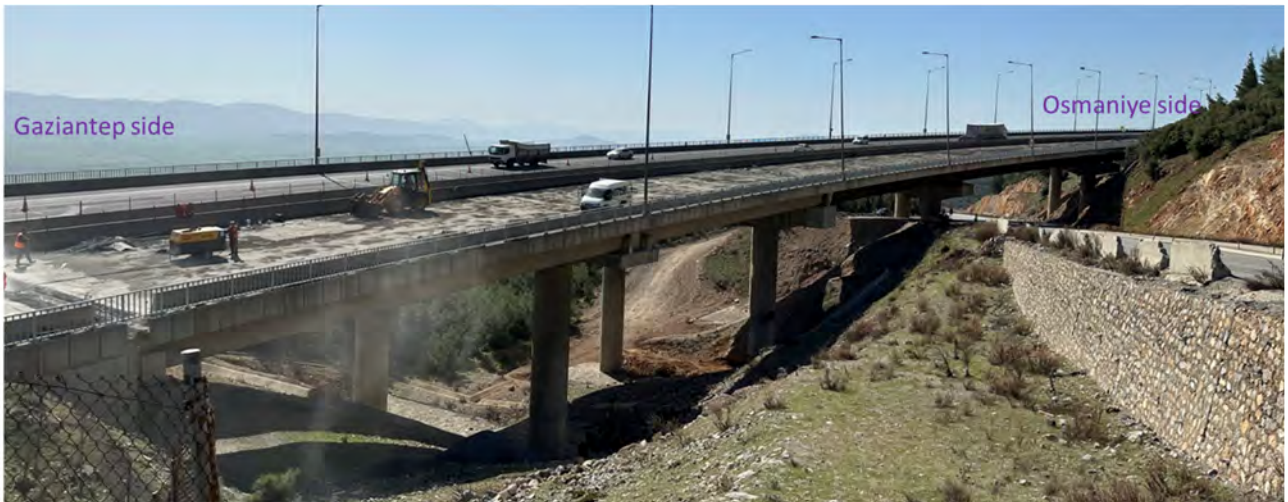
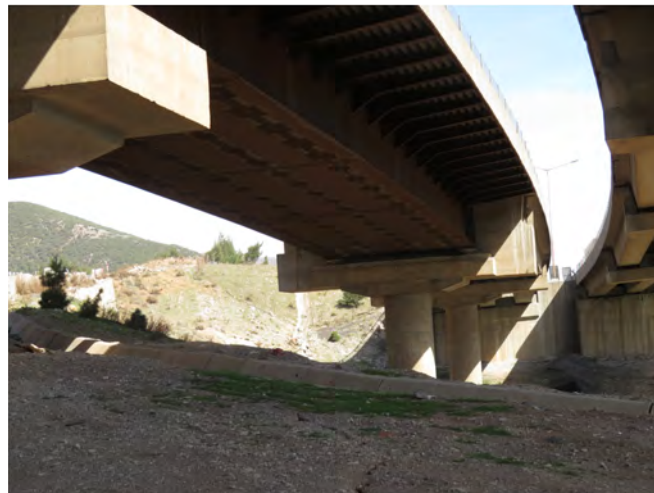
Figure 2.3-19. Nurdağı viaduct on O52

Figure 2.3-19 shows a general view of the Nurdağı Viaduct. The viaduct is separated in different directions. The bridge towards Gaziantep was in service and was temporarily switched to two-way lanes at the time of the survey. The other bridge towards Osmaniye was closed to traffic, and expansion joint replacement work was underway. Both superstructures consist of steel-box girder and prestressed concrete (PC) tub girder sections. The steel-box sections were considered continuous, and the PC tub girder sections were assumed to be connected via link slabs.

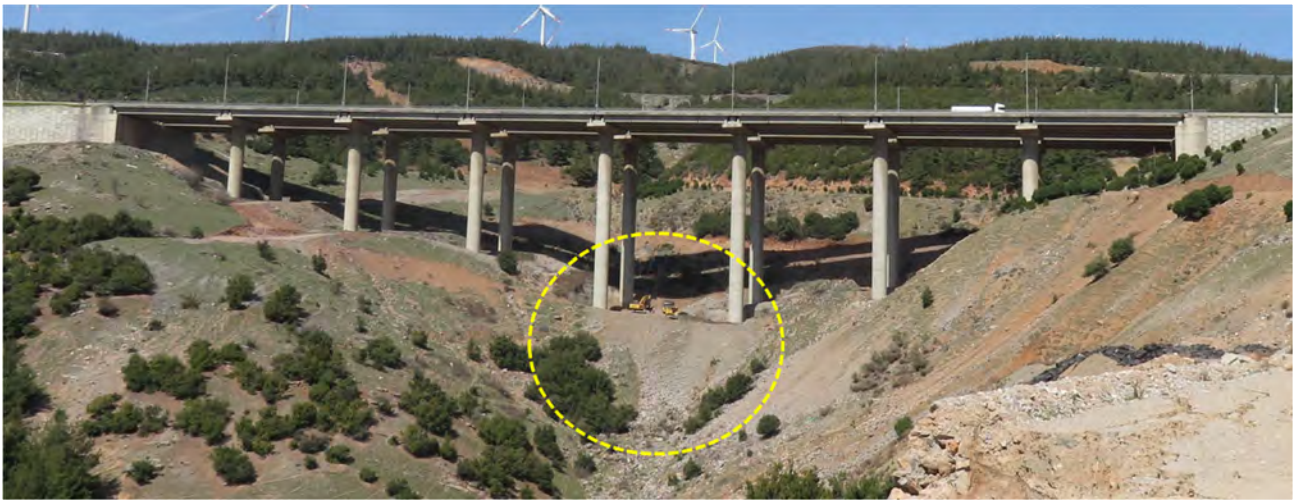
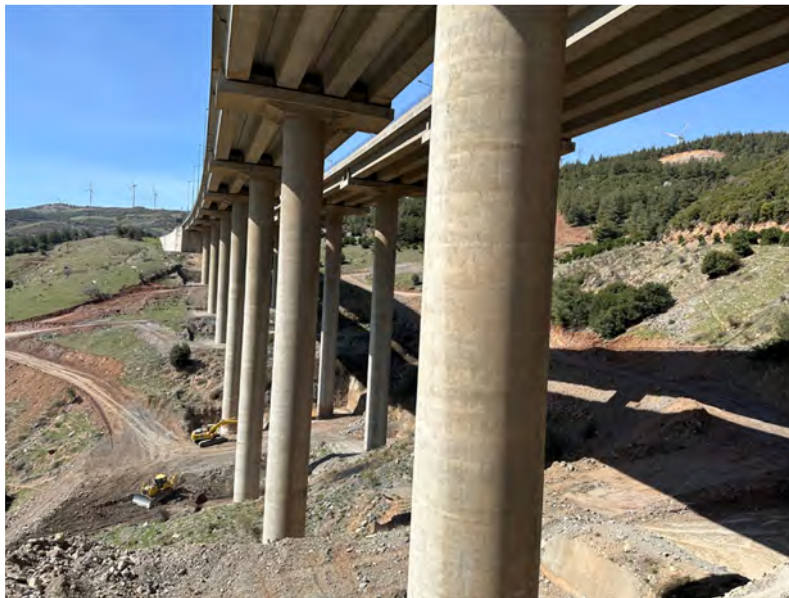
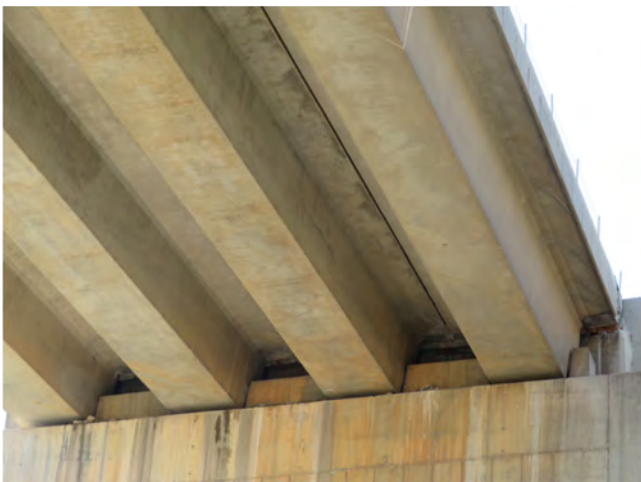
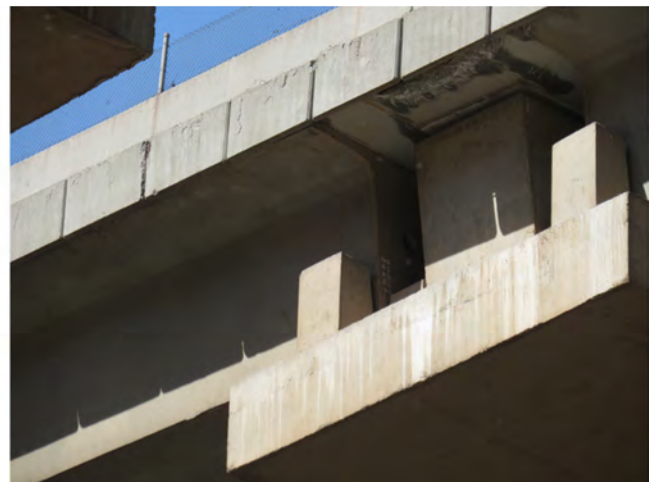
**Figure 2.3-26.** Şehitler viaduct on O52

**Figure 2.3-26** shows a general view of the bridge. The bridge structure is similar to that of the Başpınar viaduct. **Figure 2.3-26** also shows that, during the survey, earthwork was underway at the base of the valley under the bridge center span.

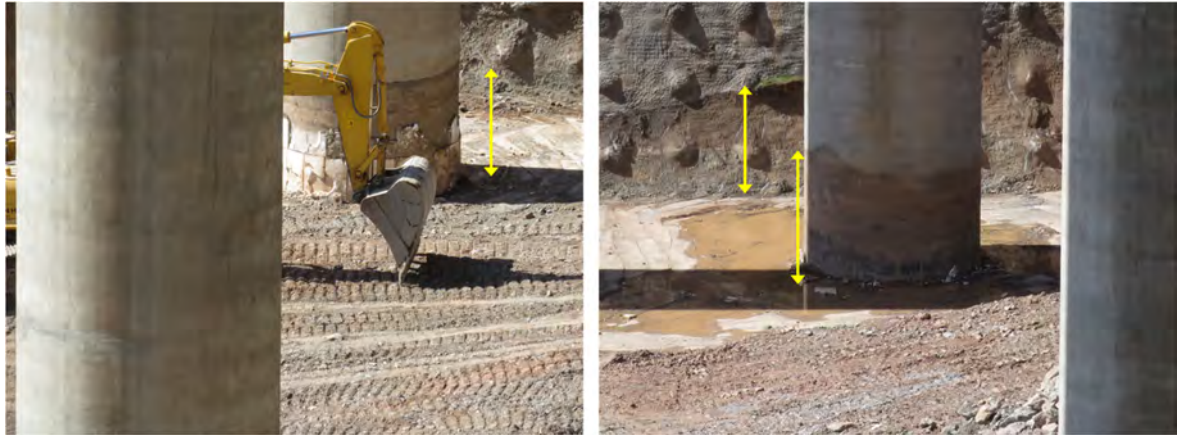
**Figure 2.3-27.** Grounds surrounding bridge piers

As shown in **Figure 2.3-27**, at the time of the survey, construction work was underway at the bottom of the valley. The ground level was considered to differ after the earthquake because of traits and stains of soil on the piers and shot concrete on the surrounding cut slope. The aim of construction work was not sure but it could be to fill the soil movement around the piers caused during the earthquake.

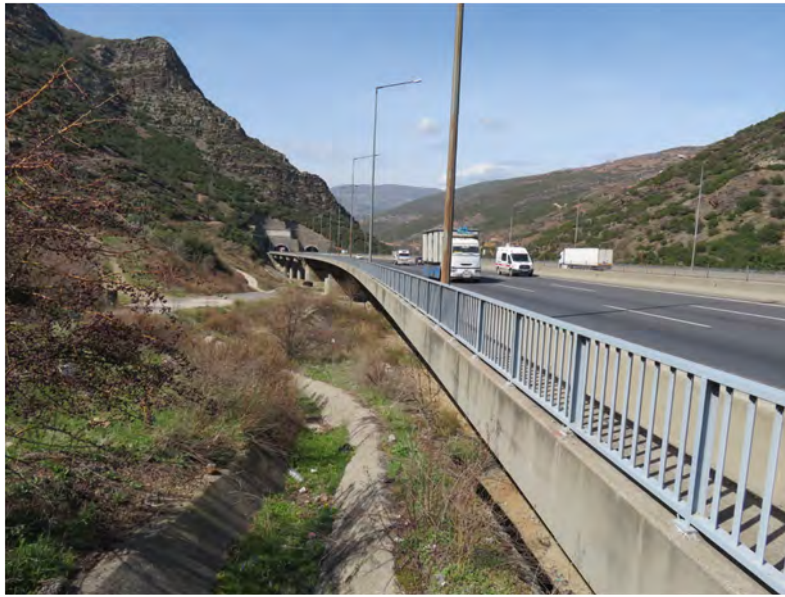
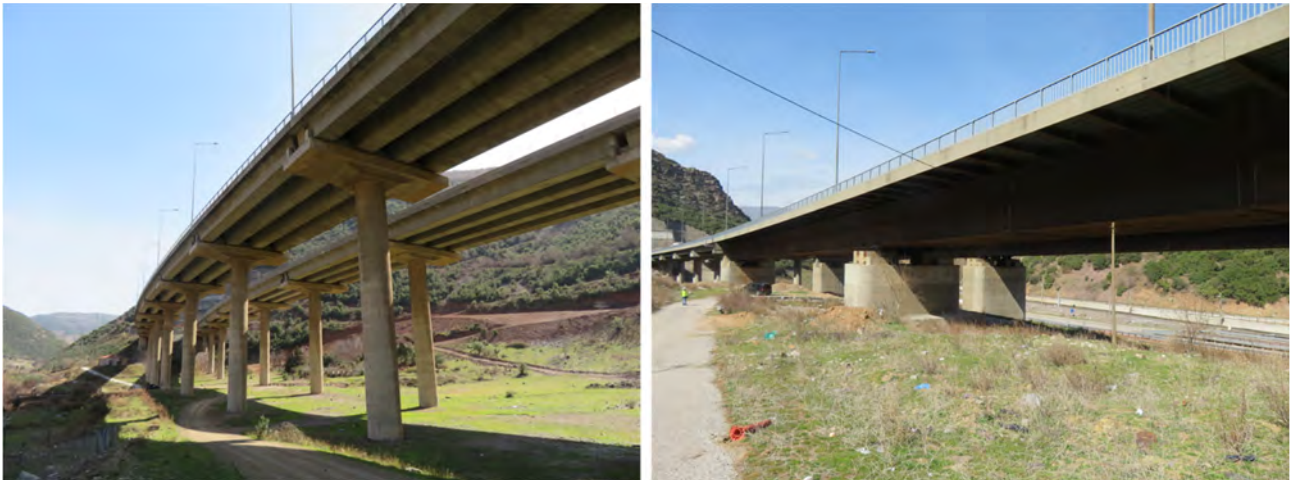
**Figure 2.3-31.** Kızlaç viaduct on O52

The viaduct is adjacent to a tunnel, as shown in **Figure 2.3-31**. As shown in **Figures 2.3-31** and **2.3-32**, the bridge has continuous steel-box and PC tub girder sections. Weathering steel is used for the steel-box girders. Separate bridges run parallel along D400 and the foot of the mountains.

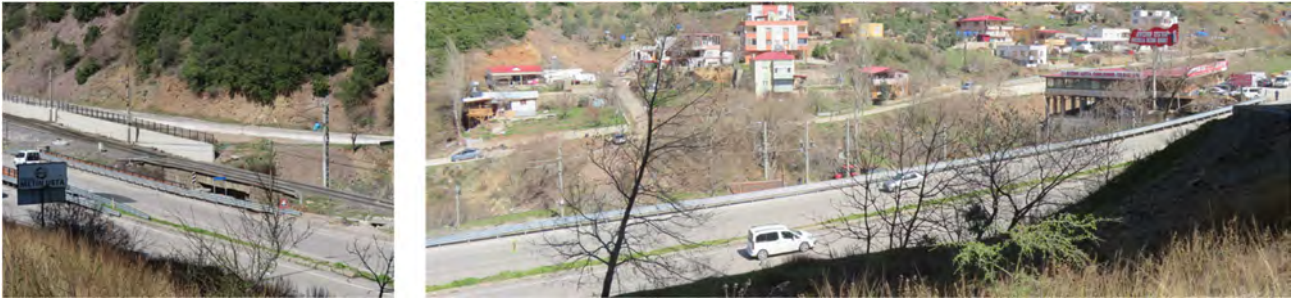
**Figure 2.3-40.** Roads and buildings around viaduct

**Figure 2.3-40** shows the neighboring roads and buildings. No notable collapse was observed. The bridge area was located over mountains from Nurdağı, and the scale of the seismic ground motion was possibly much smaller than that of the Nurdağı area.

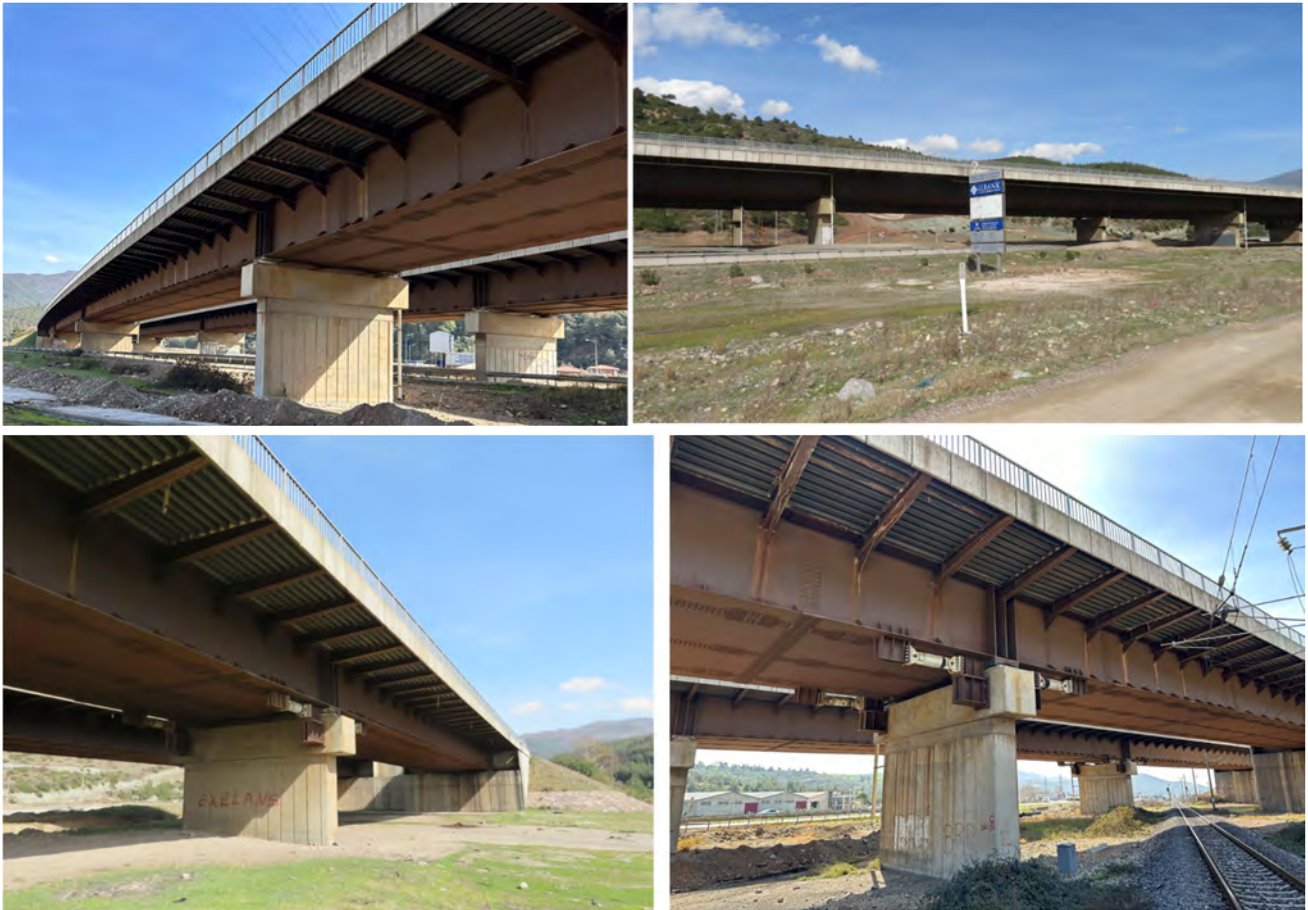
Figure 2.3-42. Vecdi Diker viaduct on O52

As shown in Figure 2.3-42, two bridges toward Gaziantep and Osmaniye are adjacent to each other. They are continuous steel-box girder bridges crossing a channel, road, and railway. Seismic dampers are installed in the first column from the abutments at both ends and connected from the column to the girder.

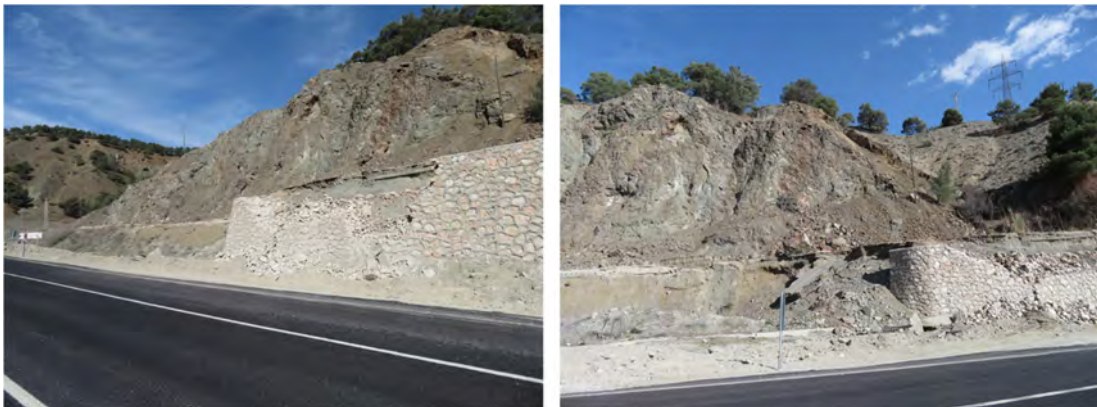
**Figure 2.4-4.** Damage to retaining walls

As shown in **Figure 2.4-4**, an old road was observed on the mountainside whose parts had collapsed.

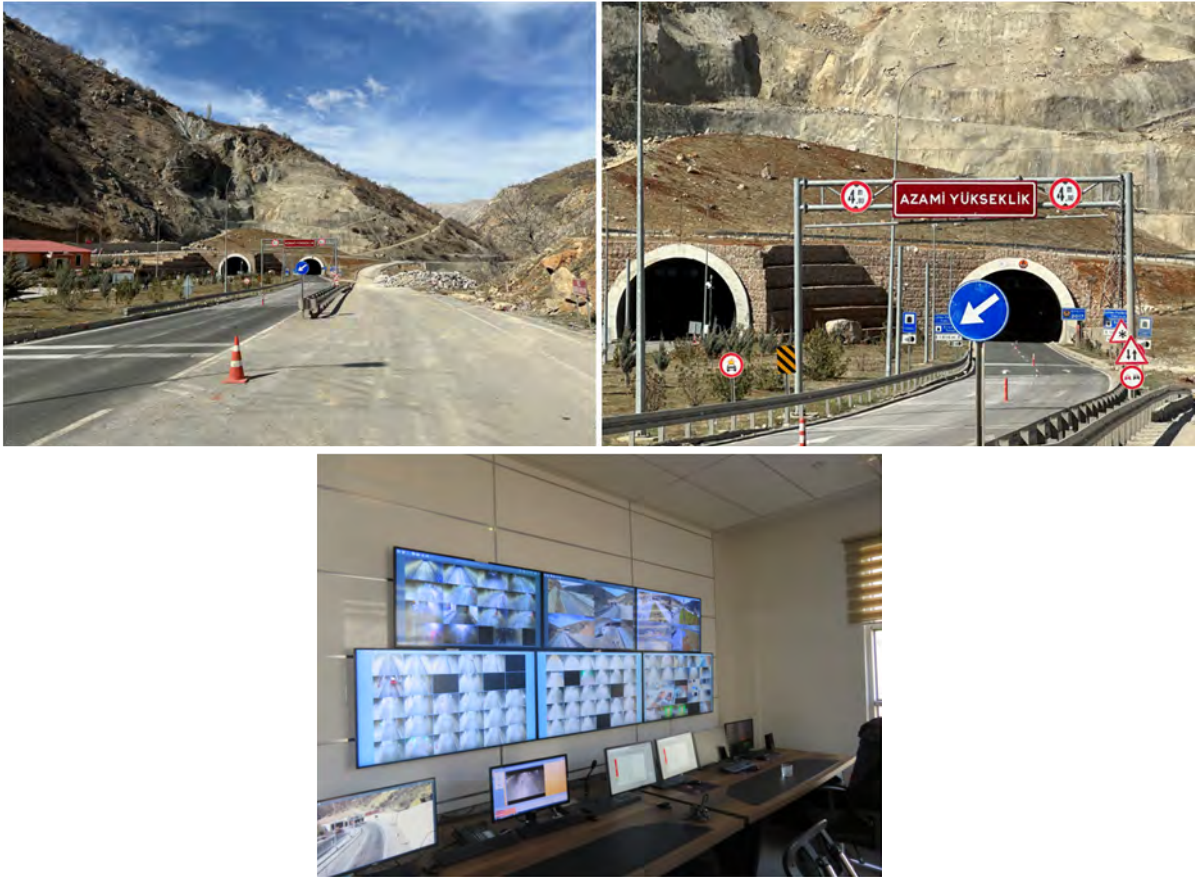
**Figure 2.4-7.** Erkenek tunnel on D850 and operation office

As shown in **Figure 2.4-7**, at the time of the survey, the northbound tunnel (the tunnel on the left side in the photo) was closed to traffic and the southbound tunnel was used for two-lane traffic facing each other. The tunnel operation office is located near the tunnel.

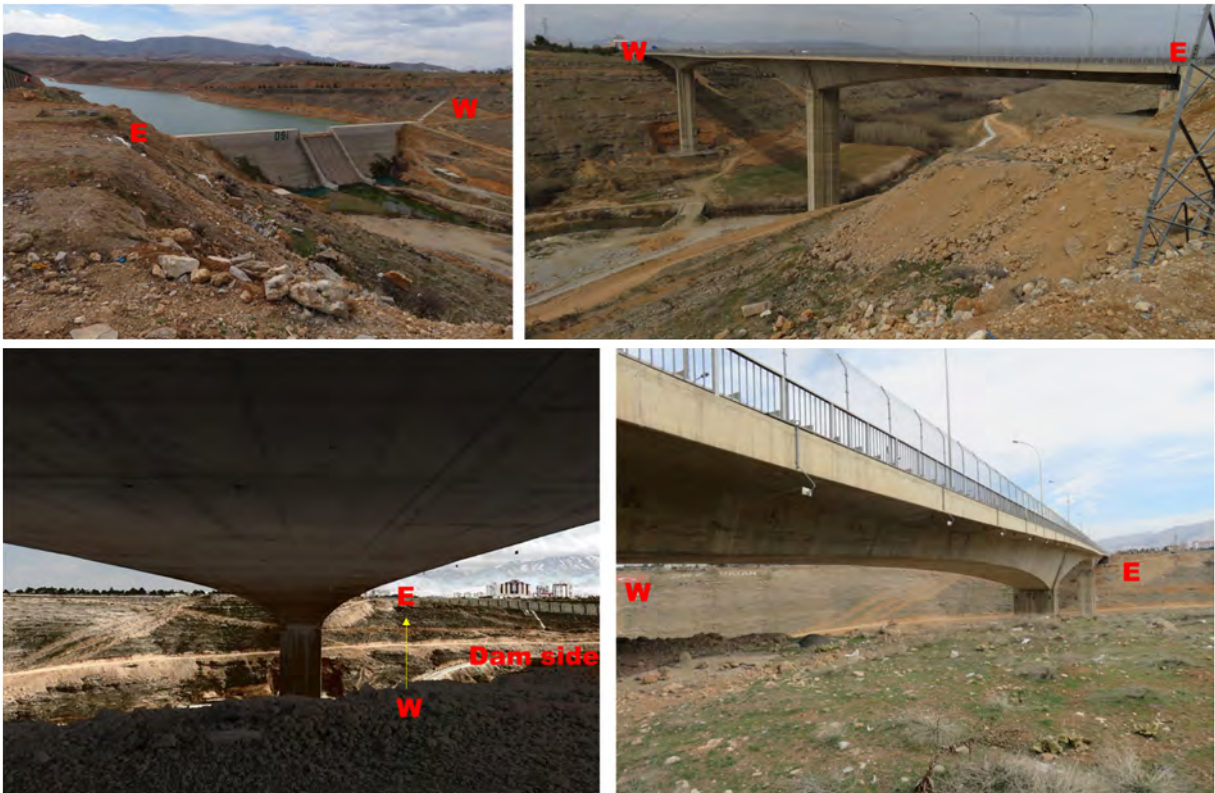
Figure 2.4-12. Beylerderesi Turgut Özal viaduct on D850 (E and W denote the east and west sides of bridge, respectively, in photos)

The bridge is located downstream of the Yeşilvadi (Beylerderesi) dam. **Figure 2.4-12** shows a general view of the bridge. The bridge is a balanced cantilever concrete box-girder bridge.

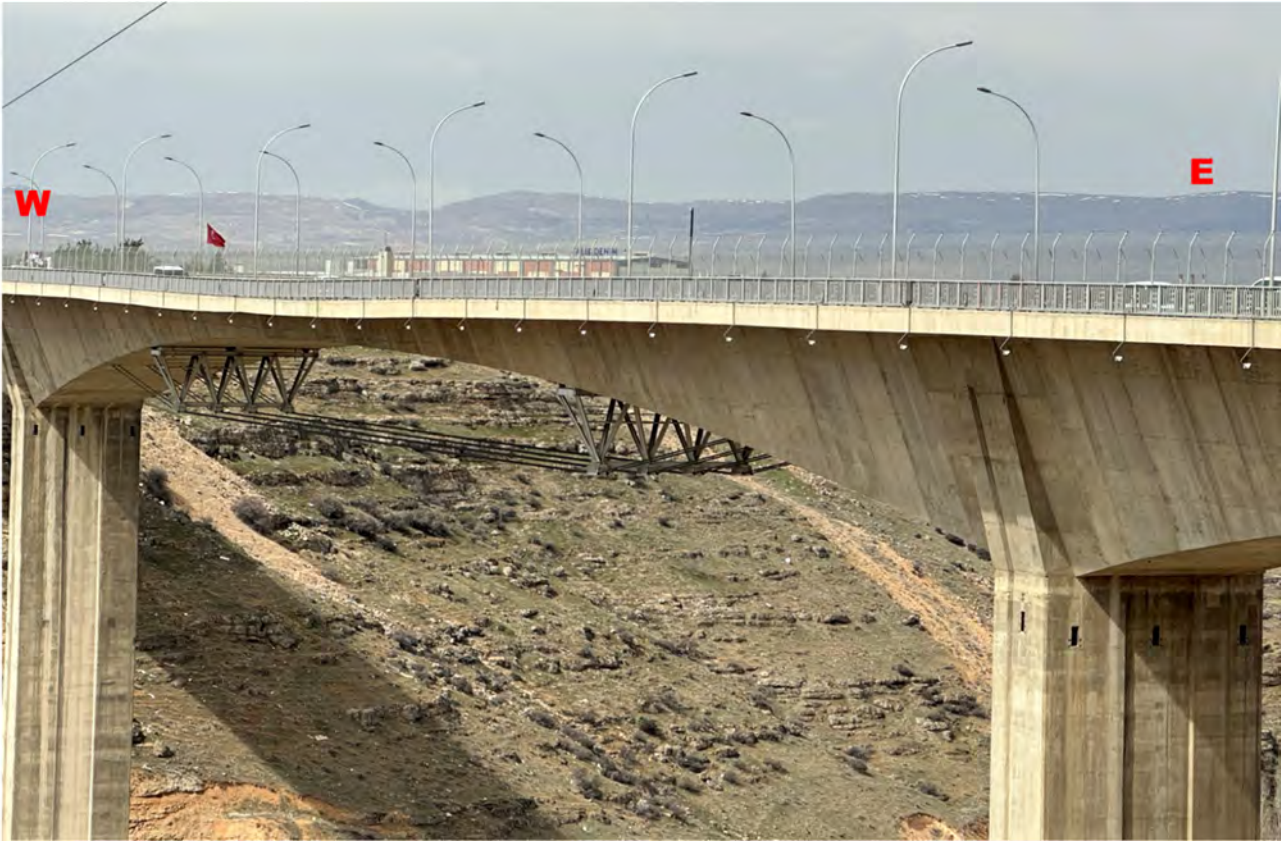
**Figure 2.4-13.** Center span sagging and outer cable system

As shown in **Figure 2.4-13**, an outer cable system is installed. **Figure 2.4-13** also shows the center span sagging toward the middle part.

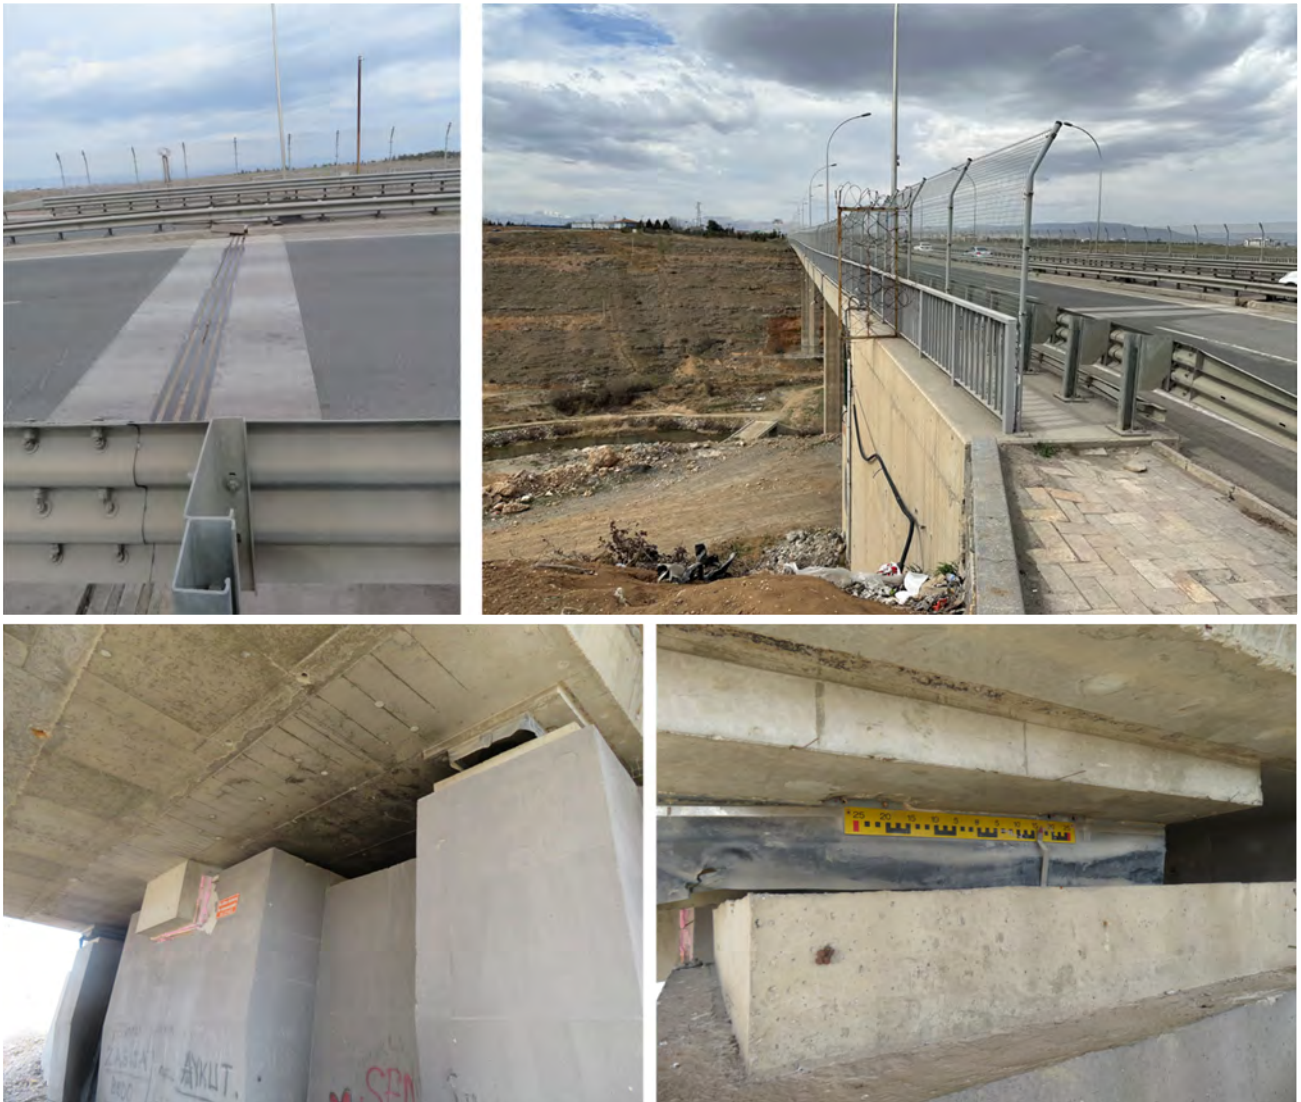
**Figure 2.4-14.** East-side abutment

**Figure 2.3-14** shows the eastern abutment. A rubber cover surrounds each bearing. The centerlines of the bearings and the bearing pedestal concrete did not match; however, it was uncertain whether the girder moved forward during the earthquake.

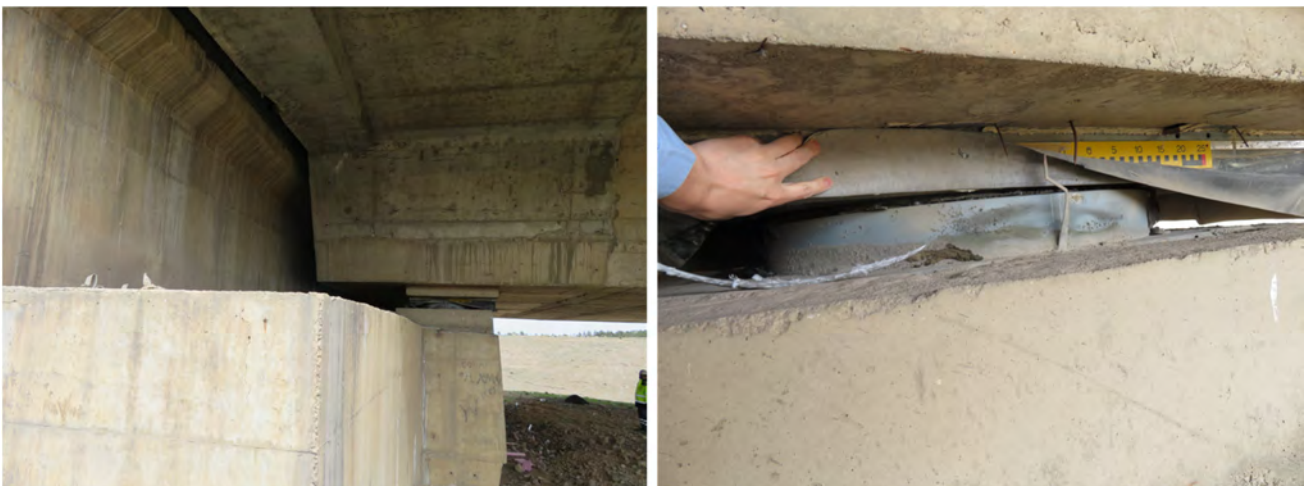
**Figure 2.4-17.** Bearings and their covers

As shown in **Figure 2.4-17**, vinyl and metal covers surrounded the bearings, hindering their inspection.

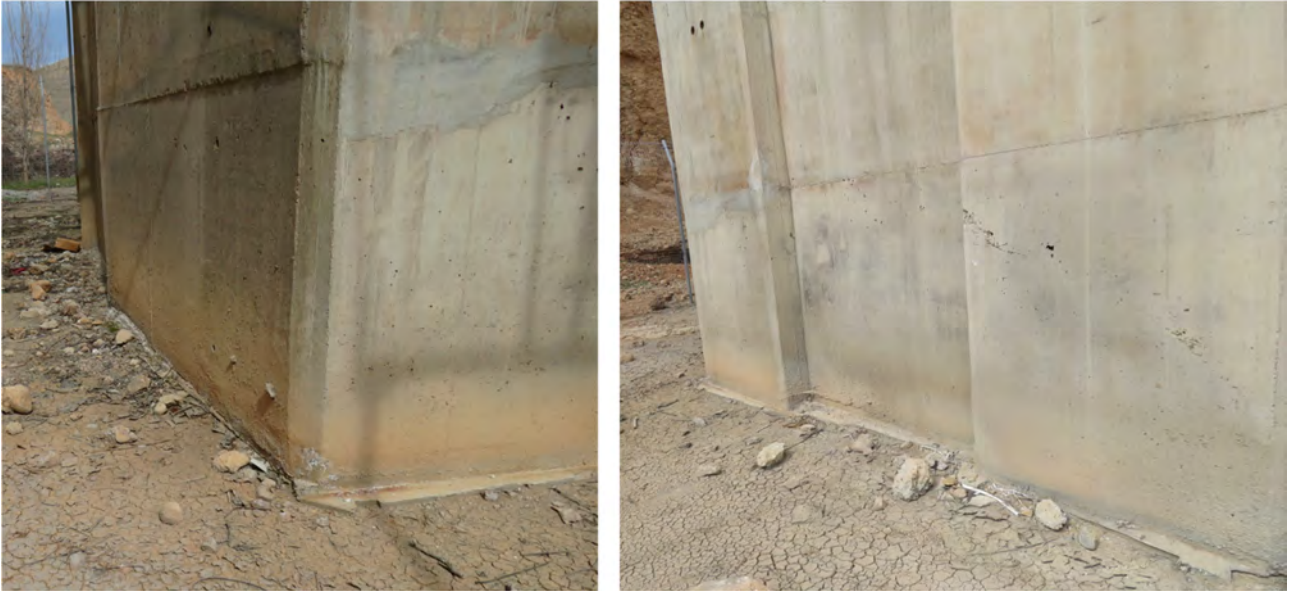
**Figure 2.4-21.** Base of west-side pier

**Figure 2.4-20** shows the western pier. A few small fallen rocks were observed around the western pier. No damage was observed on the pier, as shown in **Figure 2.4-21**.
