## 2. Field scanning records

## 2.1. Antakya city and Hatay Airport Road

### 2.1.1. Viaduct on D817 near Saraykent, Antakya city

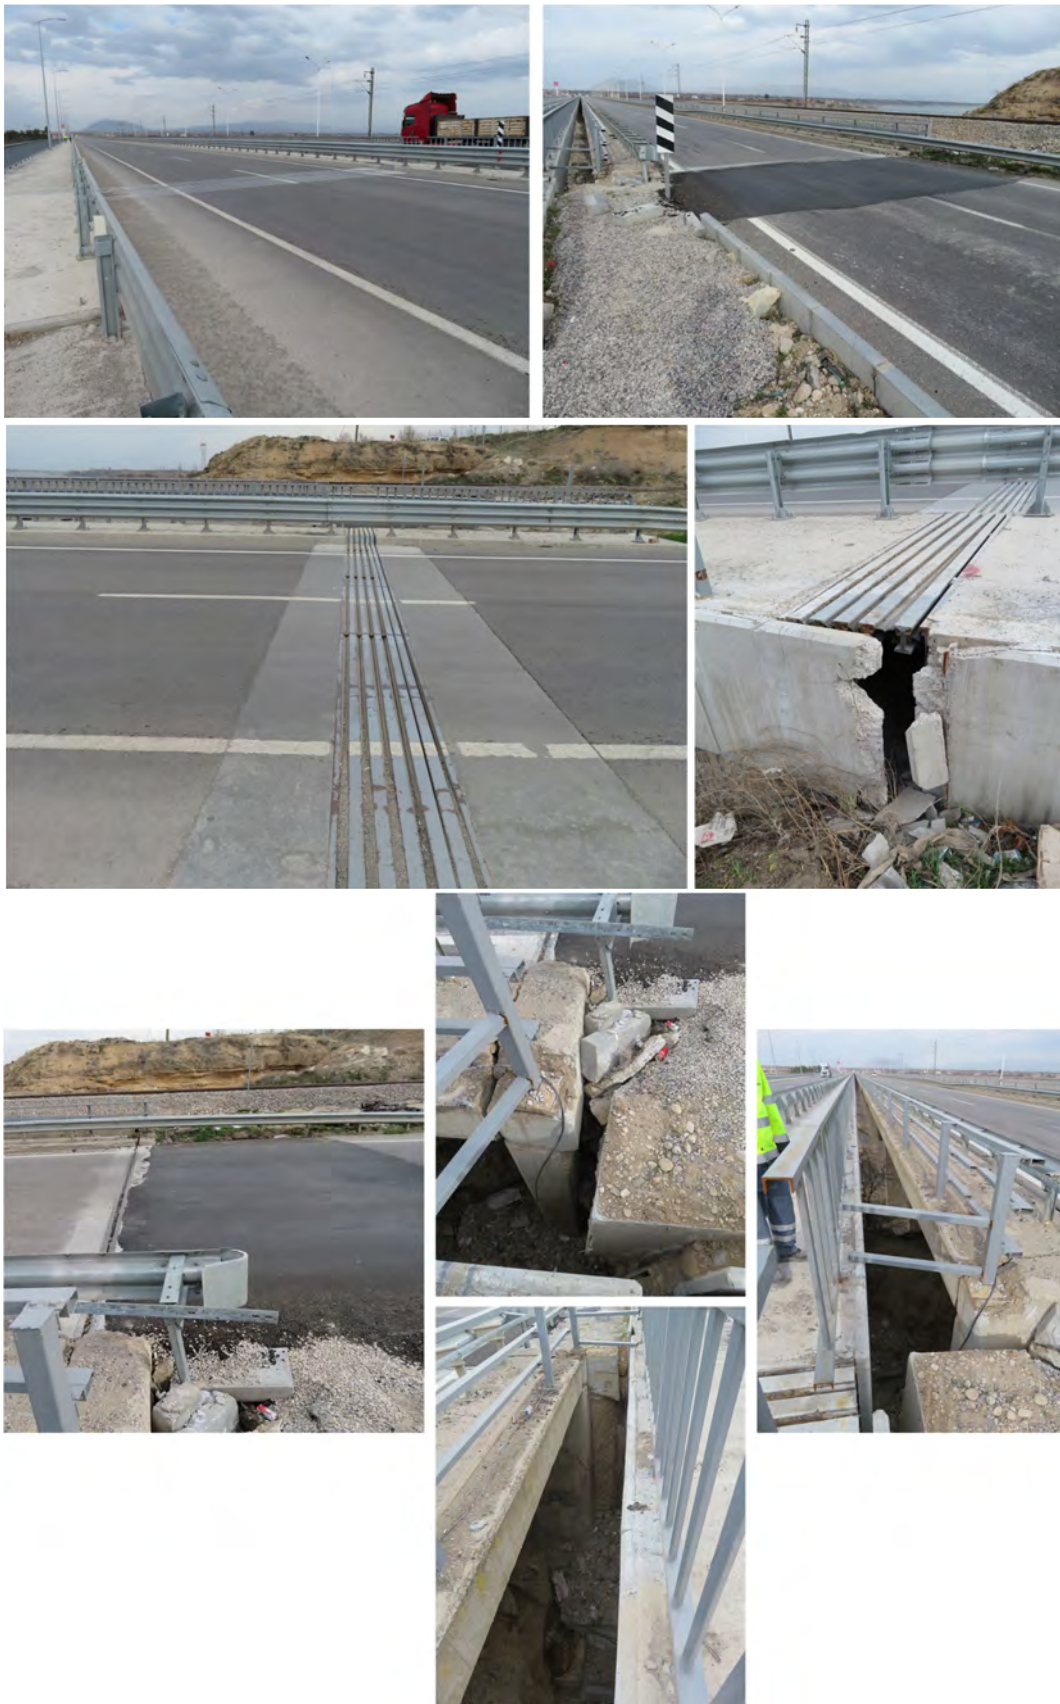
Figure 2.4-25. Examples of damage around south-side abutment

Figure 2.4-25 shows the road surface around the south-side (Malatya-side) abutment. The bridge collided with the abutment, and the superstructure and the abutment were dislocated from each other in a perpendicular direction to the bridge axis.

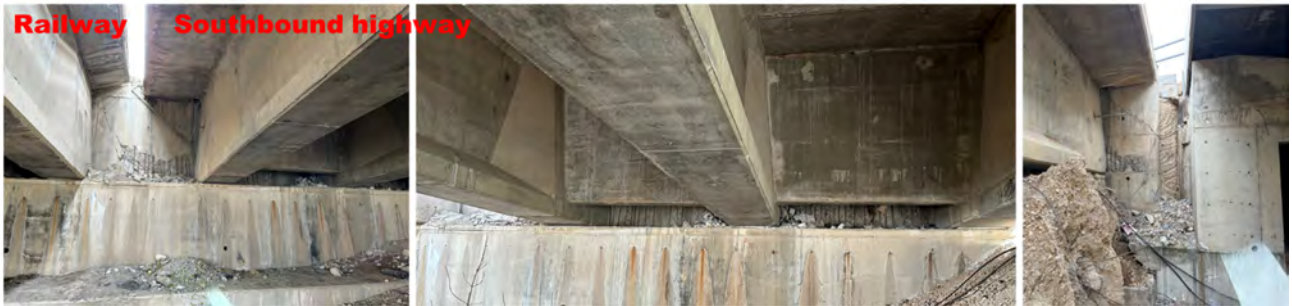
**Figure 2.4-29.** Examples of damage to abutment parapet wall and shear keys

**Figure 2.4-29** shows the old bridge had large cracks in the abutment backwall and the cover concrete ripped off over a wide range. This indicated that the concrete girder collided with the backwall during the earthquake. In addition, the shear keys on the abutment collapsed because of a collision with the adjacent beam.

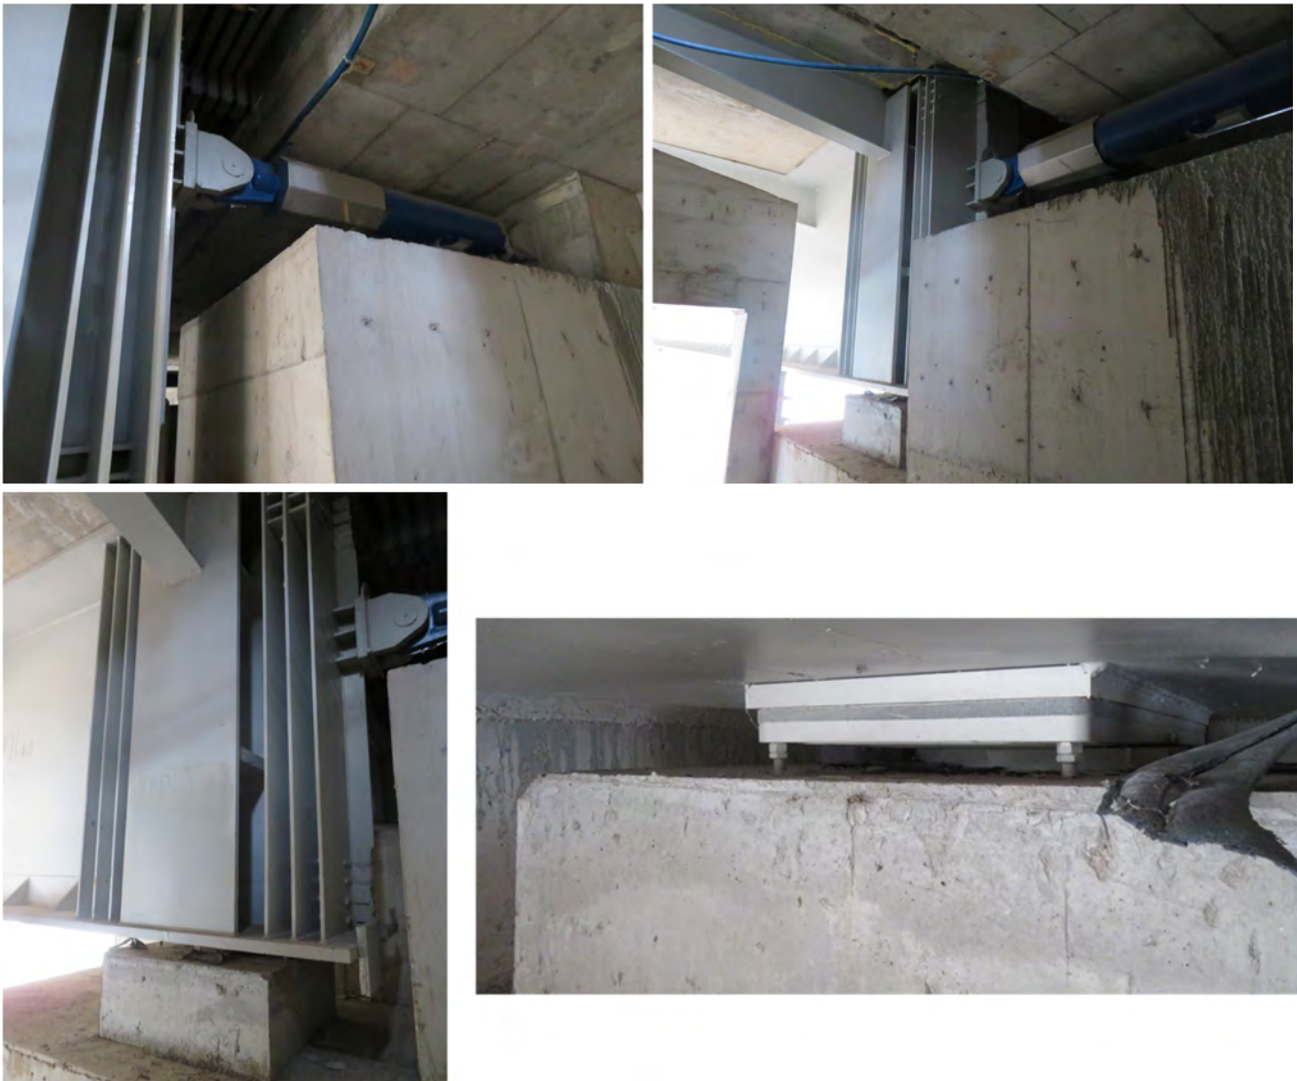
**Figure 2.4-36.** Dampers and bearings in north-side abutment of new bridge

However, as shown in **Figure 2.4-36**, dampers were installed to connect each steel girder to the north-side abutment in the new bridge, as they were at the south-side abutment. They looked intact. A photo of one of the bearings on the abutment is shown in **Figure 2.4-36**, indicating no evidence of movement during the earthquake.

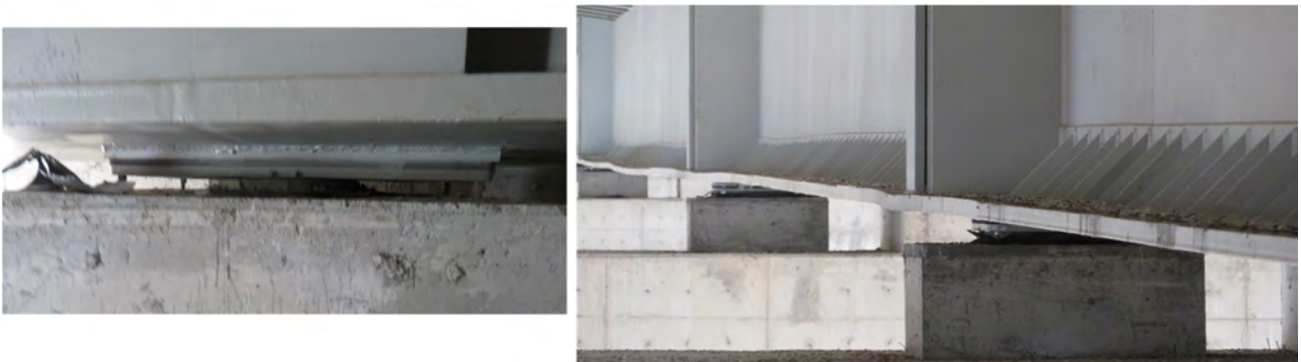
**Figure 2.4-37.** Bearings on piers of new bridge

**Figure 2.4-37** shows the bearings on the piers neighboring the north-side abutment of the new bridge. The bearings on the piers appear to be the same as those on the abutment. Based on the photo, the bottom flange of the girder was deformed; however, this was not certain.

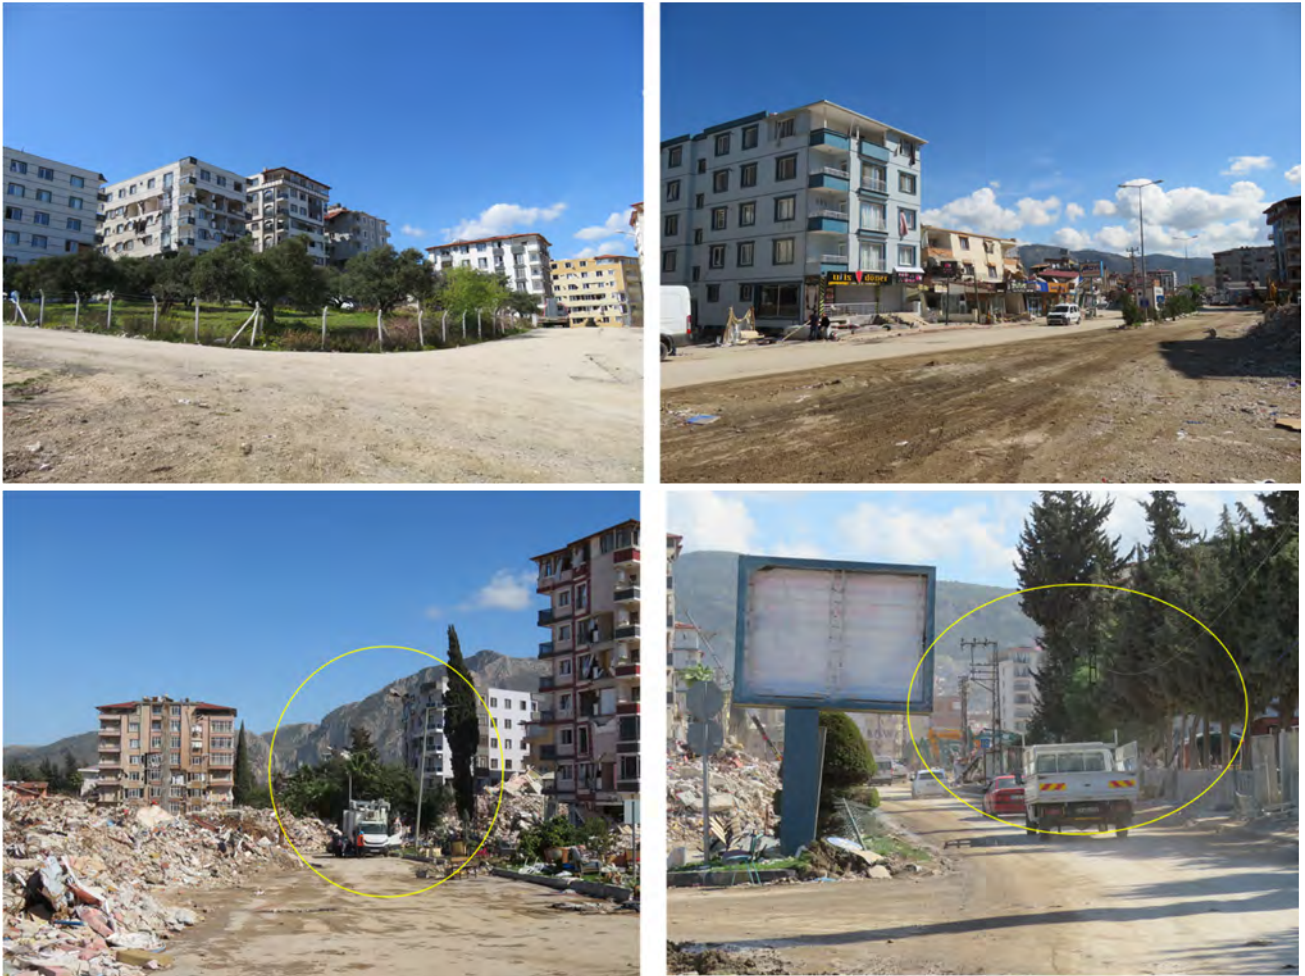
**Figure 2.5-1.** Examples of observed damage to buildings and road ancillaries in downtown Antakya city

During the survey, electric poles were rarely observed in Turkey, as shown in **Figure 2.5-1**.

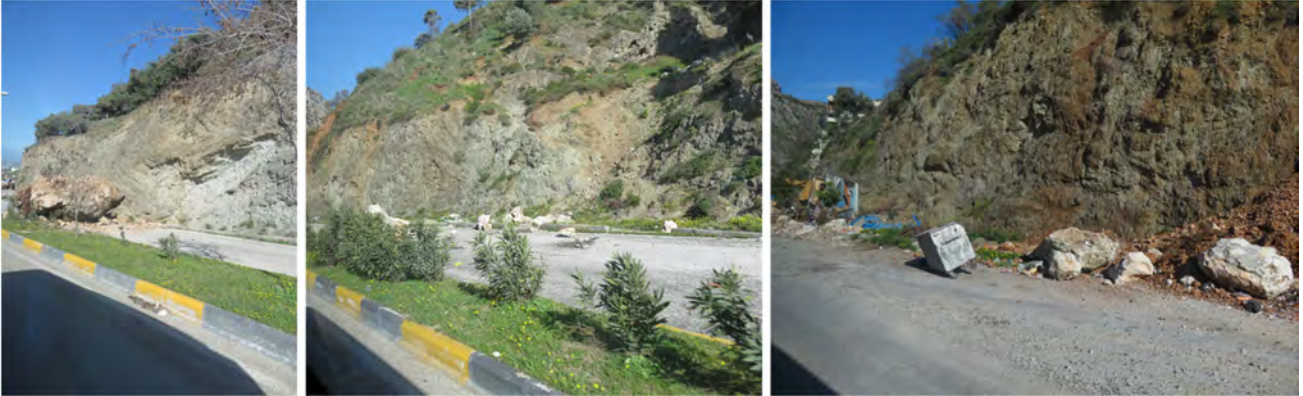
**Figure 2.5-2.** Rockfalls in suburban Antakya

**Figure 2.5-2** shows examples of rockfalls on a road in suburban Antakya. Because it was a four-lane road, the fallen rocks did not block all the lanes.
