Research on External Force and Experiment Method contributing to Structural Performance Verification for Building Members

WAKIYAMA Yoshio (Ph.D (Engineering)), Senior Researcher
INOUE Namihiko , Head
Evaluation System Division, Building Department

(Keywords) Nonstructural components, Structural performance verification, External force evaluation, Experiment method

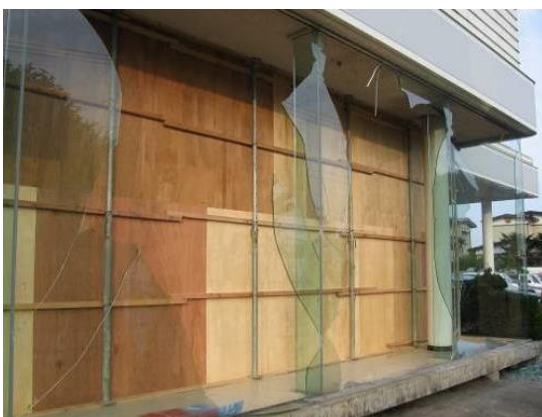
Photo 1: Damaged glass screen by earthquake after its damage
