A Case of Utilizing Results

Results of Study on Resilient Structures for Coastal Dikes

SUWA Yoshio, Head, TAKESHITA Tetsuya, Senior Researcher, HIMENO Kazuki, Researcher
Coast Division, River Department

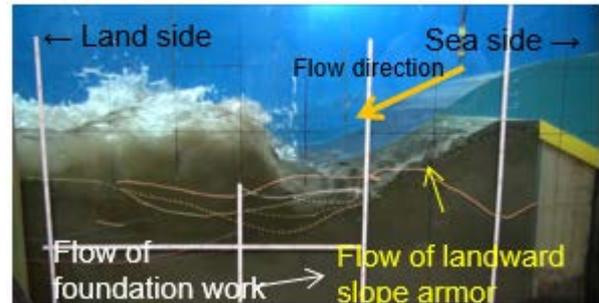
Photo: Experiment of break from the landward slope foundation work

Based on the break mechanism explained in Chapter 2, considerations are provided according to the structures of landward slope foundation work, landward slope armor, armoring work on crown, outer slope armor, outer slope

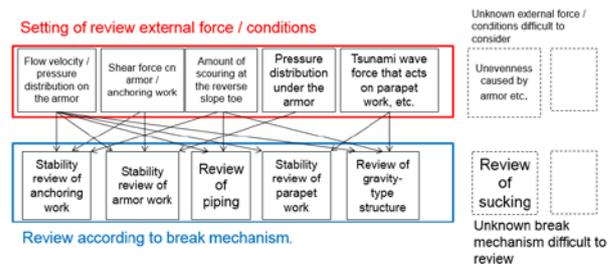
Review items were determined by setting up tsunami wave force and estimating outer force and conditions for review according to each phenomenon that triggers break. For example, in review of the landward slope foundation work, slide and fall are reviewed based on outer force / conditions for review using fluid force, scouring amount, and load from armor works. The Figure below shows outer force / conditions for review and review items.

Figure: Outer force / conditions for review and review items
