Research and Study on Management Methods to Meet the Required Performance of Embankments, Cuts, etc.

(Research period: FY2017 to FY2020)

Road Structures Department, Pavement and Earthworks Division

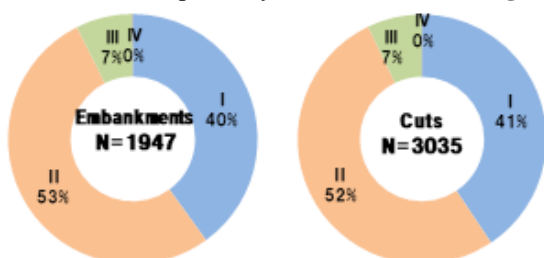
Figure 1 shows the results of inspecting the level of soundness for embankments and cuts. The trend of soundness level distribution of embankments and cuts is almost similar, and Soundness Level III accounts for about 7%.

Fig. 1: Soundness judgment result

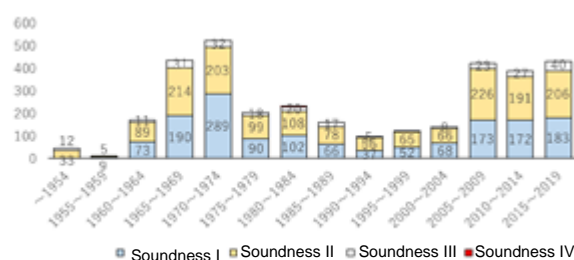
Figure 2 shows the distribution of soundness levels in each completion year, but there is no clear relationship between the completion year and soundness. **Figures**

Fig. 2: Distribution of soundness levels in each completion year (construction year)

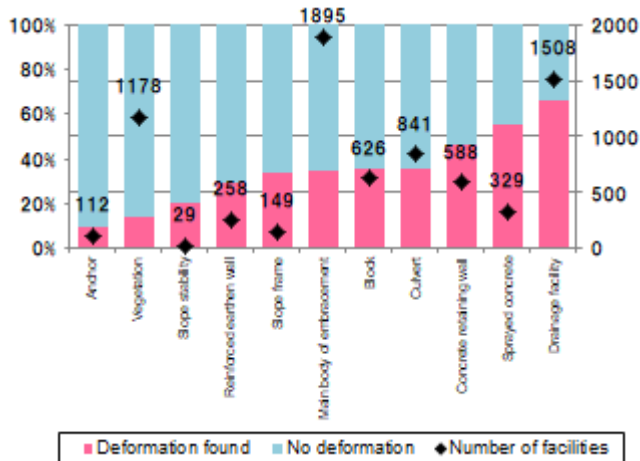
3 and **4** show the percentage of deformation by facility for embankments and cuts. The top three facilities for both embankment and cut are drainage facilities, sprayed concrete, and concrete retaining walls, which are all concrete facilities. As known from the above, it can be conjectured that soil itself, which is the main component of road earthwork structures, is less affected by deterioration with age. On the other hand, since deformation has often occurred to concrete facilities such as slope protection works and drainage systems, the effect of deterioration with age is expected to be large and the analysis should, therefore, be continued.

Fig. 3: Ratio of deformation in embankments by facility

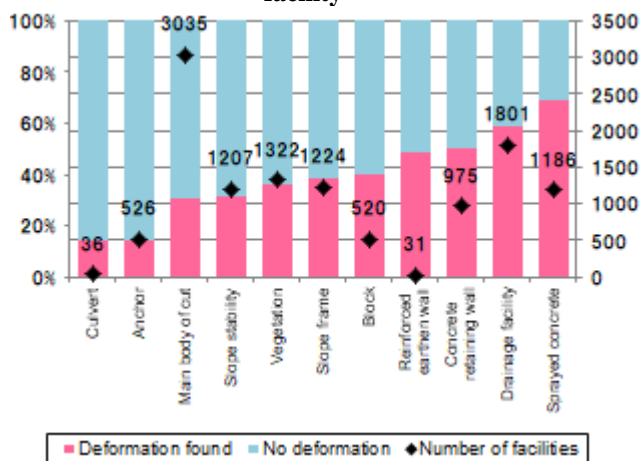
Fig. 4: Ratio of deformation in cuts by facility

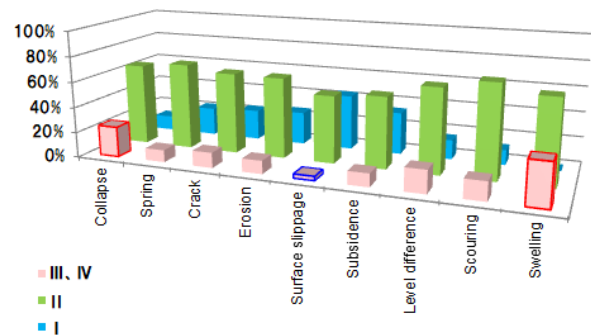
[Main body of embankment]

- If there is "collapse" or "swelling," it tends to be judged as Soundness Level III.
- Deformation caused by "surface slippage" tends to be judged as Soundness Level I or II, and is difficult to be judged as Soundness Level III.

Fig. 5: Soundness judgement for each type of deformation (Embankments)

As described above, since the tendency of deformation that is likely to be judged as Soundness Level III is different depending on the type of structure, even for road earthwork structures, it is necessary to conduct inspections with a focus on the characteristics of each structure. Note that the inspection results cover a period of two years and the number of facilities analyzed is uneven, so the data will continue to be accumulated.

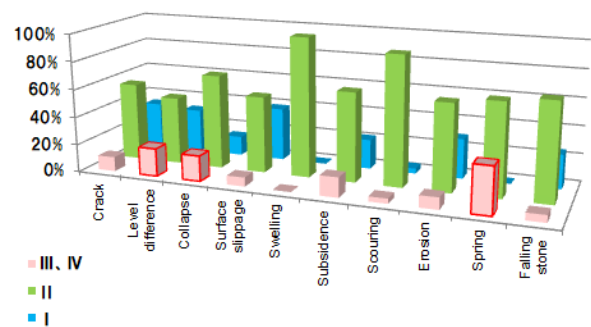
[Main body of cut]

- When there is spring, collapse, or level difference, it tends to be judged as Soundness Level III.
- "Swelling" tends to be judged as Soundness Level I or II, but not as III in any example.

Fig. 6: Soundness judgement for each type of deformation (Cuts)
