英国のインフラ維持管理とISO55000sの導入

2014年 2月 27日

株式会社三菱総合研究所

■ 英国のインフラ維持管理

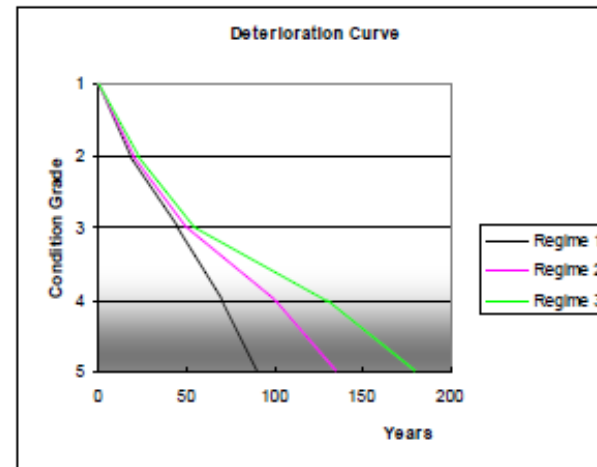
<レジーム別劣化曲線>

レジーム1	目標水準4	<ul style="list-style-type: none"> 点検、Health & Safety(H&S)修理(一年に一度) 状態3から状態4への移行期に大規模な修理・メンテナンス 状態5でアセットの交換
レジーム2	目標水準3	<ul style="list-style-type: none"> 点検、H&S修理(一年に一度) 状態3を維持するためにEAが設定したメンテナンス活動を実施 状態3から状態4への移行期に大規模な修理・メンテナンス 上記移行期以降はメンテナンス頻度を増加 状態5でアセットの交換
レジーム3	目標水準2	<ul style="list-style-type: none"> 点検、H&S修理(一年に一度) 状態2を維持するためにEAが設定したメンテナンス活動を実施 状態3から状態4への移行期に大規模な修理・メンテナンス 上記移行期以降はメンテナンス頻度を増加 状態5でアセットの交換
