Towards More Efficient Infrastructure Management

FUKUDA Yukihiro, Head of Road Structures Department

(Keywords) Road structures, road disasters, maintenance and disaster reduction, technical support, scouring

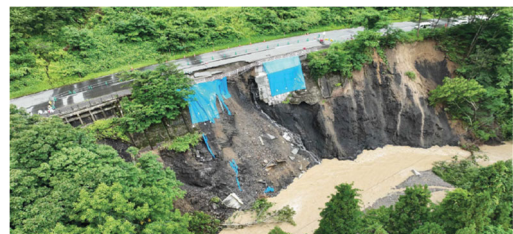
Fig. 1. Damage to National Highway 121 due to torrential rainfall in August 2022 (Yonezawa, Yamagata)

In recent years, disasters affecting bridges and earthwork structures due to torrential rain have increased in frequency and severity (fig. 1). The Road Structures Department collaborates with the Public Works Research Institute to dispatch experts to these disaster sites and provide technical support in site surveys, investigating causes, and stopgap recovery efforts, among other support. We have dispatched experts 56 times just since the current emperor assumed the throne in 2019; 70% of these dispatches related to disaster cases related to precipitation, and nearly 60% of those were primarily caused by scouring (fig. 2). How we should respond to increasingly severe torrential rain damage is a major challenge and a key research topic for road researchers. Our department makes agile use of the national resilience budget with regard to these challenges and feeds the outcomes of research and study back to sites as necessary. This paper presents some representative initiatives and discusses collaboration between infrastructure administrators.

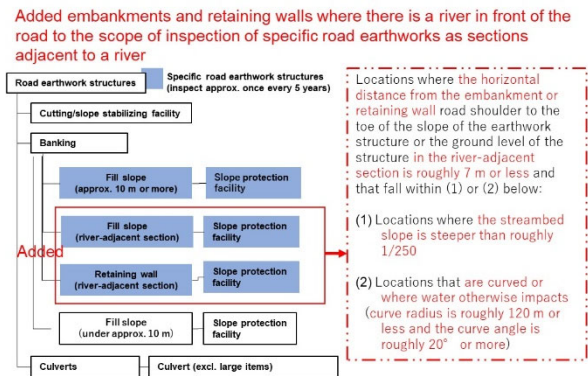
Fig. 3. Addition to the scope of inspections of road earthwork structures

Based on the results of this survey, we have added embankments and retaining walls in sections adjacent to rivers to the scope of inspections for specific road earthwork structures and have decided to place limits on the conditions when doing so, such as the horizontal distance from the road shoulder to the toe of the slope, the river slope, the curve radius, and the curve angle, and to concentrate on managing high-risk locations (fig. 3).
