# An Analysis of the Results of Regular Road Tunnel Inspections

(Research period: FY2021-)

Foundation, Tunnel and Substructures Division, Road Structures Department

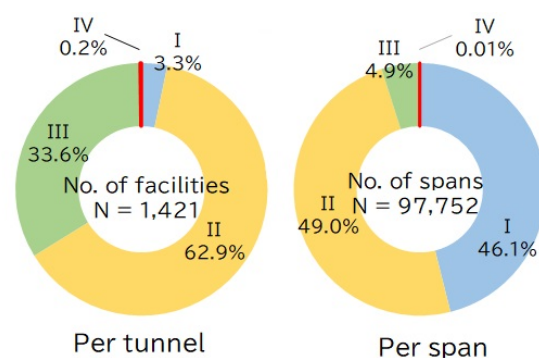
Fig. 1. Proportions of health assessment classes

Of the 1,553 national administered road tunnels that were inspected in the first round (FY2014-2018), the diagnostic results of the health of 1,421 tunnels constructed by mountain construction methods (sheet piling, mountain tunnel method) found approximately 3% in assessment class I (healthy), approximately 63% in class II (preventative maintenance stage), approximately 34% in class III (early measures stage), and approximately 0.2% in class IV (urgent measures stage), with the majority of tunnels requiring some sort of measures. Reorganizing this by span (where one span is

approx. 10 m), the proportion in class I (healthy) is approximately 46% and the proportion in classes III and IV is approximately 5% (fig. 1). This difference is due to diagnoses of tunnel health being represented by the class of the least healthy span.

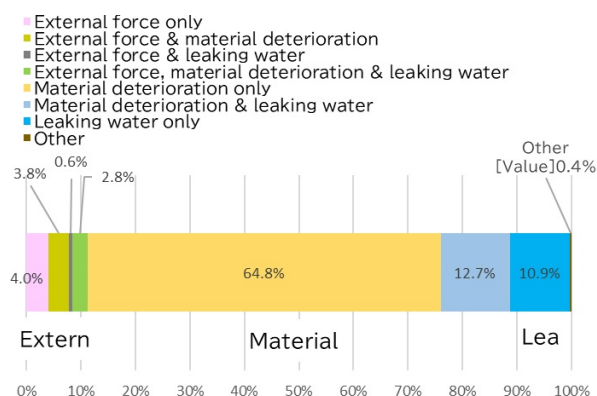
Fig. 3. Breakdown by deformation class in tunnels with class III or IV health

In addition, figure 3 shows the proportions organized by deformation class for the 503 tunnels that were diagnosed with class III or IV health, among the 1,421 facilities. The proportion where external forces were a factor is comparatively small at approximately 11%, while the proportion where material deterioration alone or both material deterioration and leaking water were a factor is larger at approximately 78%.
