JICA Group and Region-Focused Training "Building Disaster Prevention (Concerning Earthquakes, Tsunami, Fire, Typhoon, Etc.) Course"

Masonry Construction in Japan

Naoji Hasegawa

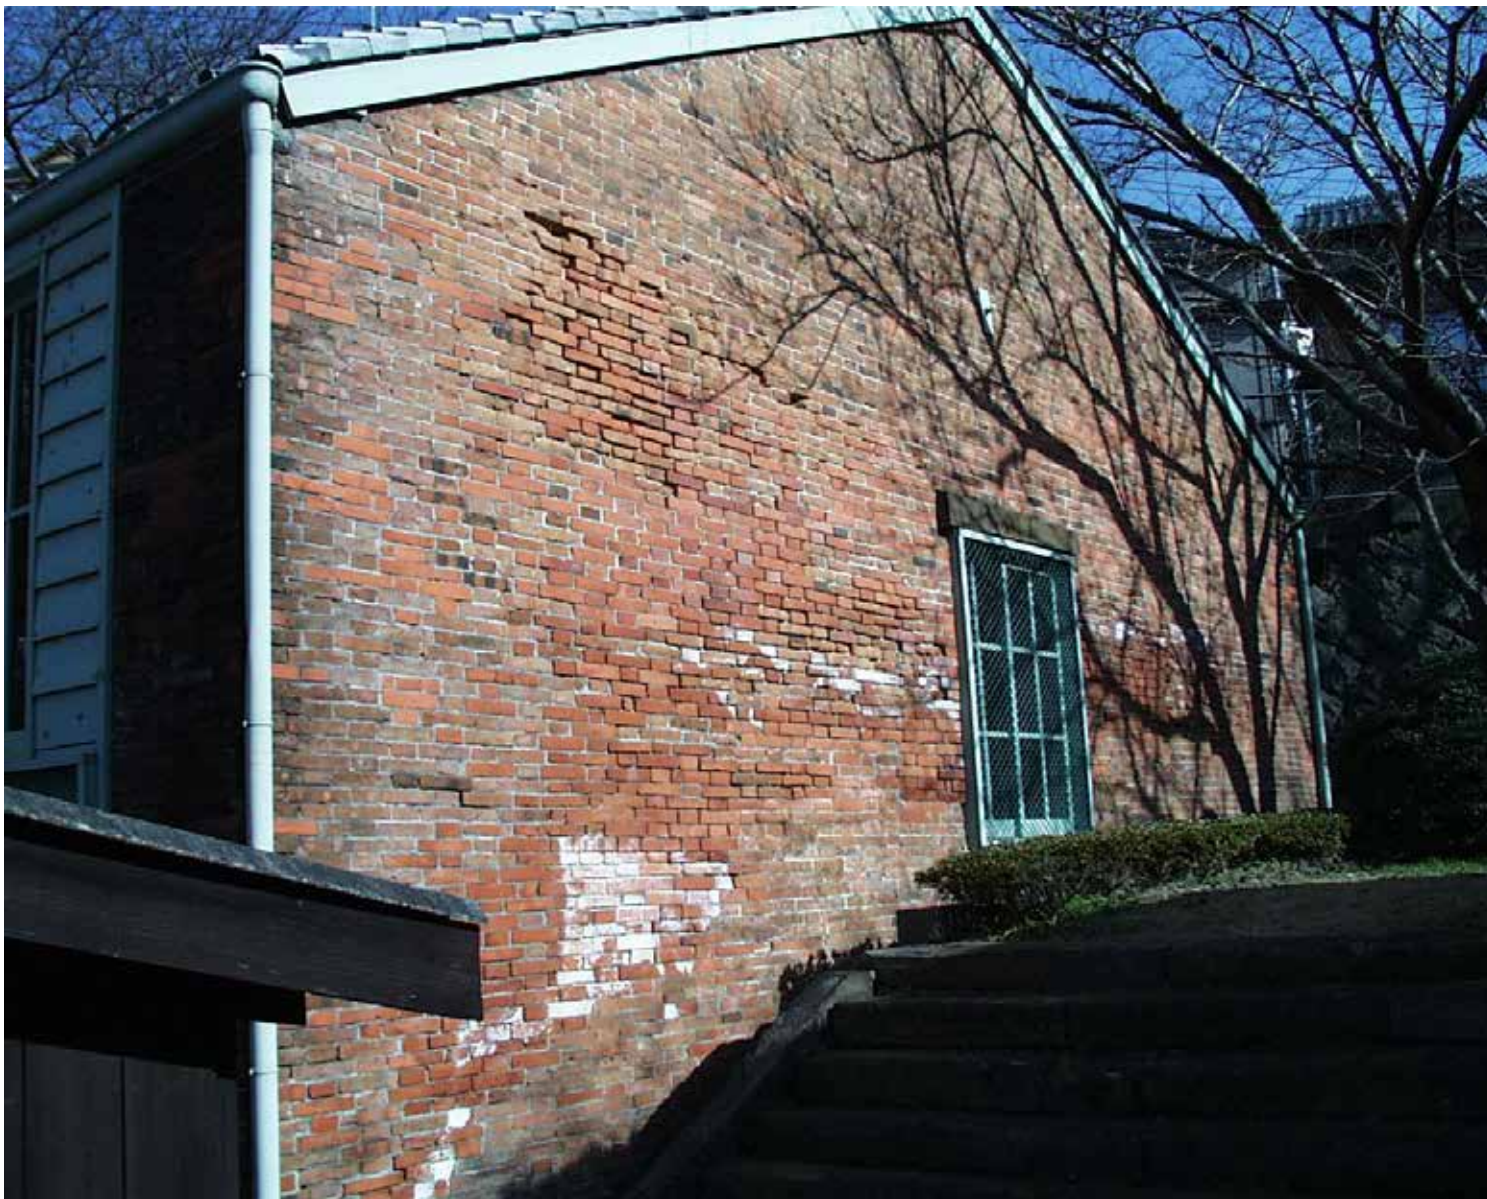
The oldest extant masonry structure Kosuge Repair Dock (1868, Nagasaki Prefecture)

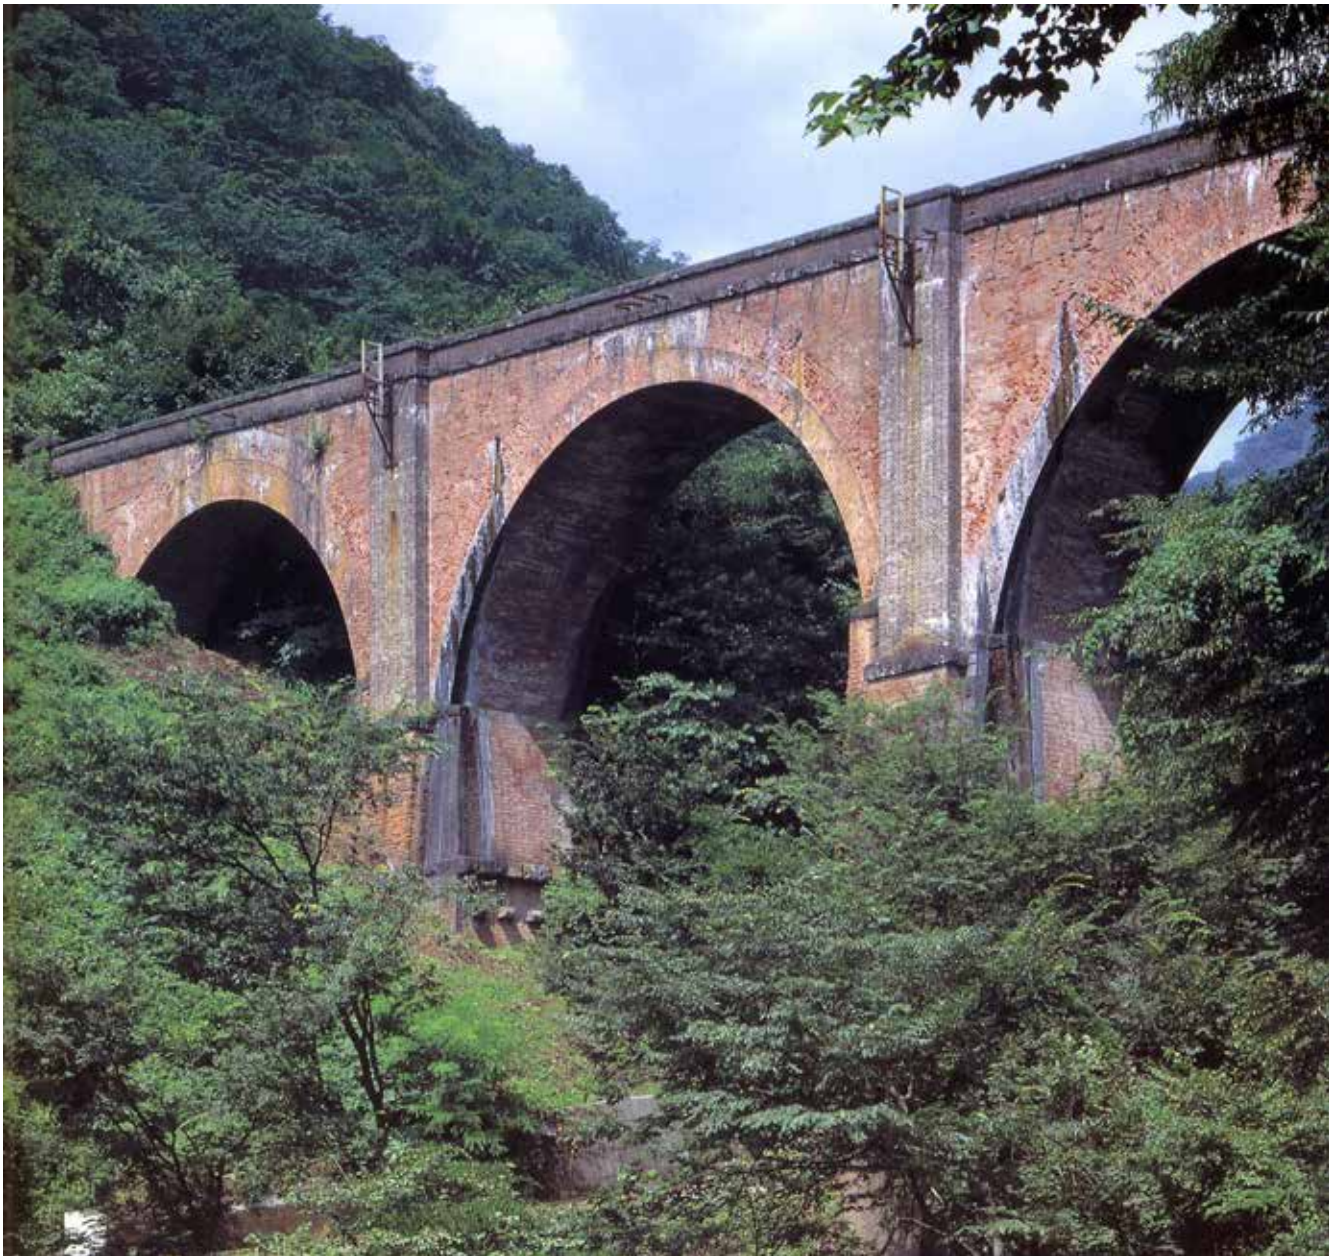
Nationally designated important cultural property Former Usui No. 3 Arch Bridge (1892, Gunma Prefecture)

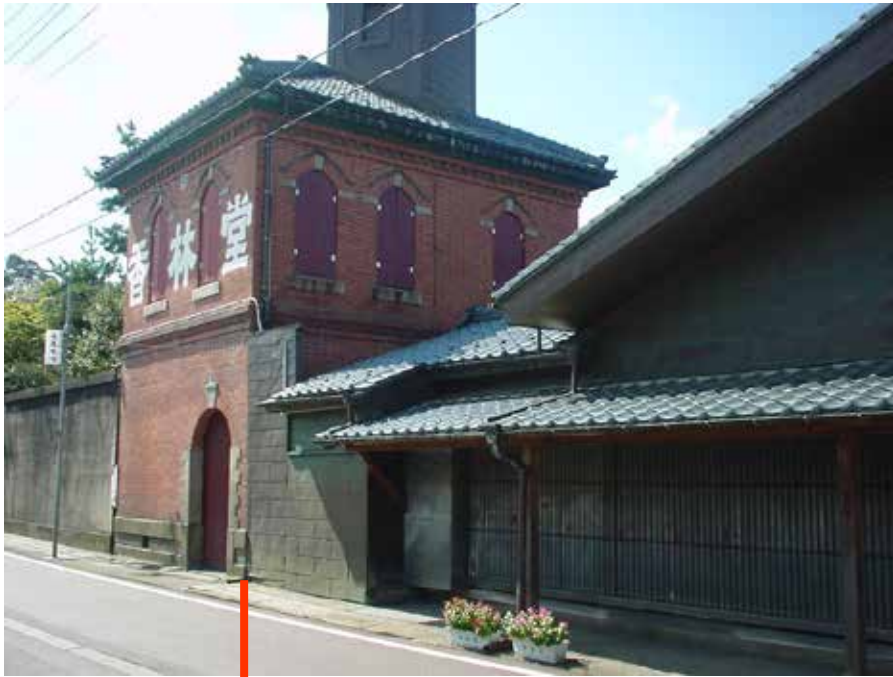
Masonry
structure

Traditional wooden
structure

An imported Western-style masonry structure and a traditional Japanese wooden structure inherited from olden times are united.

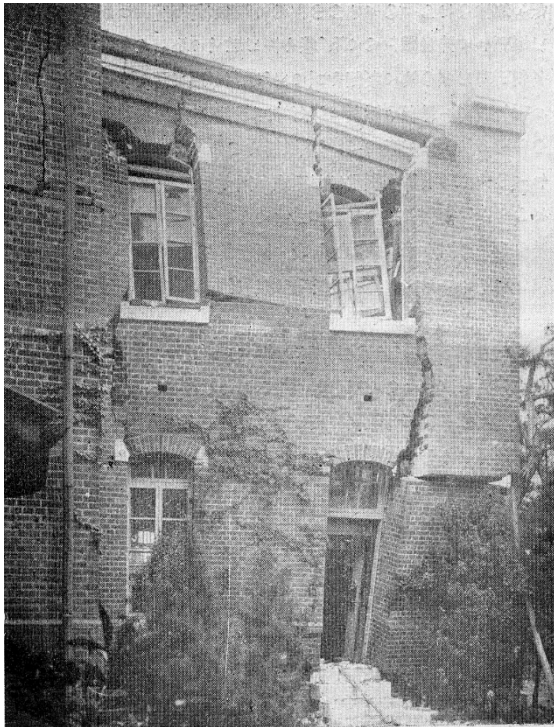
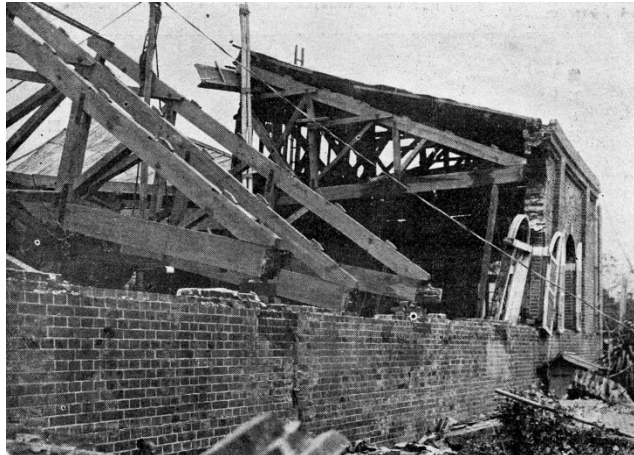
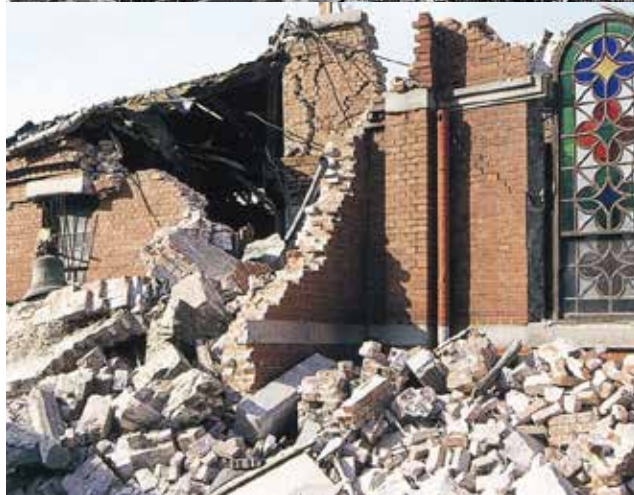
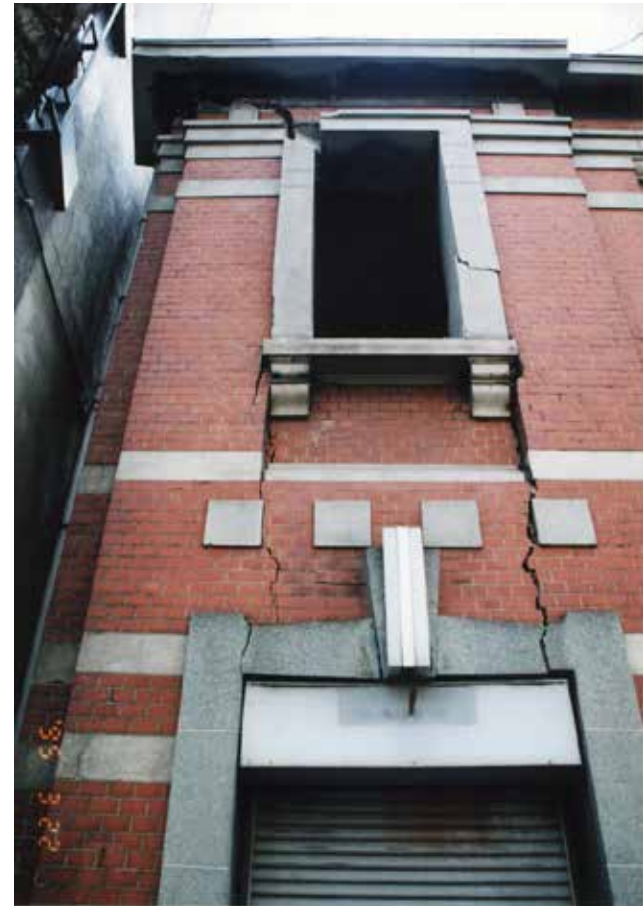
Earthquake damage caused to masonry structure buildings

Monochrome: Great Kanto Earthquake (occurred on Sept. 1, 1923)

Color: Great Hanshin-Awaji Earthquake (occurred on Jan. 17, 1995)

- (1) The destruction of walls was more remarkable in upper floors.
- (2) Damage was remarkable in projecting parts such as gable walls and chimneys.
- (3) Corner sections are likely to be destroyed.
- (4) Damage is likely to concentrate on openings such as windows as well as entrances and doorways.
- (5) Flexural cracking is dominant in masonry walls.

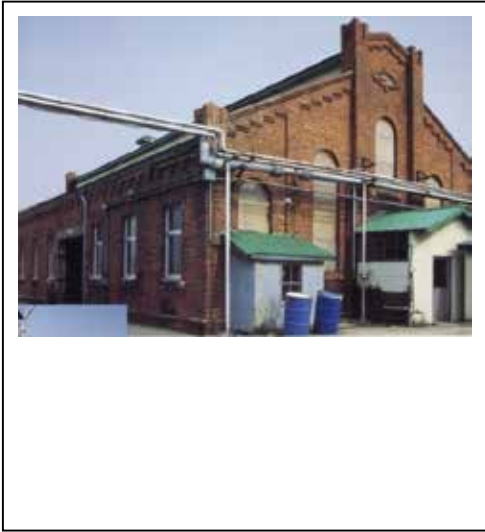
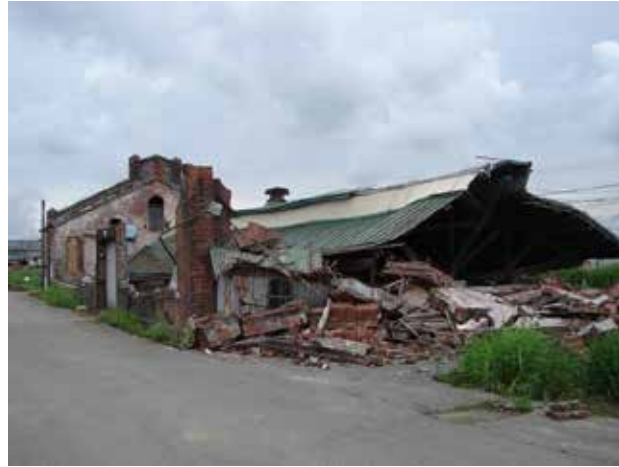
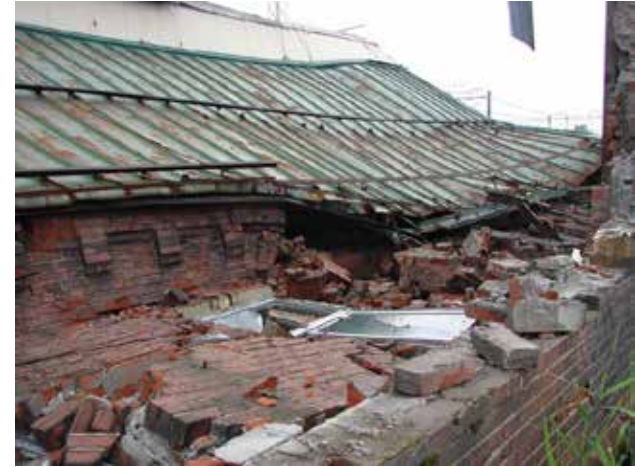
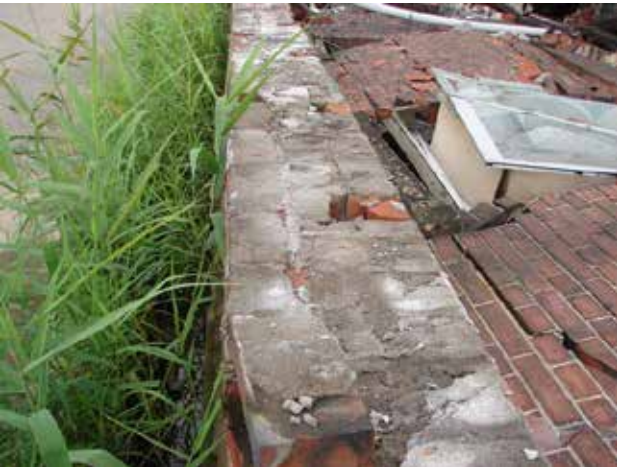
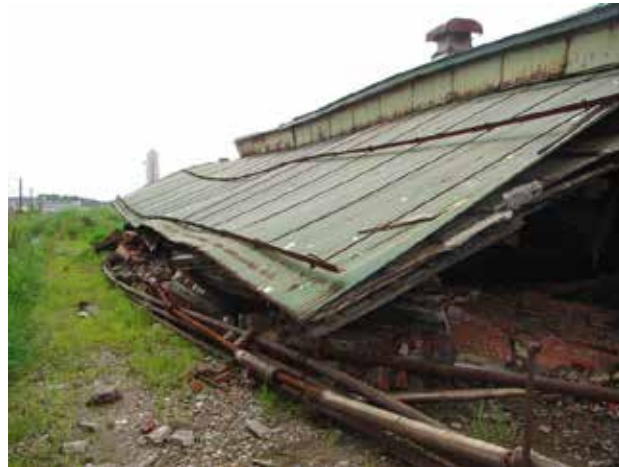
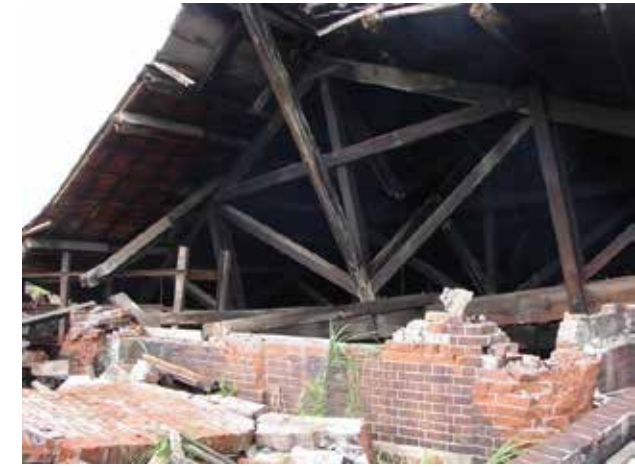
2007 Niigata Chuetsu-oki Earthquake (occurred on Jul. 16, 2007)

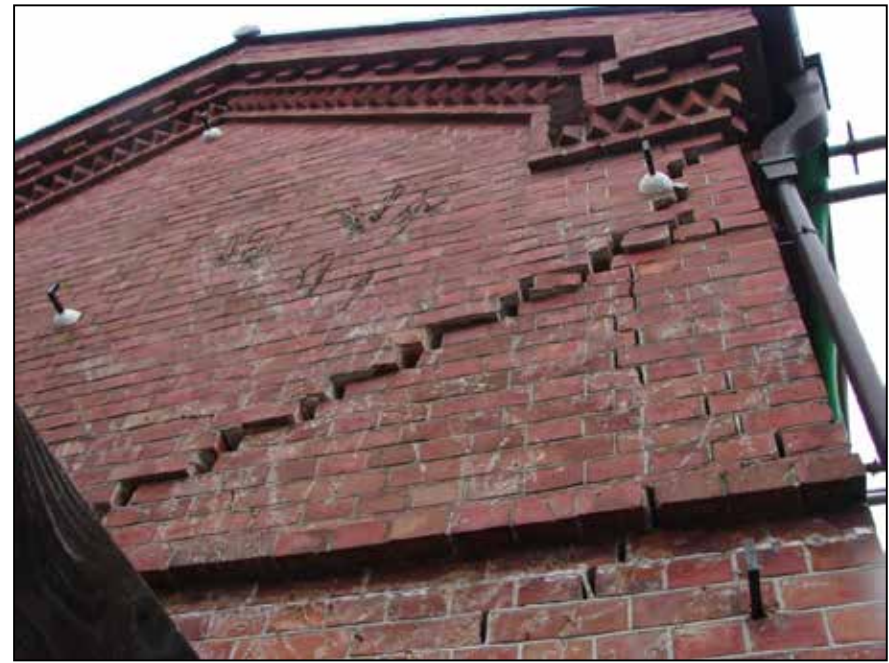
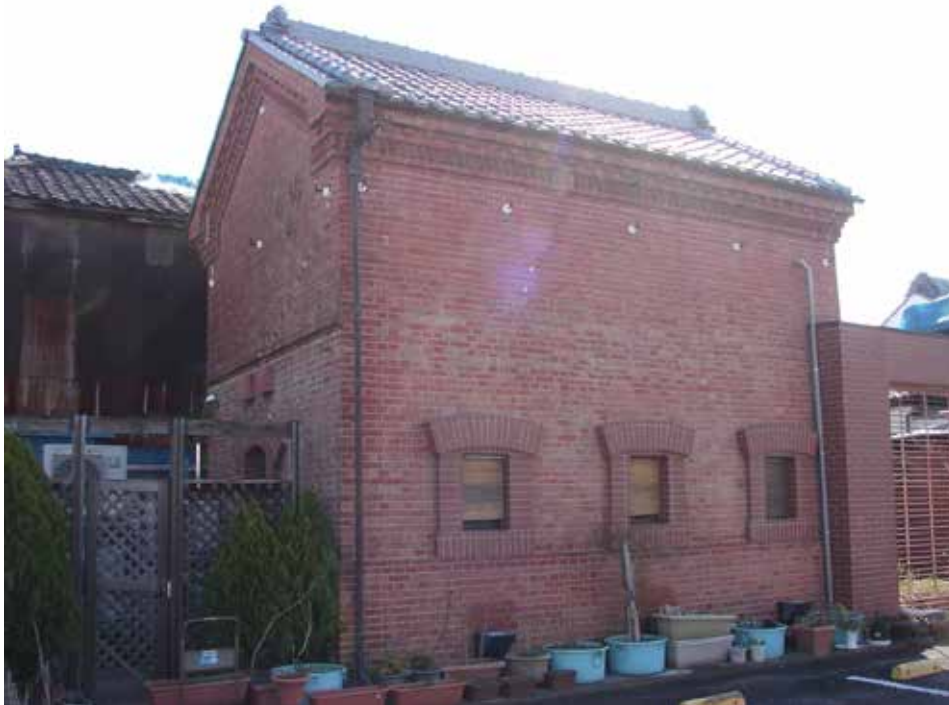
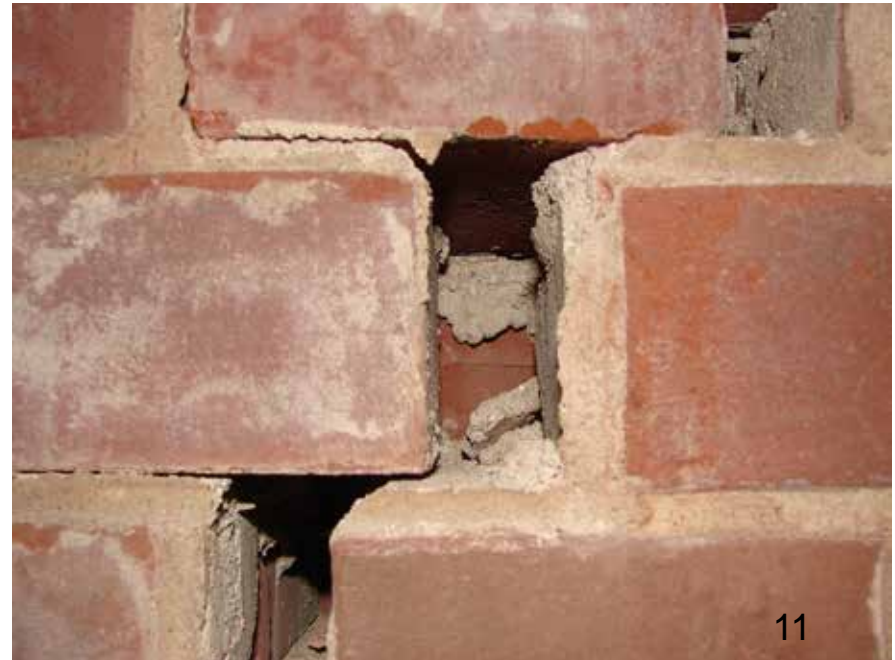
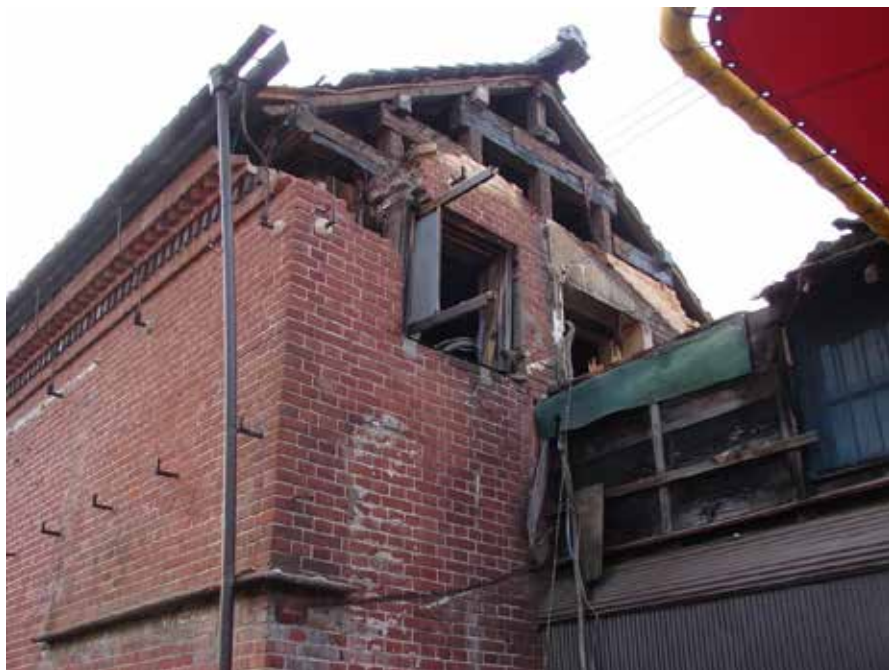
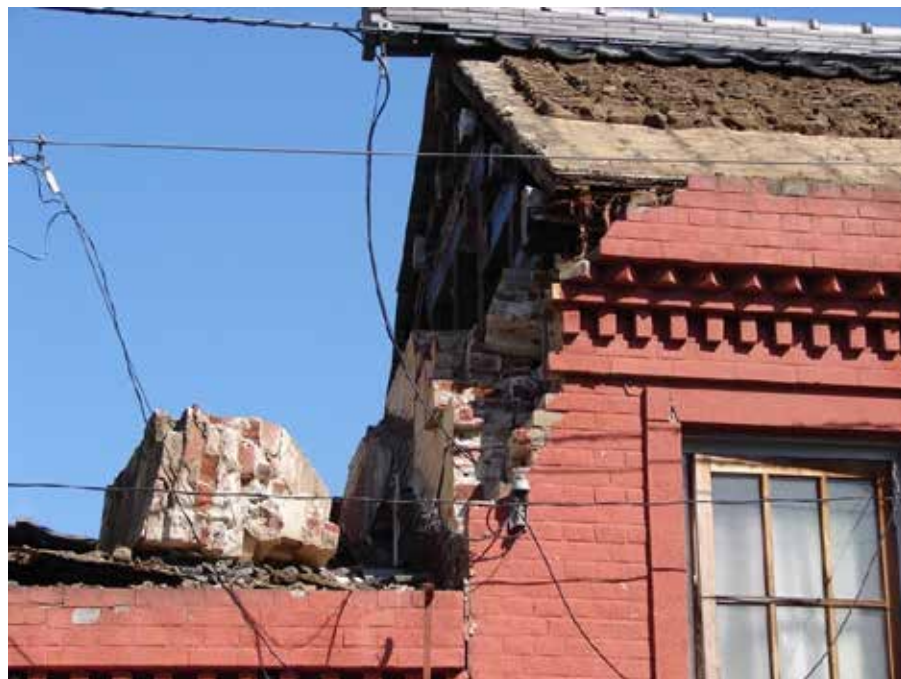
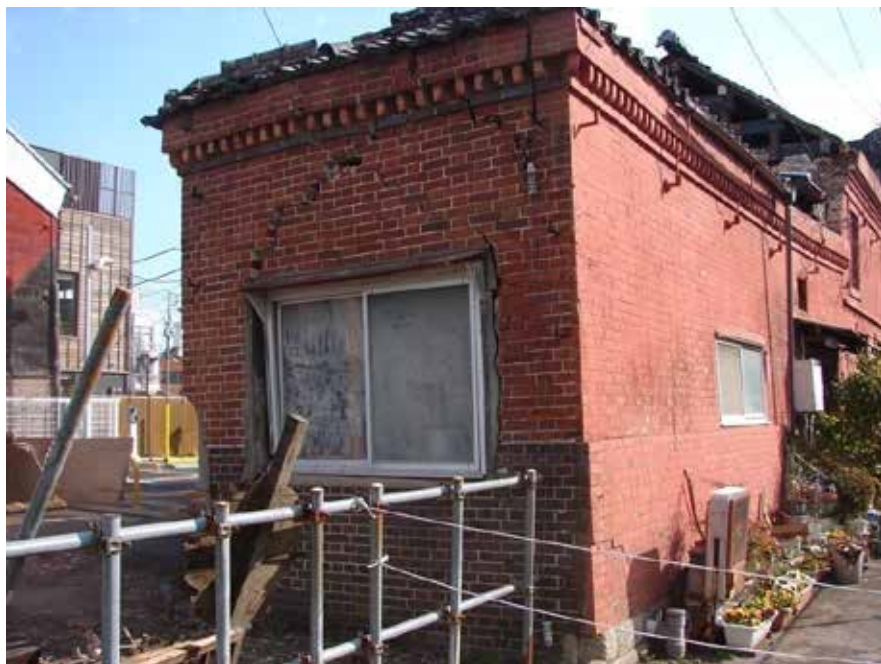
Great East Japan Earthquake (occurred on Mar. 11, 2011)

Former Nomura Shoten Salt Warehouse (1892)
Registered cultural property Tsuchiura
Machikado Kura Nomura / Coffee Shop Kura

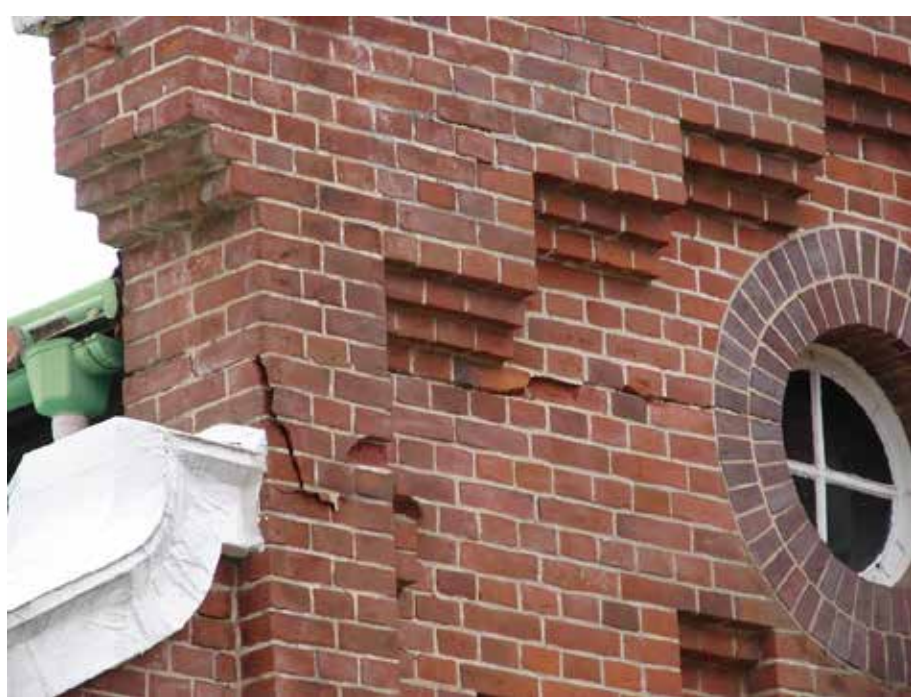
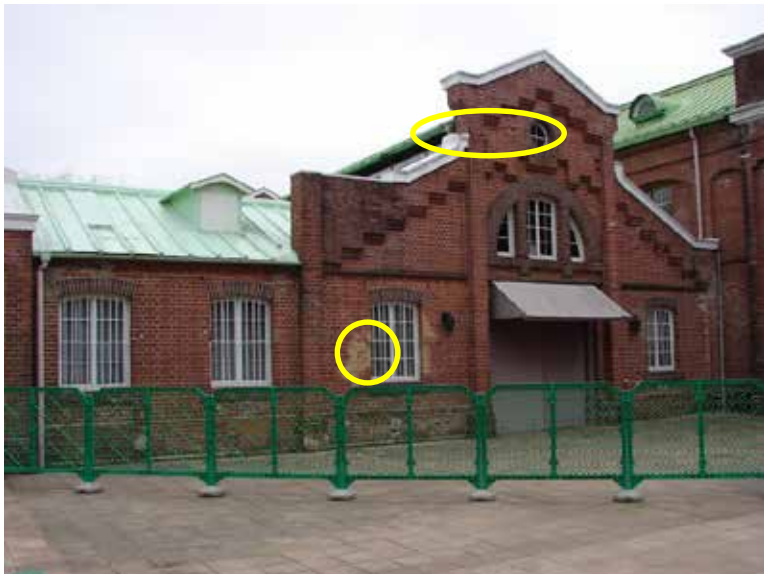
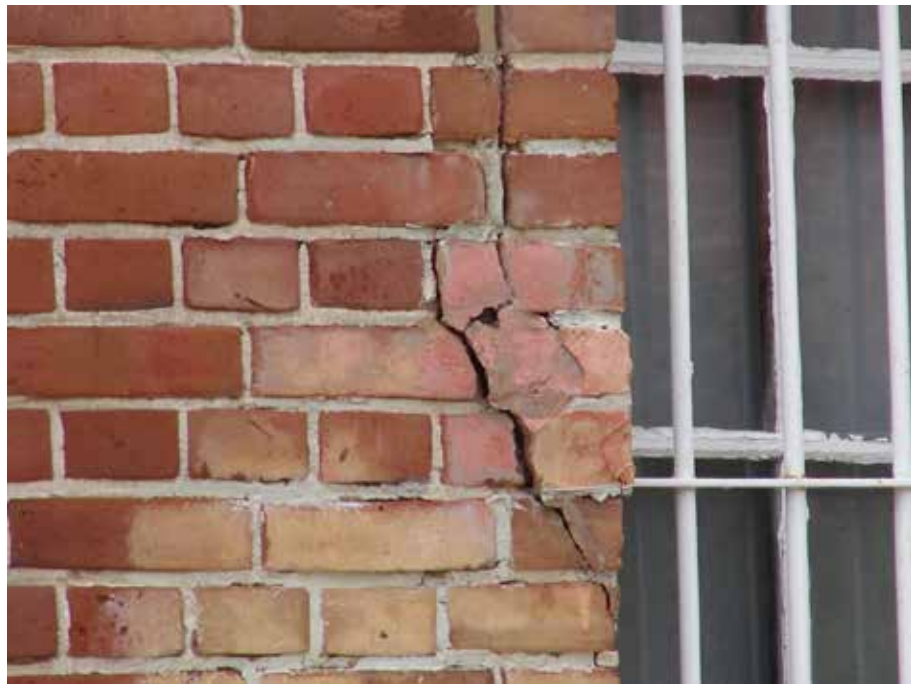
Château Kamiya former brewery
facility fermentation room (1903)

Repair of the Château Kamiya former brewery facility storehouse (a nationally designated important cultural property) after its damage caused by the Great East Japan Earthquake (Ushiku City, Ibaraki Prefecture)

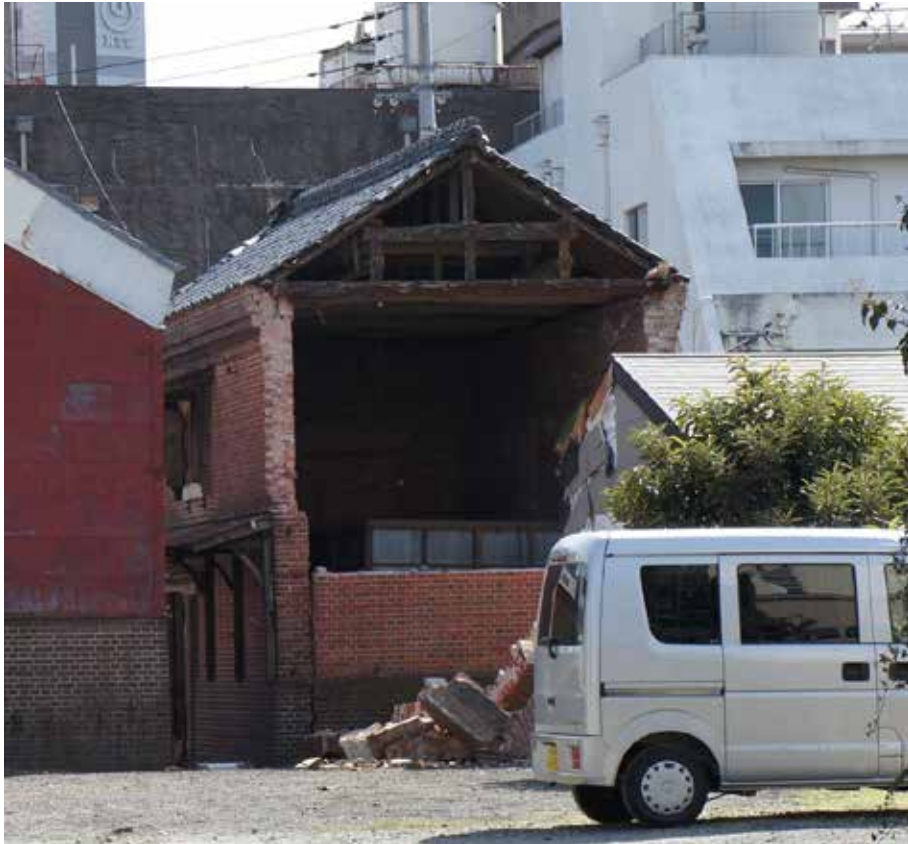
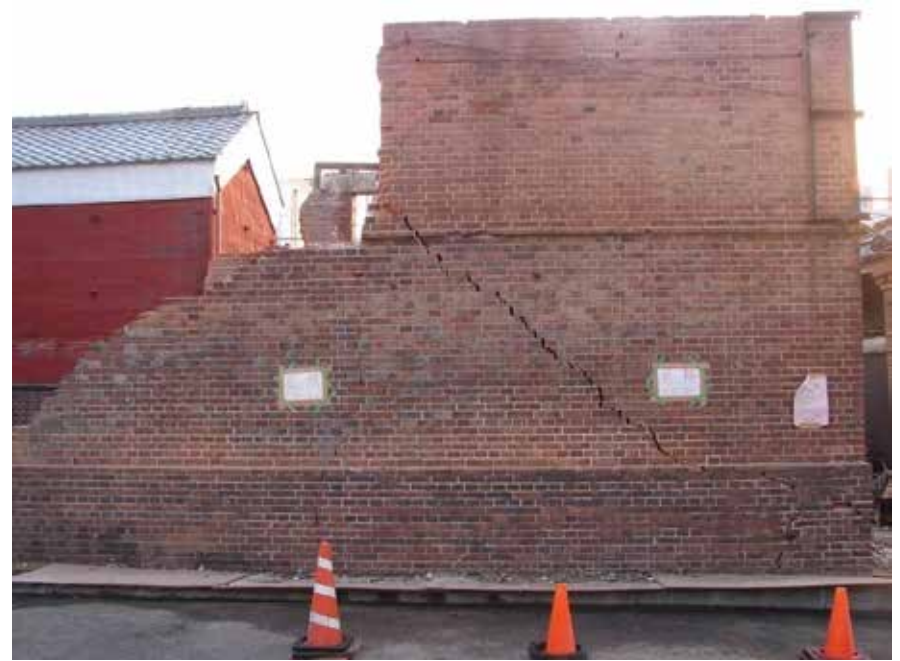
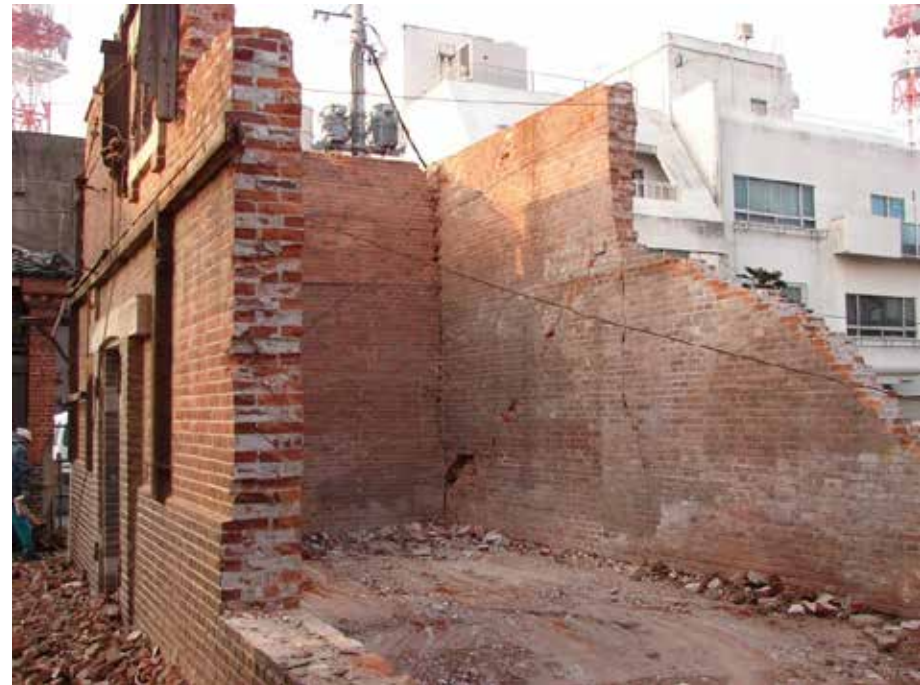
Masonry structure buildings in Tsuchiura City (circa 1892)

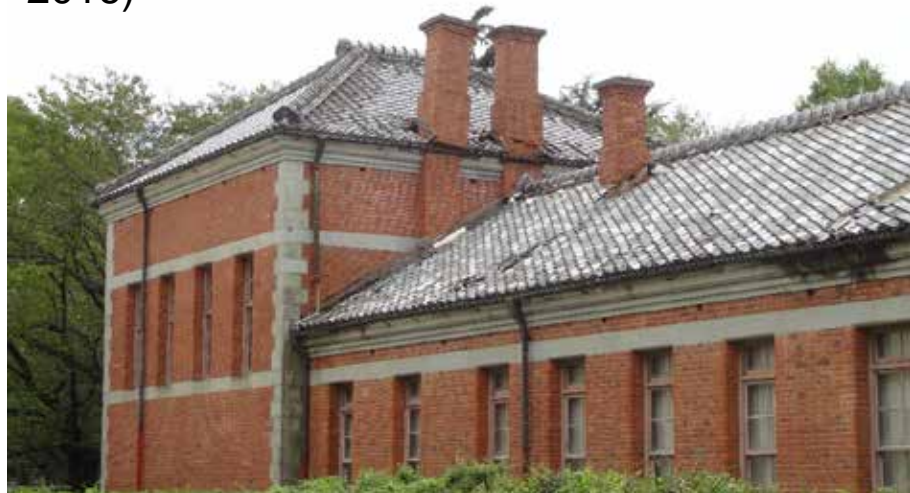
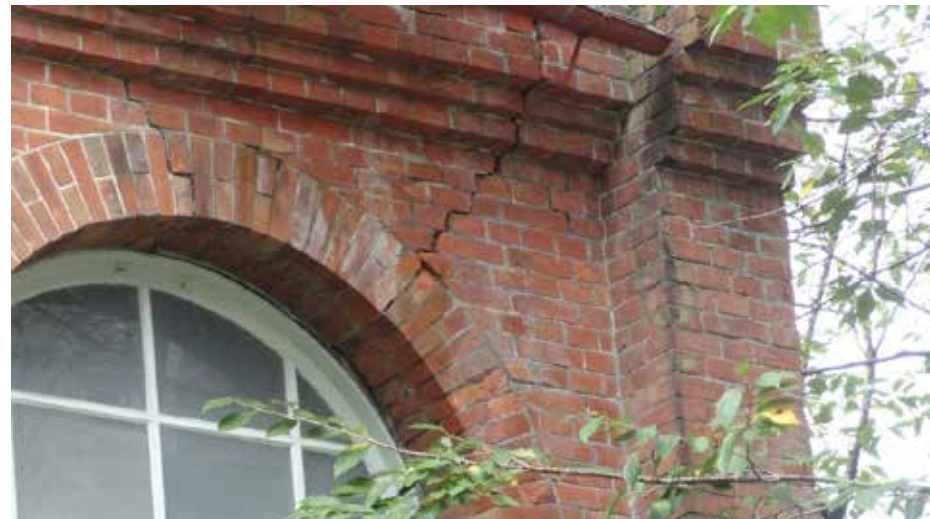
Kumamoto Earthquake (occurred on Apr. 14, 2016)

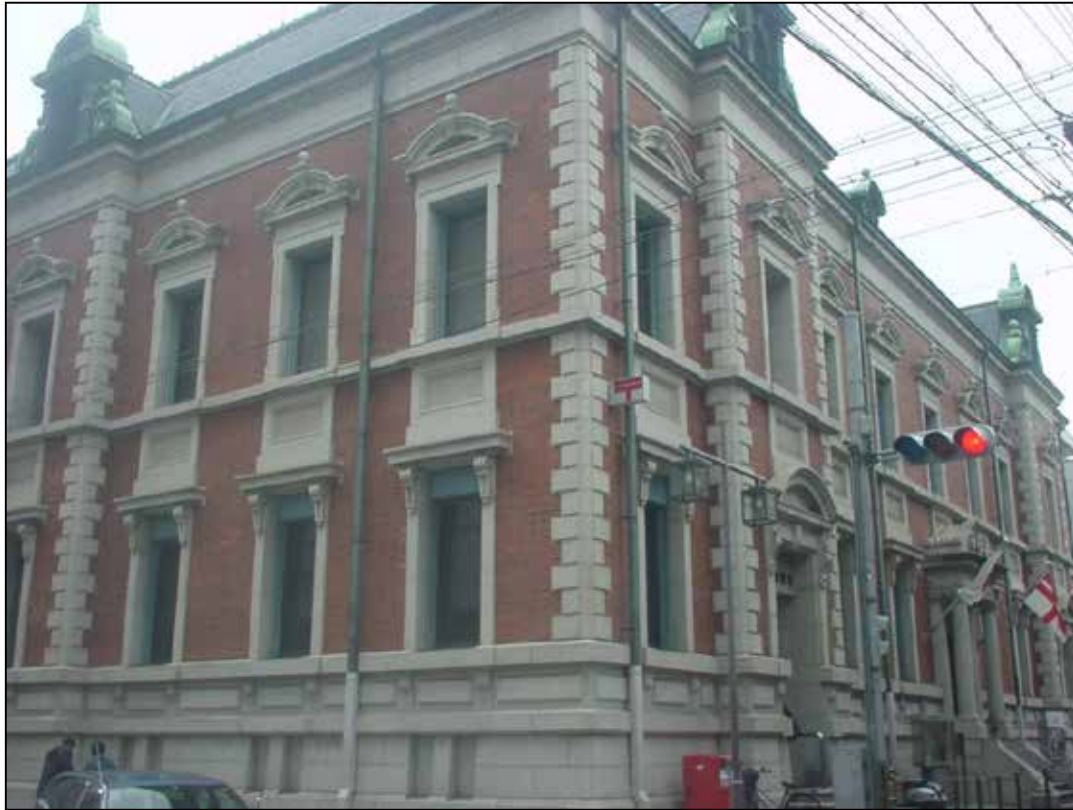
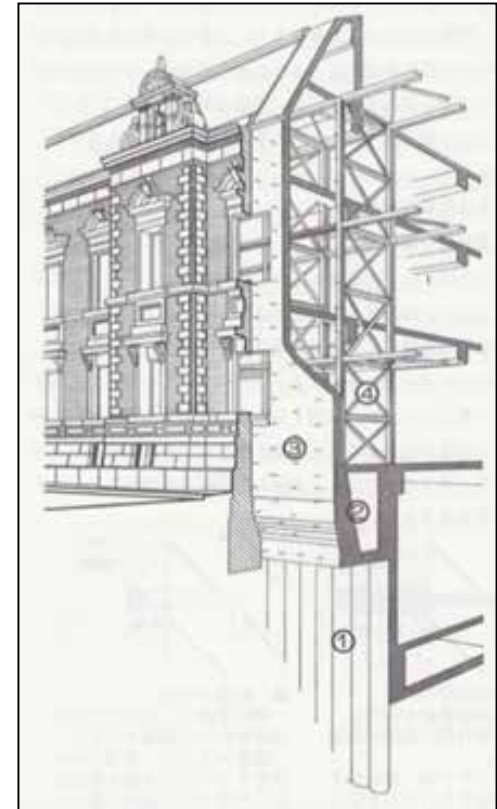
At the Nakagyo Post Office building, **reinforced concrete walls (200 - 300 mm) were newly built inside of the original masonry exterior walls**, and the walls were fastened tightly with anchor bolts. in the figure shows the newly built wall, and shows the temporarily built steel frame tower.

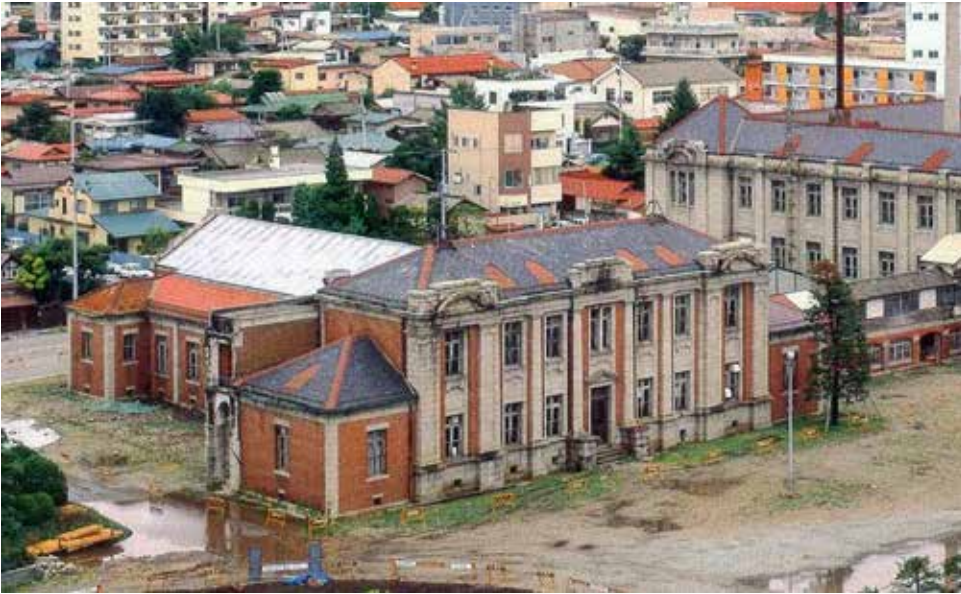
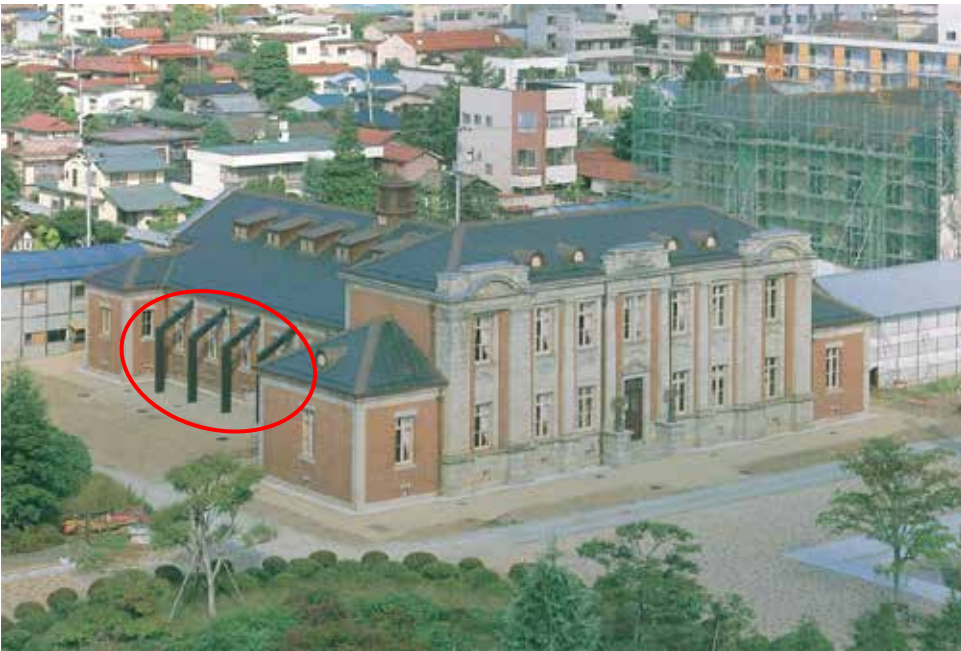
Nationally designated important cultural property Former prefectural assembly hall of the Yamagata Prefectural Government

- With a view to increasing rigidity and withstanding strength of horizontal diaphragms, steel-frame made horizontal trusses were tightly fastened to the masonry wall with anchor bolts.
- With a view to increasing the seismic performance of masonry walls, inverted L-shaped buttresses of steel frame construction were provided in the exterior wall column-shaped portion, and at the indoor side L-shaped steels were installed in the wall crest portion.

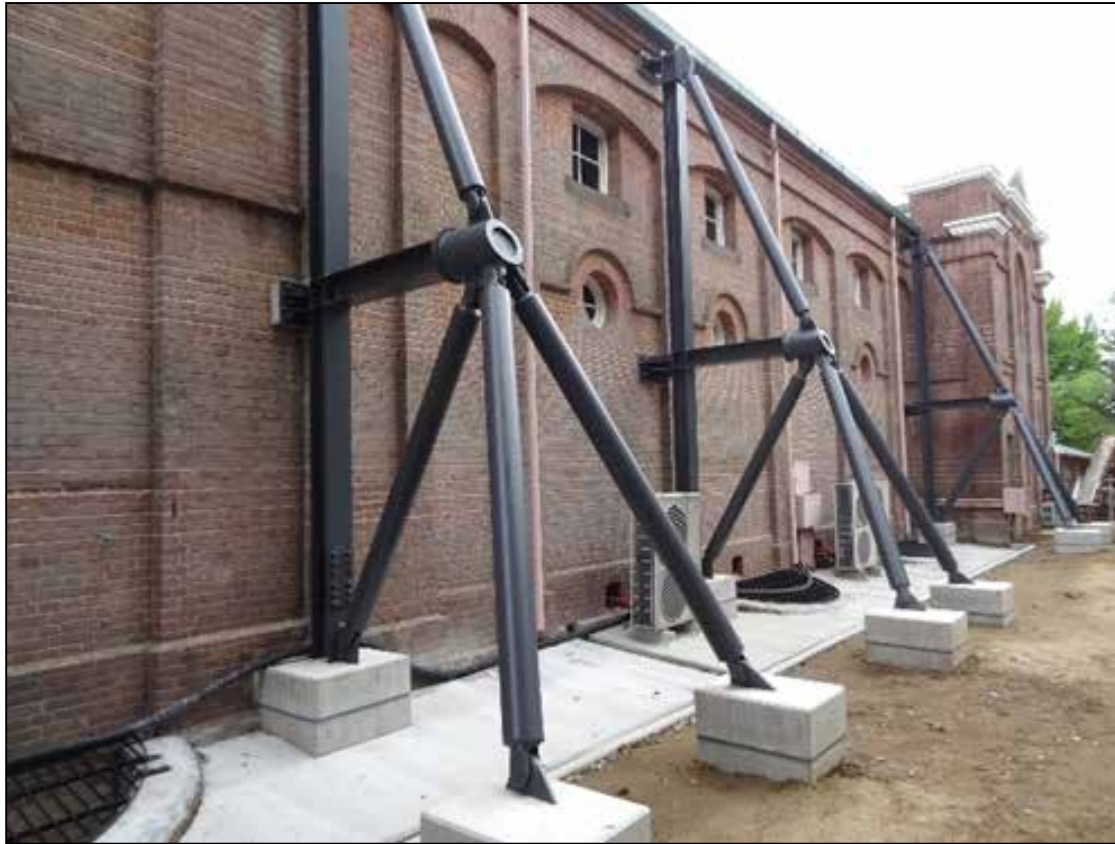
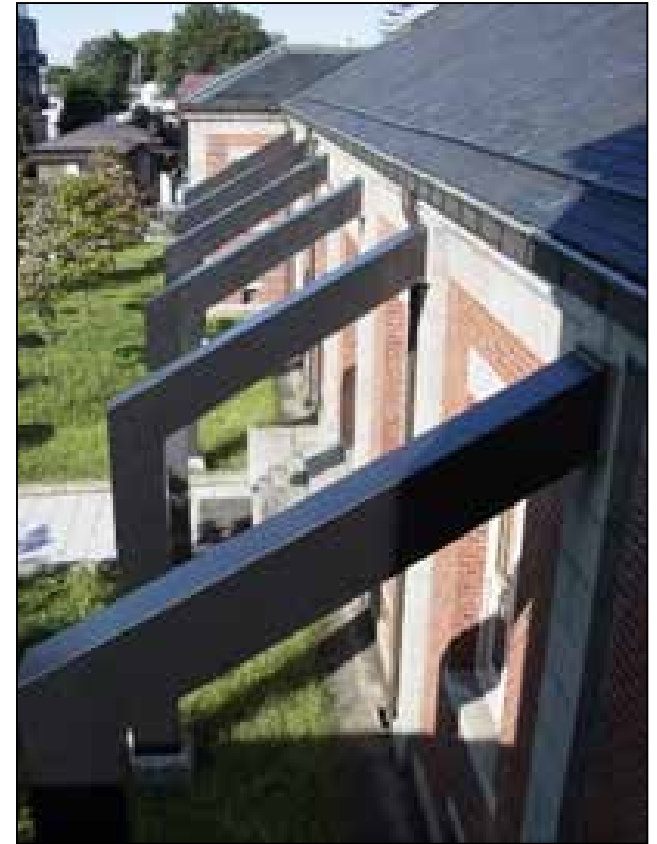
Reinforcement of the Château Kamiya former brewery facility fermentation room (a nationally designated important cultural property) **with steel frame buttresses**. Here, design properties of reinforcing materials were pursued such as the shapes of round steel pipes and jointed parts, their colors and texture.

In order to protect the values of internal space, reinforcement from the inside was avoided, and seismic reinforcement was performed by newly installing external buttresses. With regard to cultural property structures, ways of reinforcement that involves external exposure of foreign matter were deemed to be out of the question 27 theretofore.

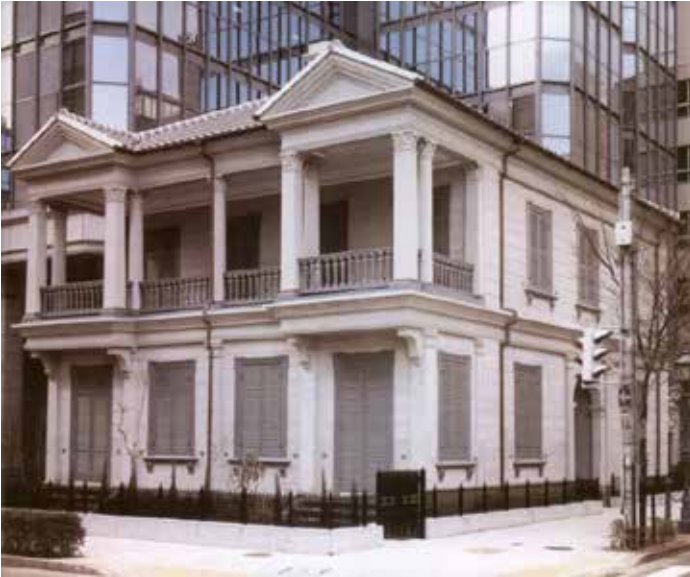
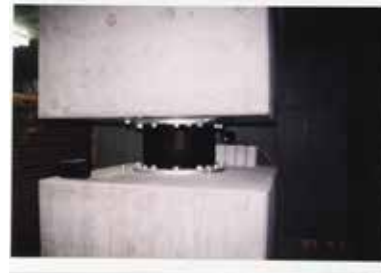
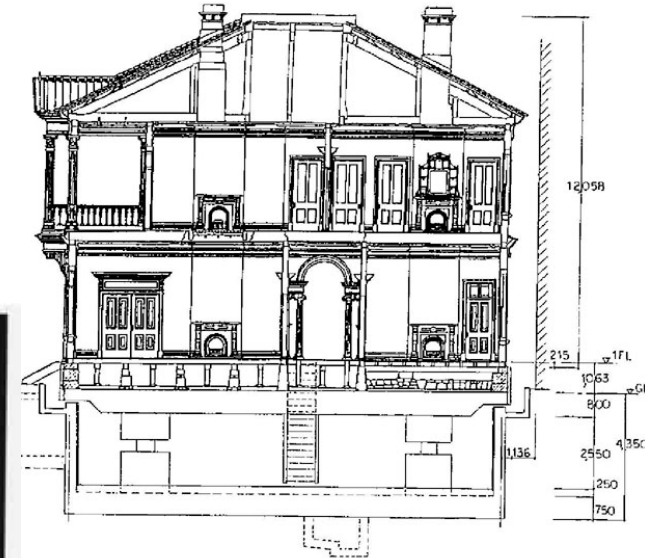
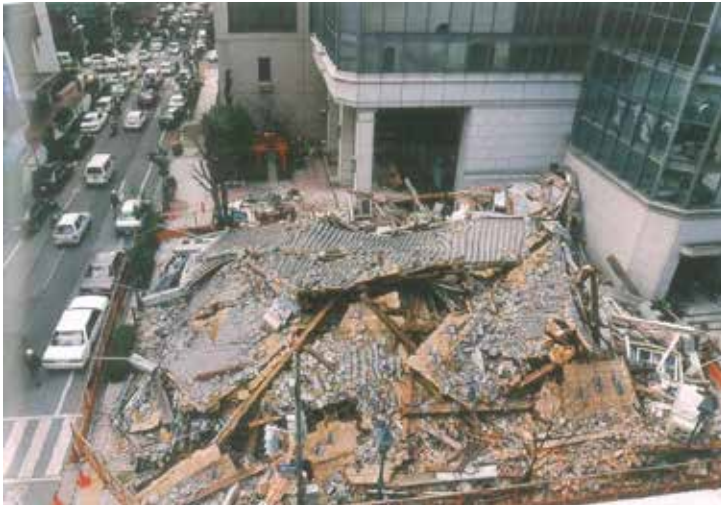
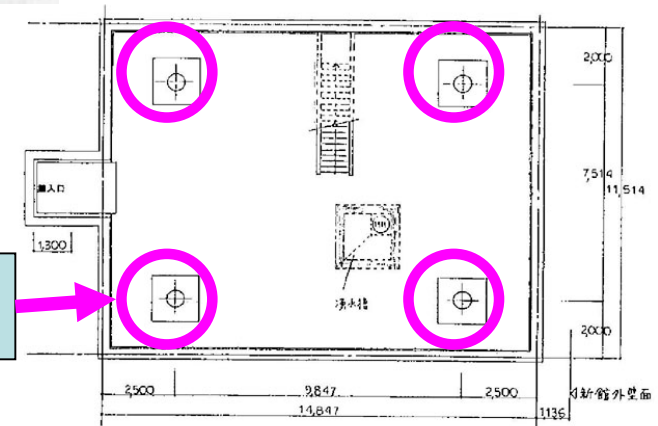
Nationally designated important cultural property Former Kobe Foreign Settlement House No. 15

- Damaged by the South Hyogo Prefecture Earthquake (Jan. 17, 1995). Rebuilt on a seismic isolation system

Seismic isolation system
of laminated rubber
mounts integrated with
lead
