JICA Group and Region-Focused Training "Building Disaster Prevention (Concerning Earthquakes, Tsunami, Fire, Typhoon, Etc.) Course"

Masonry Construction in Japan

Naoji Hasegawa

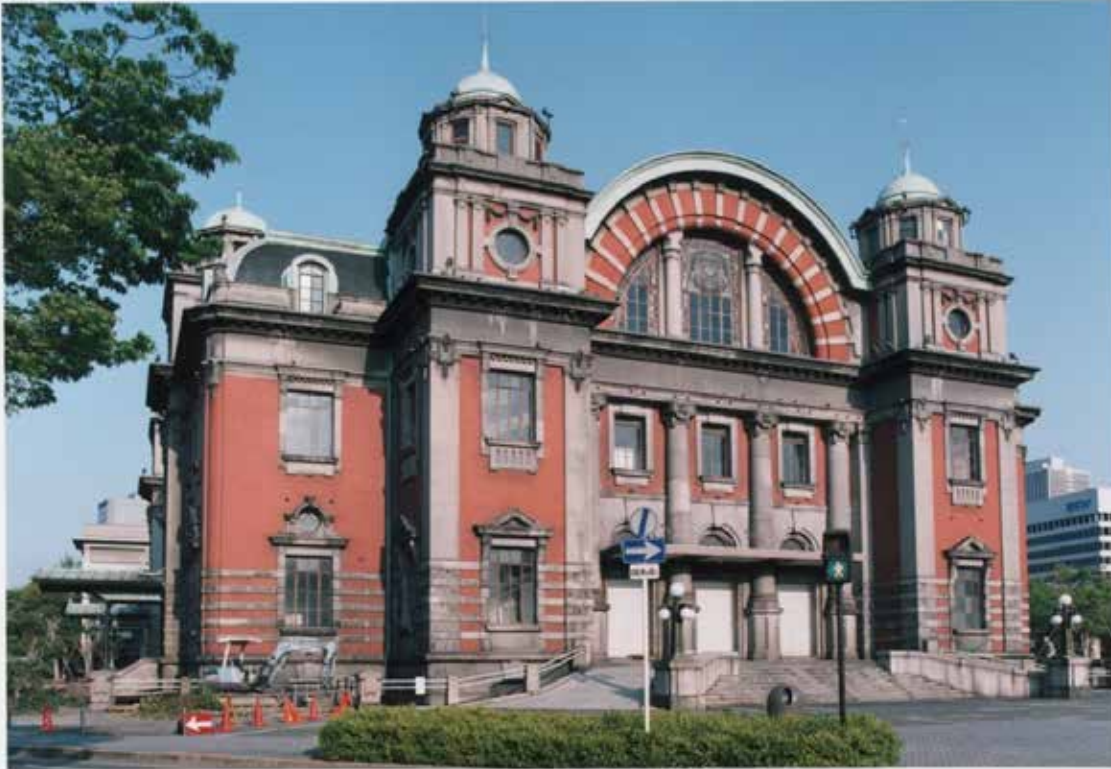
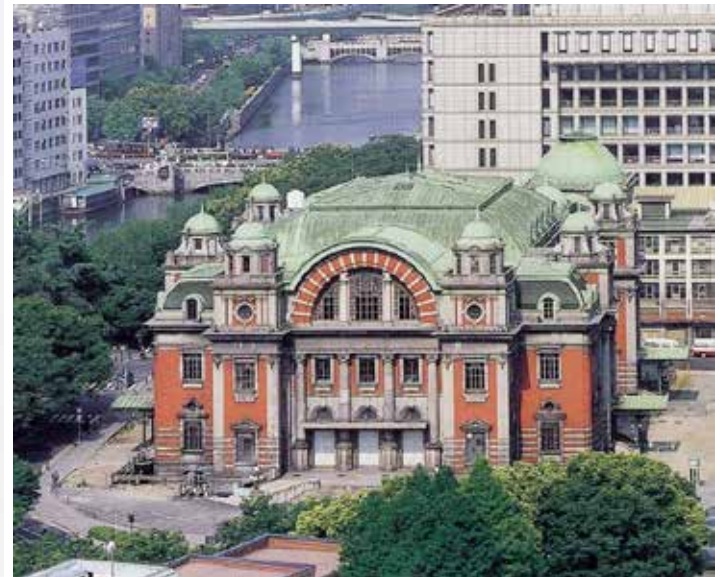
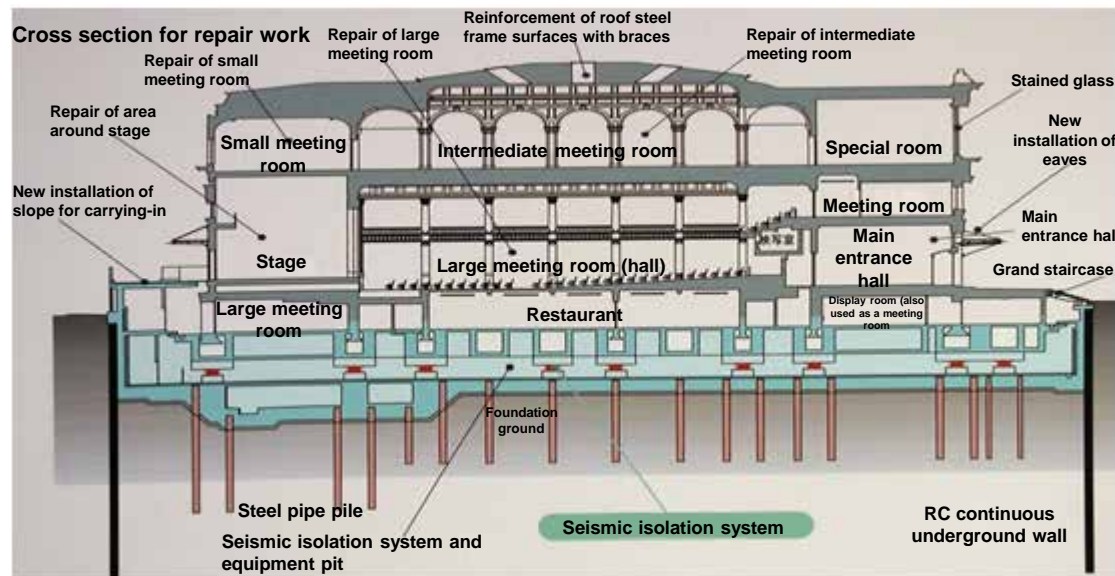
Nationally designated important cultural property Osaka City Central Public Hall Construction completed in 1918 / Repaired in 2001

- 3 floors above ground / 1 underground floor / 1 tower floor
- Total floor area: 8,425m²
- Masonry construction with steel frames
- Eaves height: 19.48m

- With a view to improving the withstand strength of the foundation, a new RC structure was built under the foundation. The structure was integrated with the foundation by means of newly installed RC reinforcing beams.
- With a view to reducing seismic force to be input into the building, a foundation seismic isolation method was adopted.

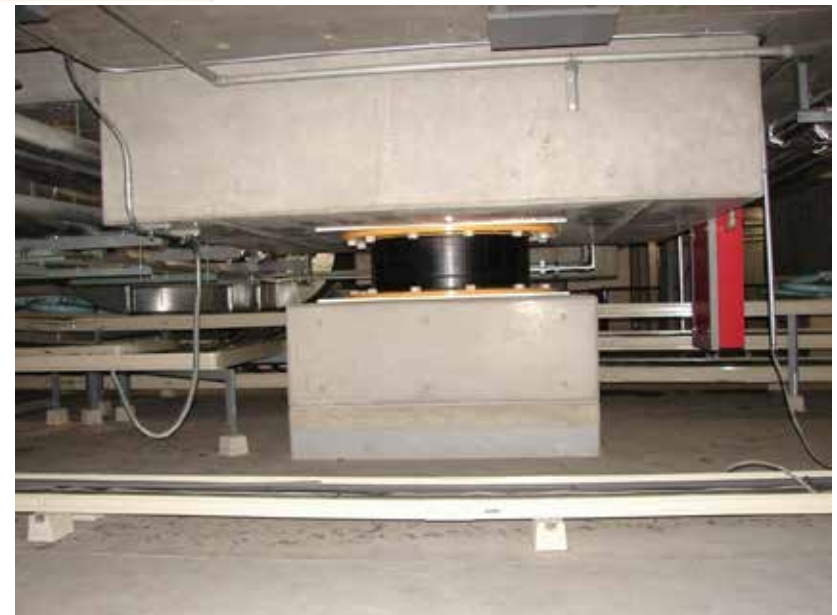
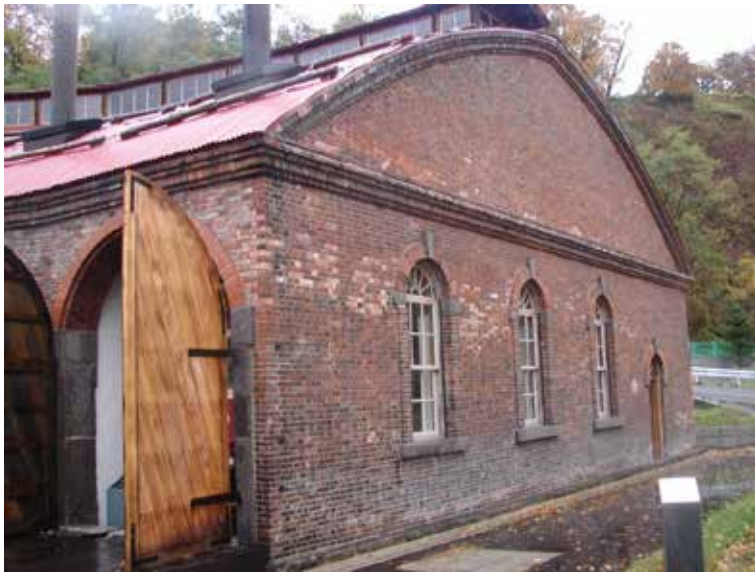
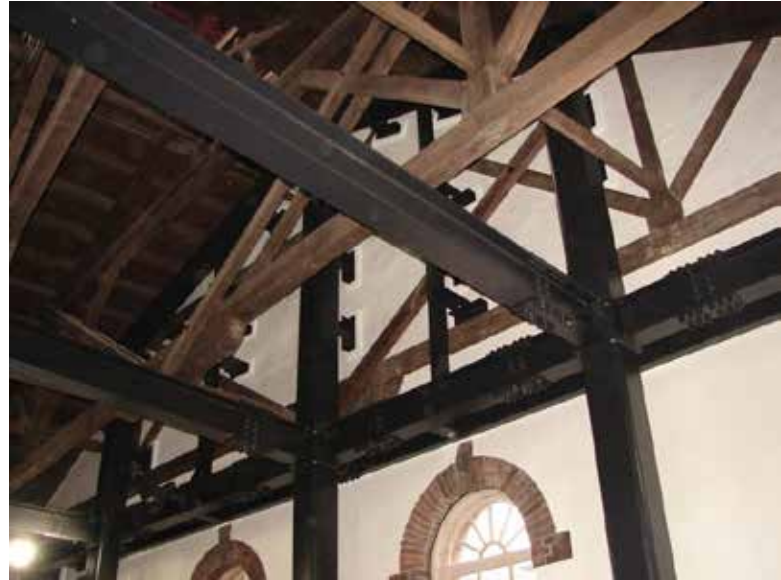
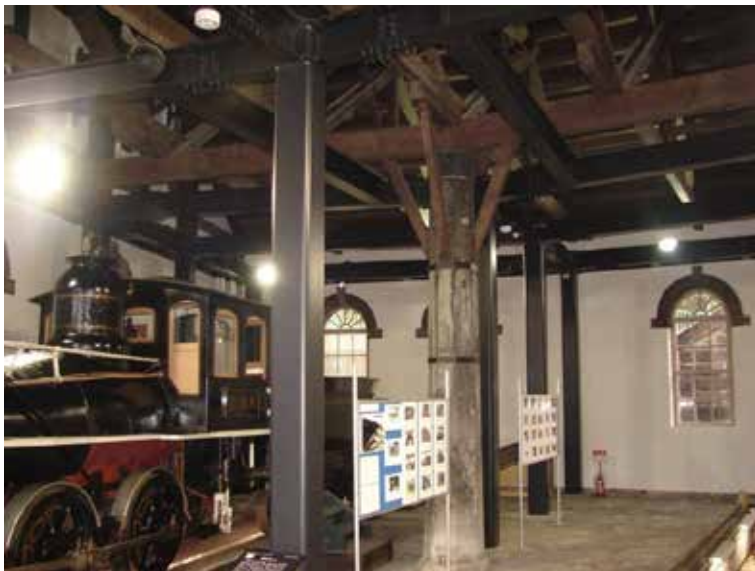
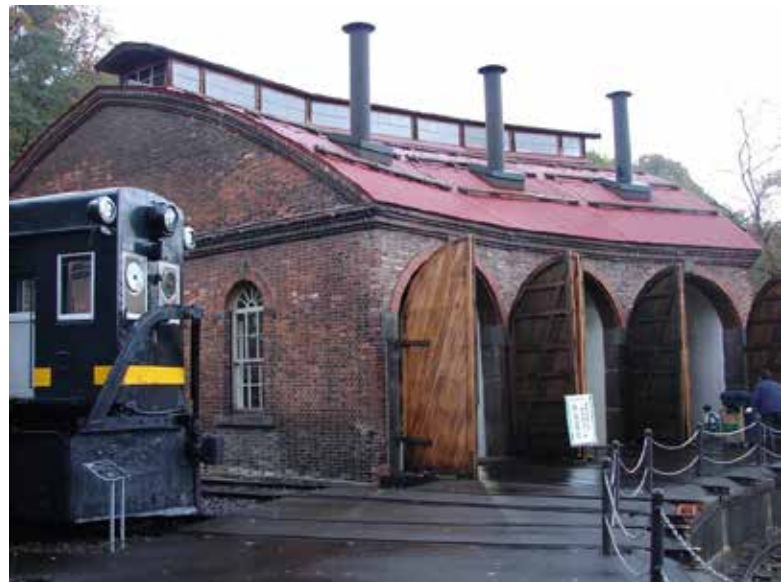
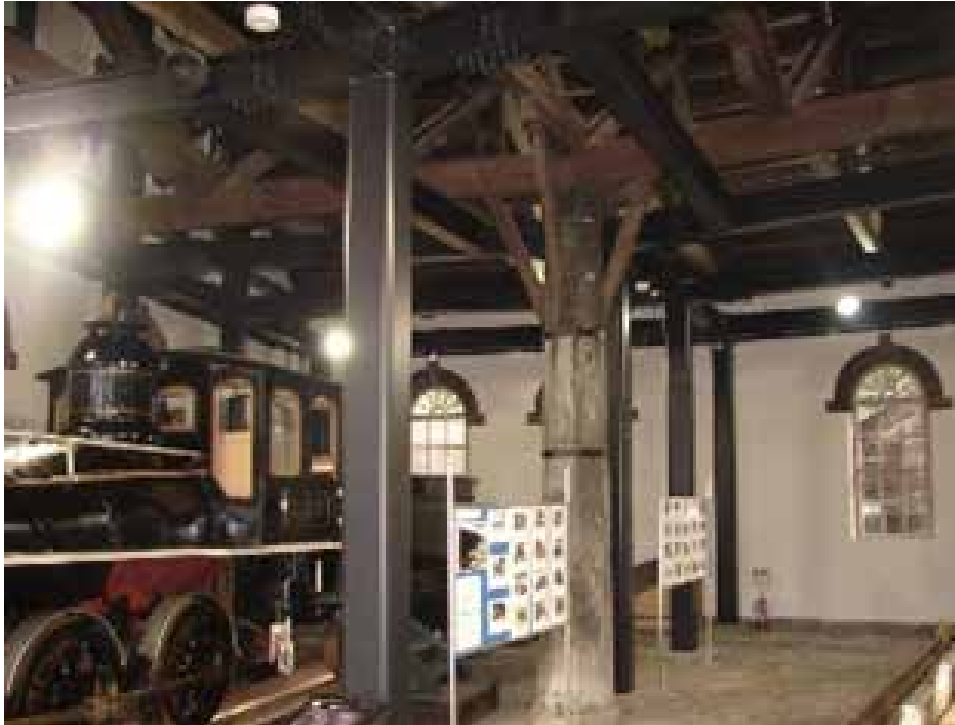
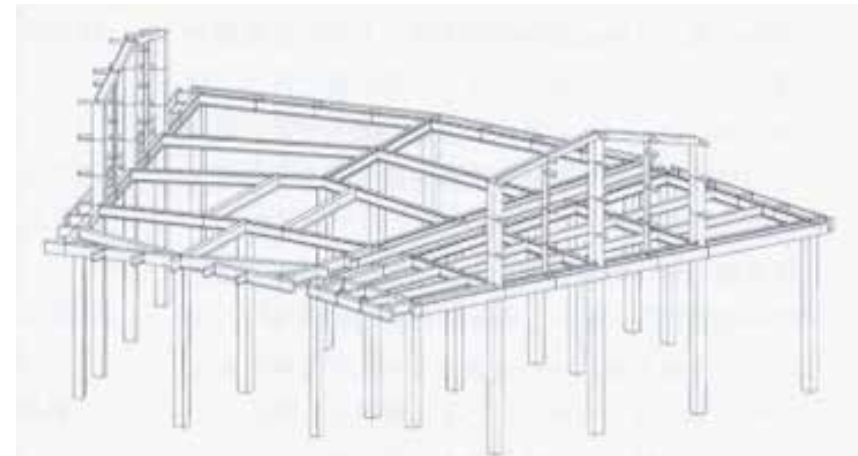
Nationally designated important cultural property
Former Temiya railroad facility locomotive warehouse No. 3

In the former Temiya railroad facility locomotive warehouse No. 3 (a nationally designated important cultural property), **reinforcement** was performed **by means of steel frames**. Although rectangular steel pipes having a relatively large cross section were used, because black was used as their color and possibly due to their similarity to the displayed locomotive, the steel pipes are not so conspicuous. The deep layer mixing method, which is one of the ground improvement work methods, was used for the foundation for the newly installed steel frames.

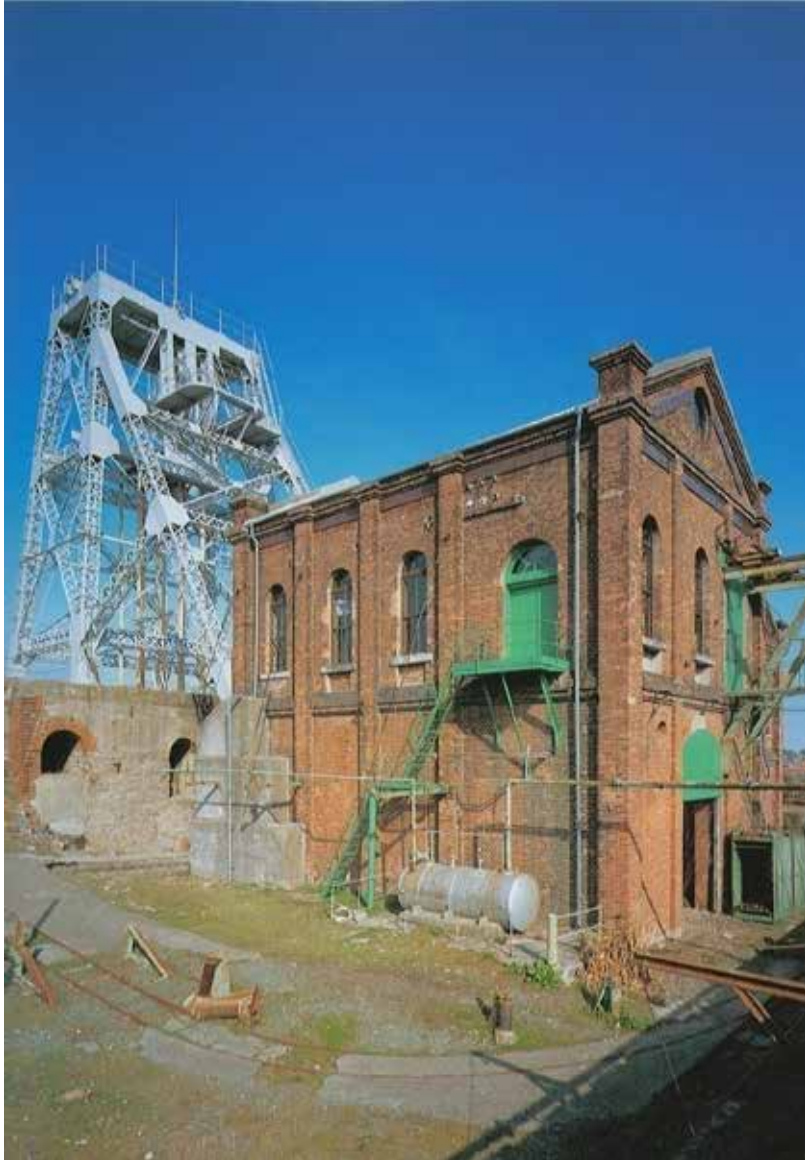
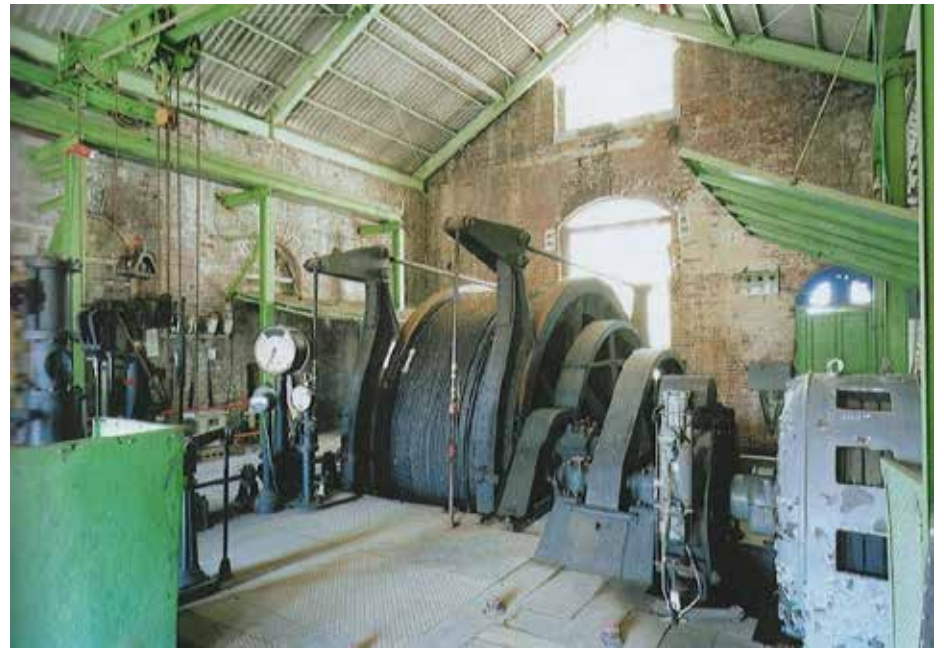
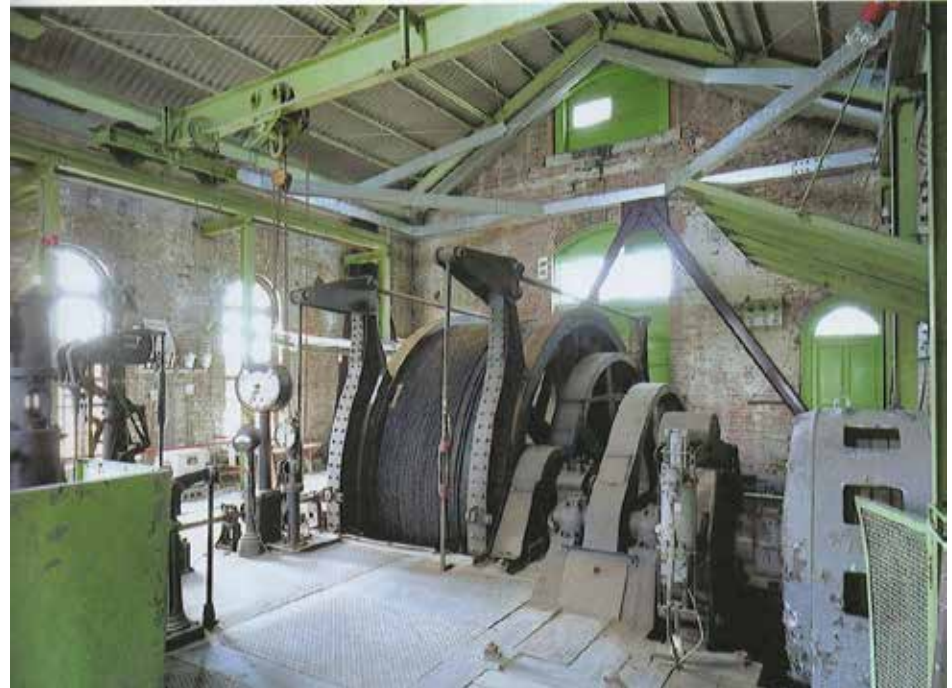
Mitsui Miike Coal Mine Former Manda Mine facility

Nationally designated important cultural property /
world cultural heritage

Construction completed in 1909
