Promotion of Road Greening (Roadside Trees and Slope Greening)

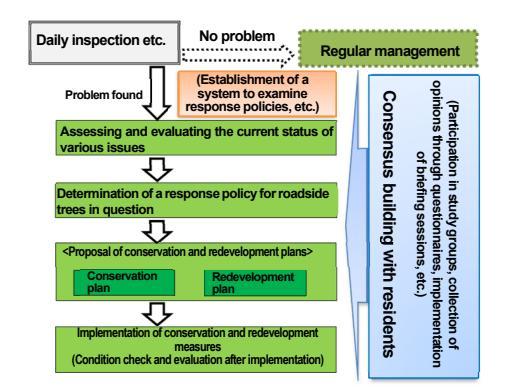
Figure 2 Roadside Tree Restoration Procedures

In order to address these issues, the NILIM conducted a survey on the current status of roadside trees, greening techniques for conservation and rehabilitation, and methods of cooperation with residents, targeting cases where conservation or rehabilitation was implemented to address problems that had arisen with roadside trees. As a result, the NILIM compiled a guide for roadside tree administrators on how to survey the current conditions of roadside trees, examine policies for dealing with the conditions, conservation, and redevelopment techniques, and build consensus among residents. Along with this, the NILIM is introducing specific examples of initiatives (see Figure 2).

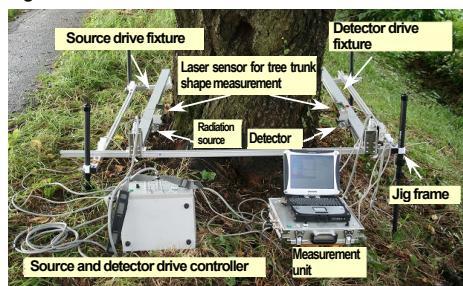
Photo 1 γ-ray tree decay diagnostic machine

To address these issues, the NILIM has developed a decay diagnostic machine that uses γ rays to measure the decay status of trees without damaging the trunks (see Photo 1).

When roadside trees are affected by wood rotting disease, the wood cells decompose, and the trunk becomes spongy and hollow, increasing the risk of breakage from strong winds and other forces. It is thus important to understand the internal condition of the trunk during tree diagnosis.

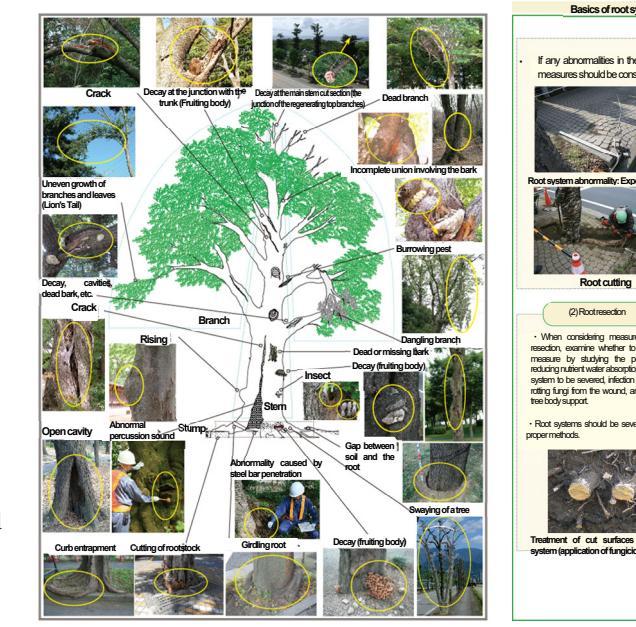
Figure 3 Focus of inspection and diagnosis of roadside trees

control the occurrence of toppling and fallen branches in the design, planting, and maintenance phases of roadside greening. The NILIM also organized inspection and diagnostic methods, which are positioned to prevent toppling and fallen branches. In addition, the second edition includes new explanations on how to identify abnormalities of roadside trees during road management patrols and inspections, the use of information provided by road users, and considerations for road greening to prevent toppling based on the clarified causes (Figures 3 and 4).

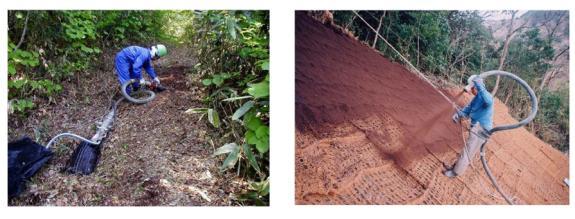
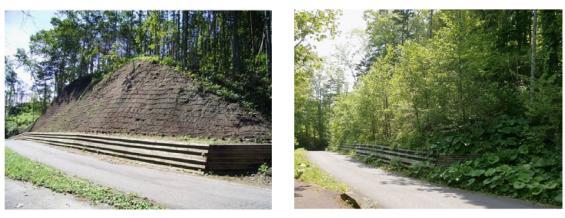
Figure 5 Example of slope greening using topsoil application

Based on the results obtained from construction experiments and vegetation monitoring surveys at case study sites, the NILIM has compiled a list of methods for setting greening targets and implementation methods for introducing slope greening that is friendly to the local ecosystem (see Figure 5). The list also introduces the status of vegetation establishment at case study sites throughout Japan and provides explanations of plant species commonly found on post-construction slopes by using many photographs.

(1) Collection of topsoil, (2) Mixing the topsoil with vegetation base material and spraying

(3) Immediately after the topsoil application, (4) Six years after the topsoil application
