# Large-scale sediment disasters caused by Typhoon No.12 in the Kii Mountains

OKAMOTO Atsushi, Head  
UCHIDA Taro, Senior Researcher

Research Center for Disaster Risk Management, Erosion and Sediment Control Division

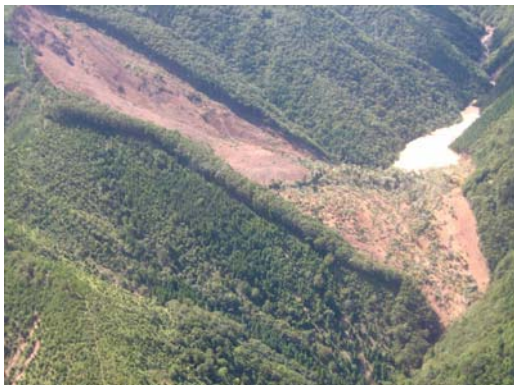
Photo 1. River Course Blockage at Nagadono Valley in Totsukawa Mura in Nara Prefecture

This typhoon caused many deep-seated landslides, forming river course blockages (landslide dams) at 17 locations (Photo 1). At five of these locations where the height of landslide dam was 20 m or higher, and where there are about 10 or more buildings with habitable rooms downstream from the landslide dam, emergency surveys were performed by the Ministry of Land, Infrastructure, Transport and Tourism under the Law for Partial Revision of the Act on Sediment Disaster Countermeasures for Sediment Disaster Prone Areas, which was enacted on May 1, 2011<sup>1)</sup>.
