# Revision of Airport Pavement Maintenance and Rehabilitation Manual

MIZUKAMI Junichi, Head  
 Airport Department, Airport Design Standard Division  
 TSUBOKAWA Yukitomo (Dr.(Eng.)), Senior Researcher  
 Airport Department

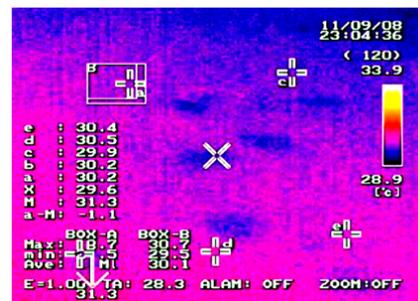
Figure 1. Infrared image (center blue circles indicate low temperature part due to de-bonding)

De-bonding between asphalt concrete layers has been inspected by an impact acoustic method using a hammer. However, it takes many days to complete the inspection by this method at a large airport. To develop a new efficient method to detect de-bonding, NILIM conducted a study to verify the applicability of the infrared thermographic inspection method. This method is based on the surface temperature difference between bonded and de-bonded areas caused by de-bonding as shown in Figure 1. The result clarified that this method could detect de-bonding quickly in both the daytime and nighttime in the summer. In the revision of the manual, this method was added as new inspection method.

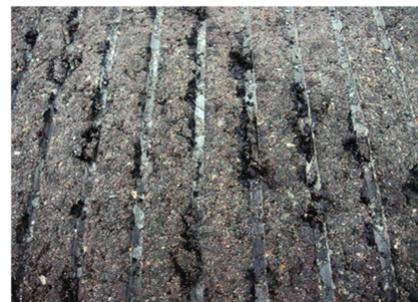
Figure 2. Failure of grooves

Grooves, whose width is 6mm and depth is 6mm, are constructed on the surface of a runway to drain water quickly and to maintain skid resistance. To prevent failure of the grooves soon after the construction as shown in Figure 2, grooves shall be constructed 2 months after construction of the surface course. This means that the surface condition of runway is “non-grooves” for 2 months after rehabilitation works. However, a laboratory loading test has revealed that grooves constructed on modified asphalt concrete have higher stability than those on straight asphalt concrete. Thus, trial construction of grooves was done on a runway to confirm the stability of grooves. The result of the trial construction verified

that grooves on modified asphalt concrete constructed 1 month after construction of the surface course have high stability. In the revision of the manual, the curing term for grooves was shortened to 1 month in cases where modified asphalt concrete was used for the surface course.
