Development of River Embankment Structure Highly Resistant to Overtopping under Public Private Partnership

River Department, River Division

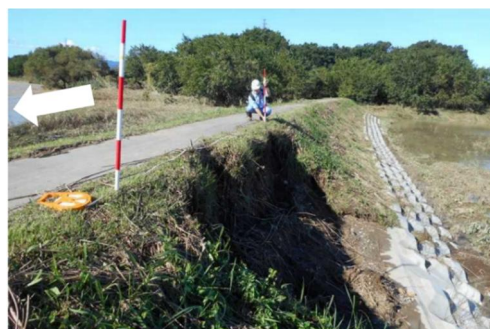
Photo-1 Erosion of inner slope at the area where the risk management type hardware measures have been taken

So far, we have implemented “risk management type hardware measures” paving the top-end or placing blocks at the bottom of the city-side slope, to reinforce embankments against overtopping in vulnerable areas along rivers all over Japan. The purpose is to delay scouring of slope bottoms and collapsing of top-ends that could potentially accelerate the process from the start of overtopping to embankment collapse. This measure has strengthened existing embankments at a relatively low cost. I will show the situation after overtopping at the place where the risk management type hardware measures have been taken in Photo-1.

We can confirm that no scouring of the slope bottom occurred, and top-end pavement worked as an overhang reducing erosion of the embankment. On the other hand, the city-side slope, which is only covered

with vegetation, may be eroded once overflow water depth becomes greater and the speed of the flow increases. It may eventually collapse if overtopping continues for a long time.

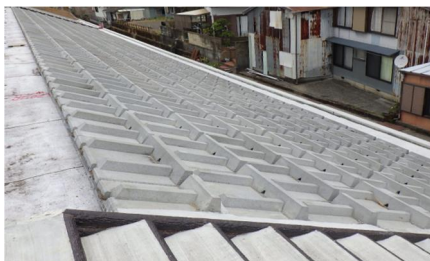
Photo-2 Example of highly resistant river embankment

Taking this into account, we have devised a highly resistant river embankment (Photo-2) (hereinafter referred to as “block structure”) The structure consists of covering the city-side slope of the embankment with soil draw-out retaining material and concrete blocks used for protecting the slope. The structural details have gone through repeated waterway experiments. The results of this research and development were summarized in technical documents (draft) ¹⁾ and publicly disclosed. We have already made pilot works of this structure at around 14 places all over Japan and we keep monitoring changes after the works.

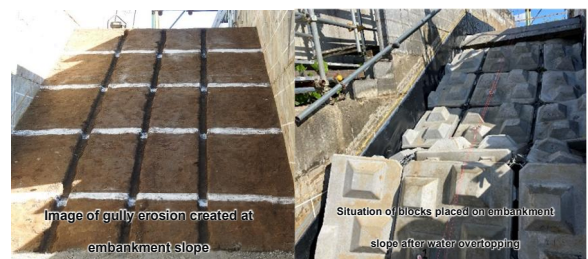
Photo-3 Experiment image having gully erosion at embankment slope

Consequently, we make verification using a hydraulic experiment, systematically summarizing the causal relationship between on-site uncertainty and destruction of embankment in drawing, and selecting on-site uncertainty, from that which is assumed to lead to embankment collapse. For example, in block structure, we "dig down" destruction modes attributed to various on-site uncertainties by making experiments setting such status as making unevenness under the block assuming the occurrence of gully erosion, due to a long period of rainfalls for initial status of the experiment (refer to Photo-3). With this, we can confirm that the highly resistant river embankment would be vulnerable to some kind of uncertainty, the damage mechanism at such time and the structure to overcome such vulnerability and things to take note of for the maintenance and management. These verifications are also made for technologies highly evaluated in the open call previously mentioned, obtaining cooperation from the applicants themselves. From the research results, we would like to identify risks that are difficult to find under ideal circumstances, and to publicly propose a process to improve reliability in making countermeasures.
