1. SCOPE AND OBJECTIVE

The main purpose of this report is to describe an example of quick inspection procedure which can be applied mainly to reinforced concrete apartment houses in Turkey, emphasizing on the technical aspects of the procedure. Although the procedure proposed herein was developed after several field surveys of typical building damage due to the 1999 Kocaeli Earthquake carried out in Avcular (Istanbul), Izmit, Adapazari, Duzce, it should be noticed that the procedure may need some revisions after its further field applications. It should be also pointed out that although not discussed in this report, organizing and managing the inspection work is essential for immediate and efficient inspections, and should be discussed and planned considering earthquake preparedness program in each country and/or community.

QUICK INSPECTION OF DAMAGED BUILDINGS (REINFORCED CONCRETE STRUCTURES)

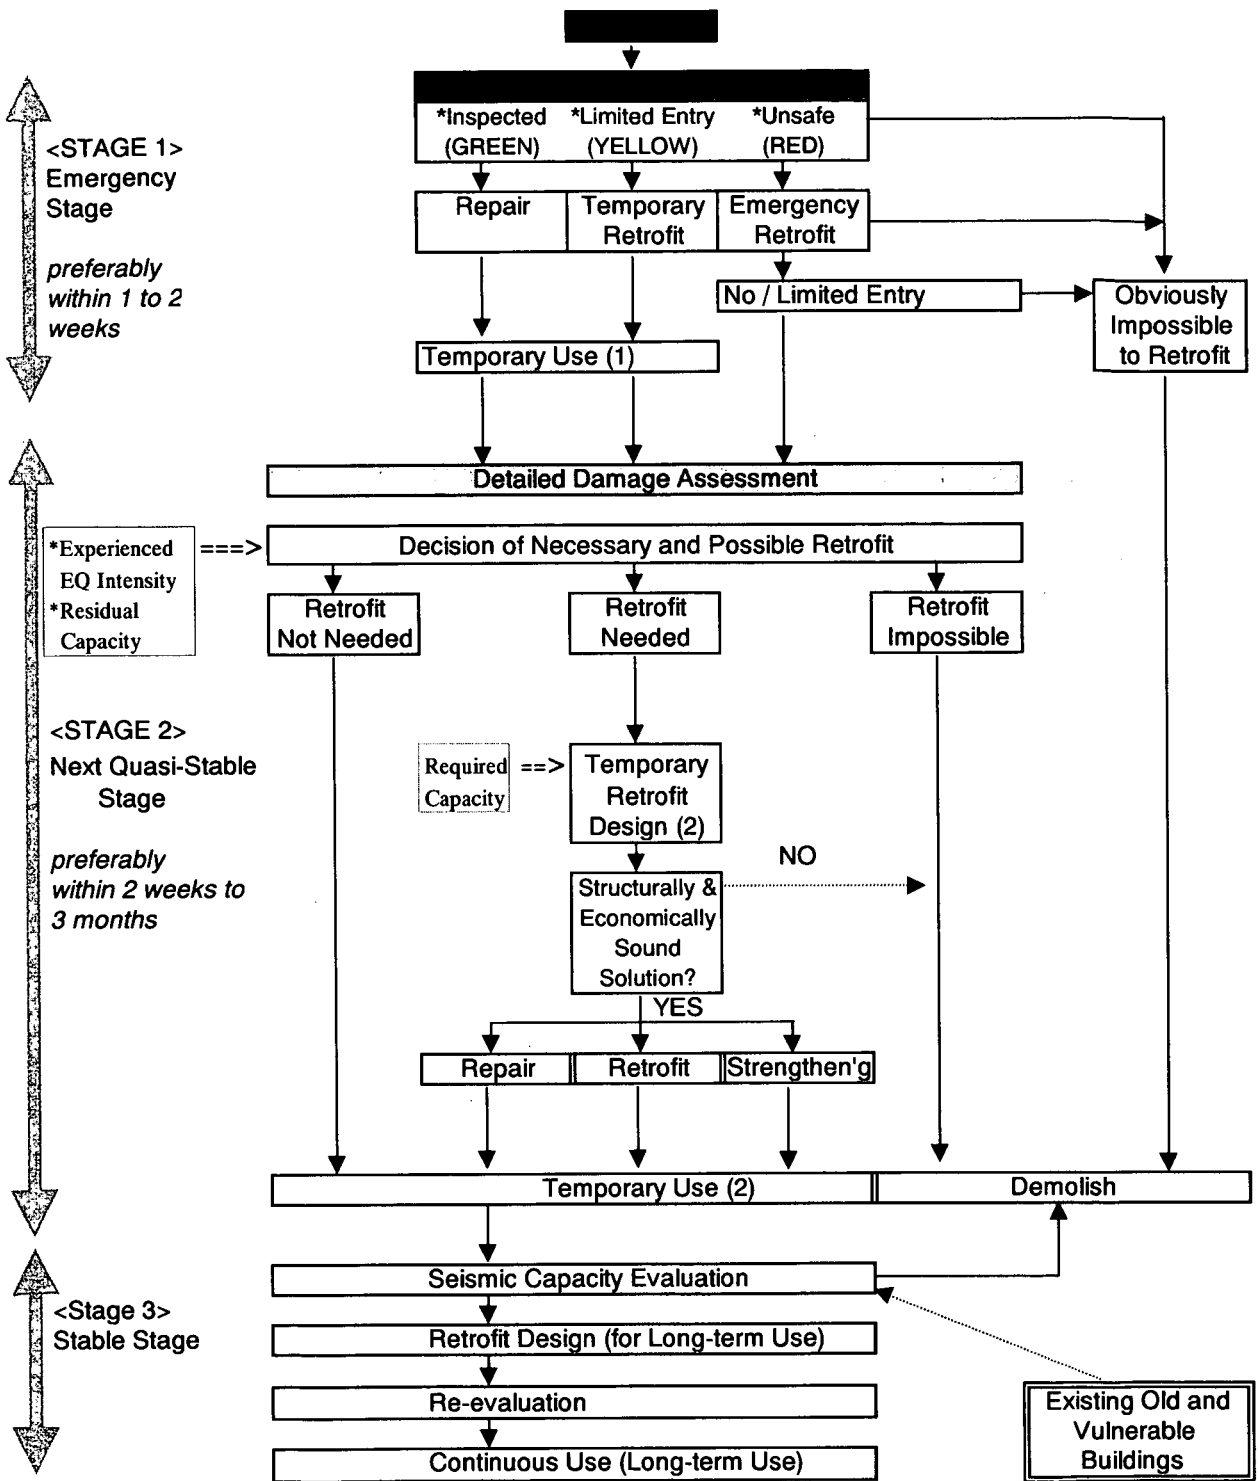
Figure 2.1: General Flow of Reconstruction Strategy

To restore a damaged community as early as possible, well-prepared reconstruction strategy, which needs deep and wide discussions among engineers and governmental personnel prior to disaster, is most essential. Figure 2.1 shows an example of reconstruction strategy for earthquake damaged buildings, which is under discussion in Japan. As is shown in the figure, there may be several stages chronologically after the event in general. Although the detailed and practical flow should be determined after further discussions considering wide array of issues related to earthquake disaster planning and social system in each country, local authority and community, a quick inspection can be definitely the first action to be taken immediately after a major earthquake.

As can be found in the flow chart, it is recommended to perform stages 1 and 2 within “1 to 2 weeks” and “2 weeks to 3 months”, respectively, but it is highly dependent on the disaster scale. It may be informative that quick inspections could not be completed in Japan even 1 month after the 1995 Hyogo-ken Nambu (Kobe) Earthquake due to the huge scale damage, although quick inspectors system had been already established in several prefectures at the time of the quake. Considering the lessons learned from such evidence, nationwide quick inspectors system was developed to mutually cooperate in case of emergency.

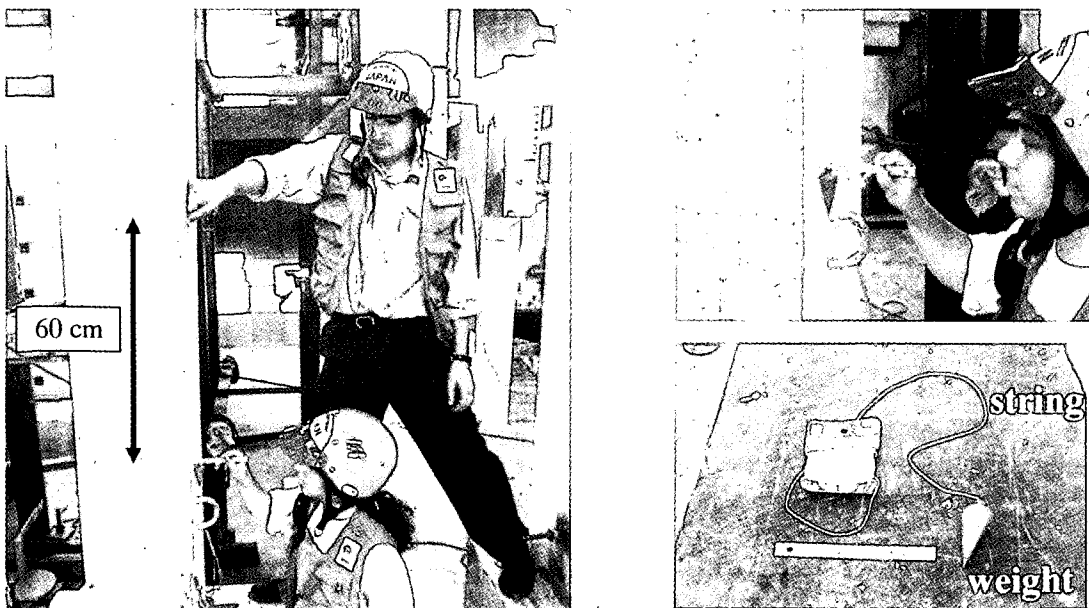
1. When some damage around or to the building is found, check as such in questions a. through c. Ordinarily noticeable inclination may be larger than 2 degrees ($1/30$ rad.) and rank C would be appropriate, while unnoticeable inclination may be smaller than 1 degree ($1/60$ rad.) and rank A would be appropriate. If the building is seemingly inclined but the degree is uncertain, inclination measurement is recommended. Inclination can be easily noticed with a pendant-type measurement as shown below.

note: If the string is adjusted 60 cm long, inclination can be easily measured by the distance from the column surface to the string. (e.g. 1 cm : $1/60$ rad. and 2 cm : $1/30$ rad.)

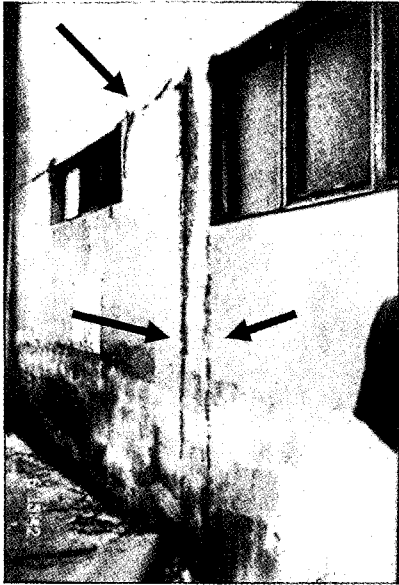
Cracks along interface between structural members (column and beam) and nonstructural wall are clearly observed.

2. Identify the most seriously damaged story and inspect column damage in the story. Note that it is essential to identify structural and nonstructural members to assess structural safety. Column surface is often flush with nonstructural (ordinarily brick) walls but vertically or horizontally continuous cracks can be a sign of border between structural and nonstructural members.

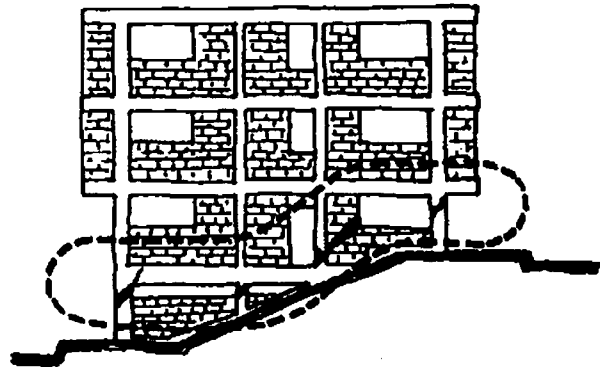
3. Sketch the building configuration and column location of the inspected story, find out columns with damage rank \geq III and then identify them on the sketch. If no serious damage to a column but some to beams and/or beam-column joints is found above or below the column, take it into account assuming them as damage to the column. Definitions of damage rank and examples will appear in Chapter 4. Note that this inspection sheet is designed to rate the building damage based on damage III, IV, and V, it is significantly time-saving only to identify columns with damage rank \geq III.
4. It is often found that a building is located on the slope and damage to columns in two adjacent stories is observed. In such a case, it may be a solution to allow for both stories and to take heavier damage into account as shown below.

5. Count the number of columns having damage rank III, IV, or V as indicated on the right-hand side of the sketch area and calculate the damage ratio as indicated in questions d-1 and d-2.
6. Judge the structural safety as defined in the sheet. It should be noted that interior inspection may lead to newly found damage, and either interior inspections or interview to occupants/users is strongly recommended if the building is rated "INSPECTED".

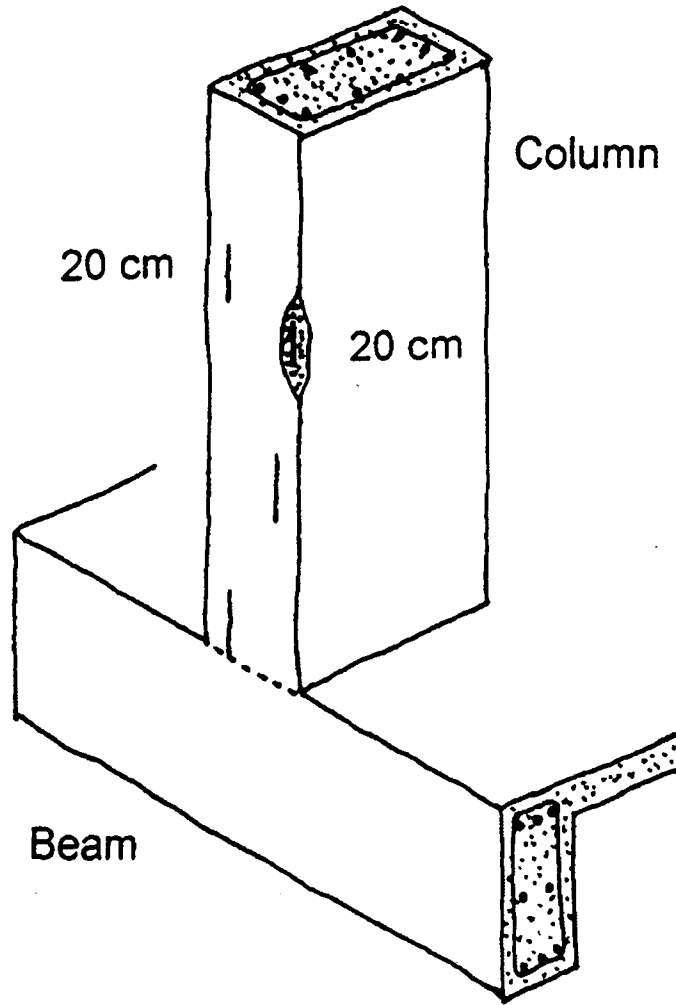
Fig.4.1.1.2 Negligible Cracks and Spalling of Concrete in Damage Rank Evaluation

If the length of longitudinal cracks along the structural member is less than 20cm, the cracks are negligible in the damage rank evaluation. (Fig.4.1.1.2)

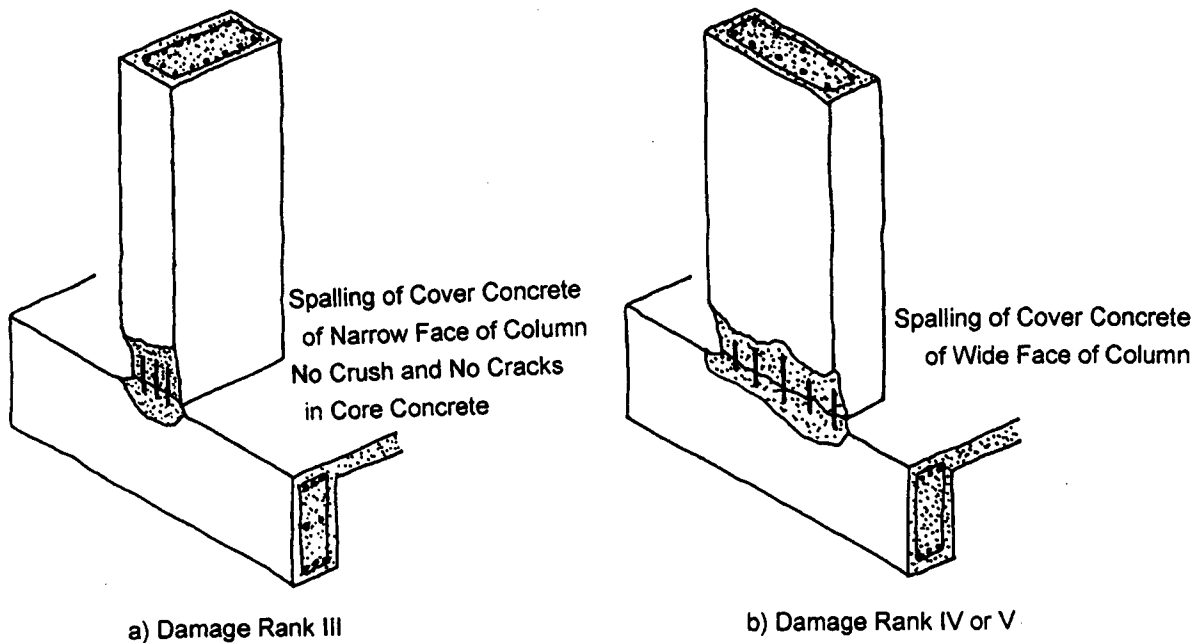
Fig.4.1.3.1 Damage Rank of Columns,
the Cover Concrete is Spalled off Locally at the Bottom of columns

The columns are evaluated in damage rank III in case that the cover concrete of bottom and narrow face of columns is spalled, but there is no crush and no cracks in the core concrete. (Fig.4.1.3.1 a))

But the spalling of cover concrete occurs at the wide face of columns, the damage rank should be IV or V. (Fig.4.1.3.1 b))

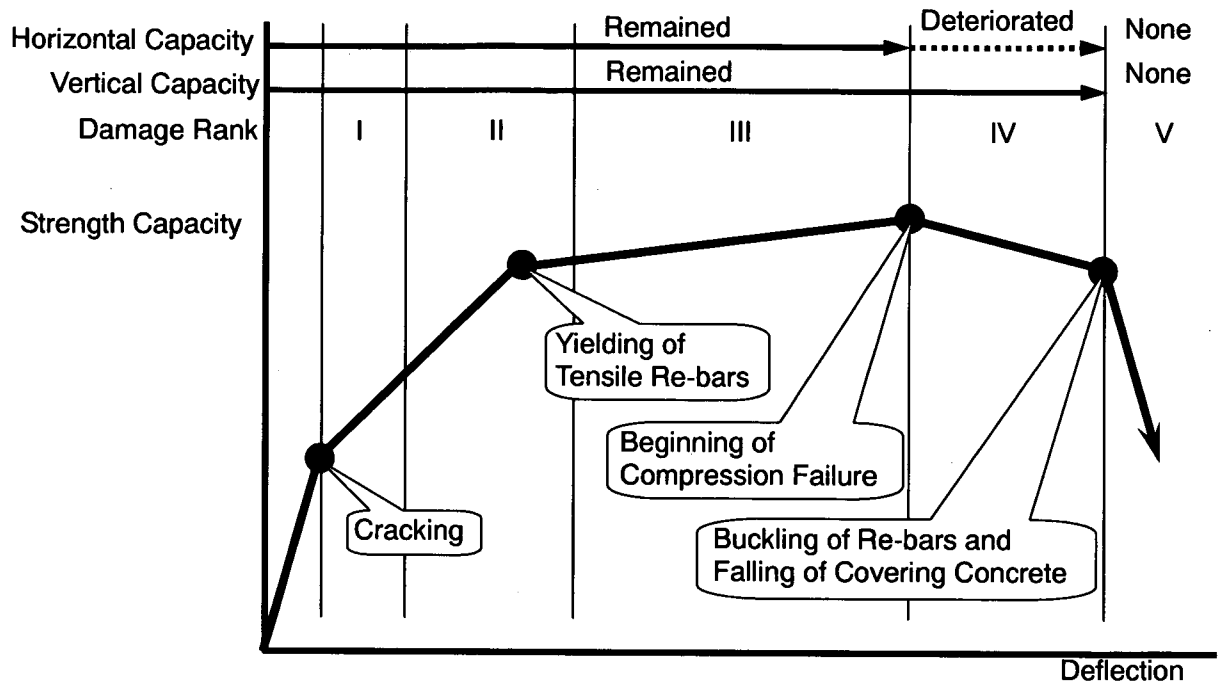
Fig.4.1.4.1 Concept of Damage Rank and Structural Performance of Ductile Members

Following figures, Fig.4.1.4.1 and 4.1.4.2, show the concept of damage rank and structural performance of structural members.

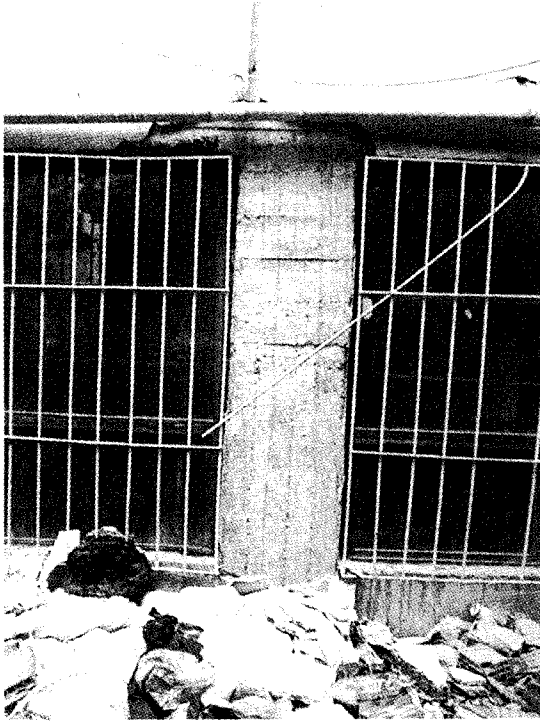
1) Mortar is separated and fallen down, and No shear cracks are observed.

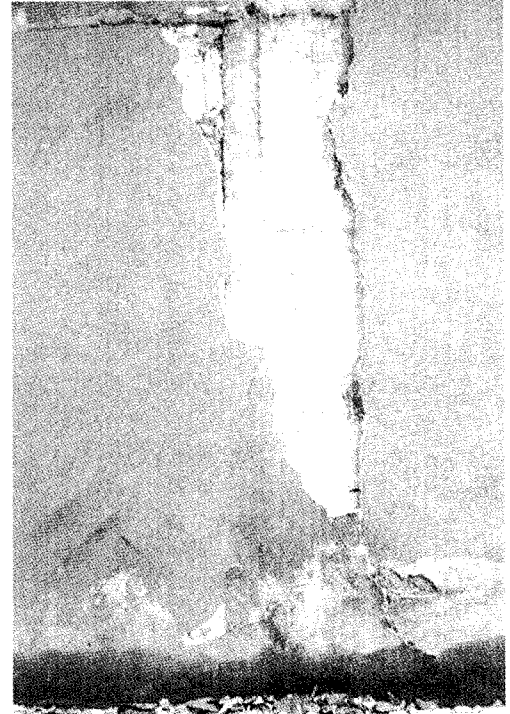
2) Mortar is separated and fallen down, and No shear cracks are observed.

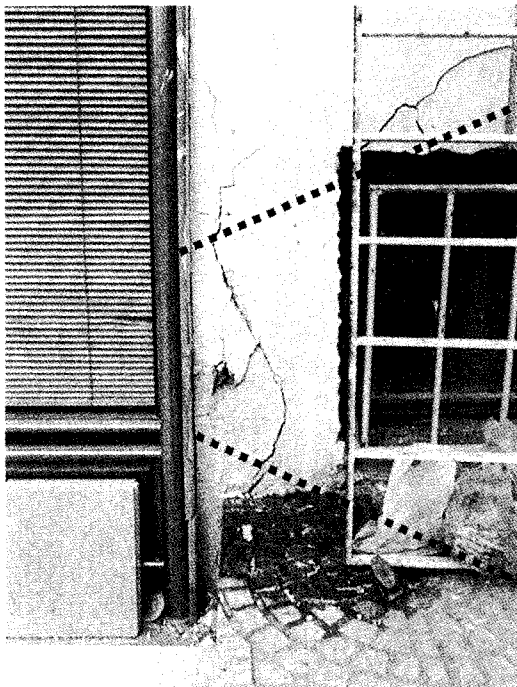
3) Big crack is observed on mortar. But take the mortar away, no crack is observed on the face of concrete.

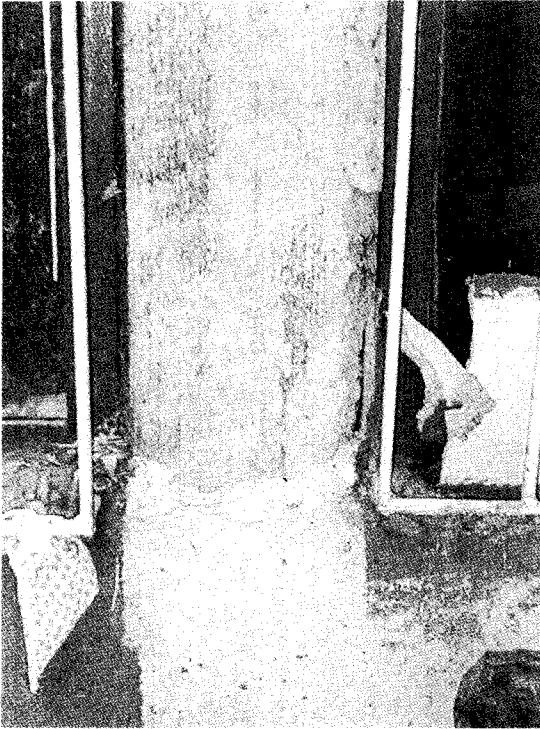
4) Corner cover concrete is spalled off.
But shear cracks are not observed.

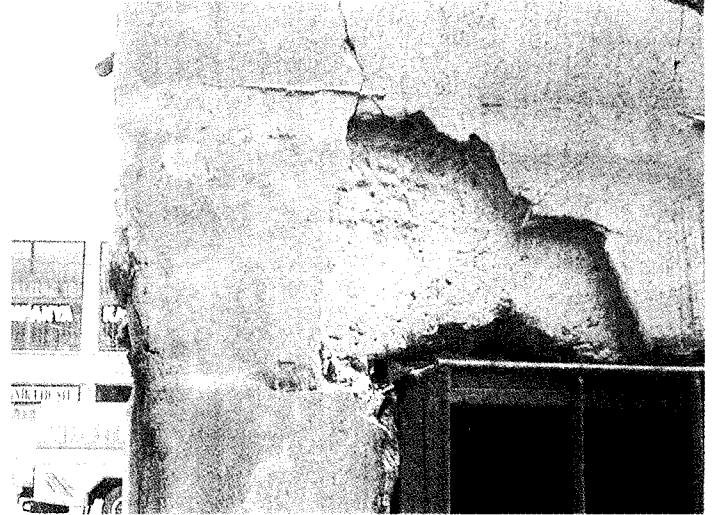
5) Only flexural cracks occur in beam

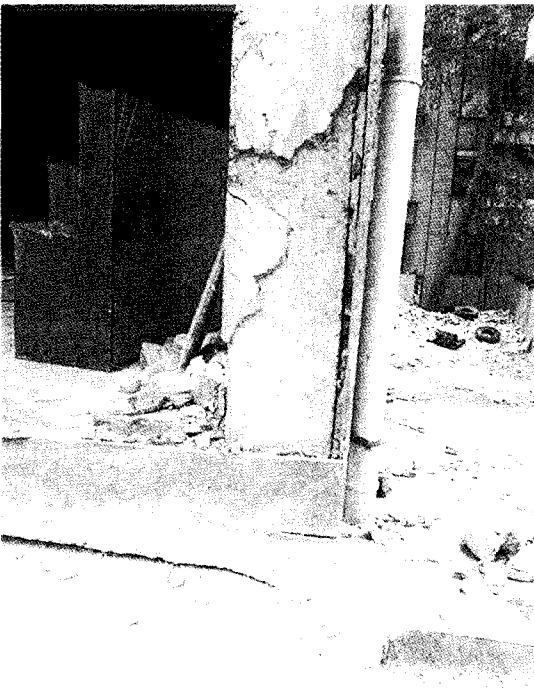
6) Corner cover concrete is spalled off.
But shear cracks are not observed.

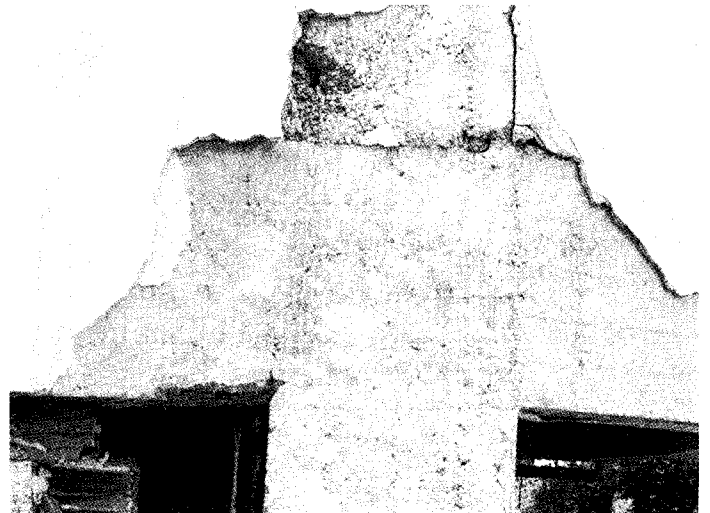
7) Visibly narrow shear crack and flexural crack occur
in beam. No shear cracks are observed in the beam-
column joint.

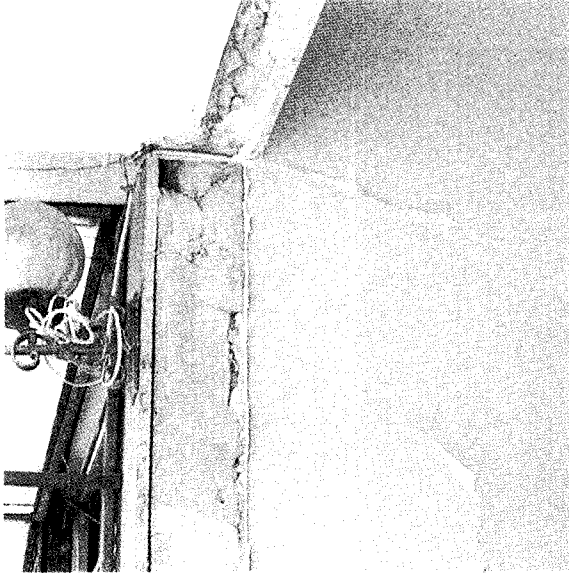
1) Mortar does not fall down, and only small cracks are observed on mortar.

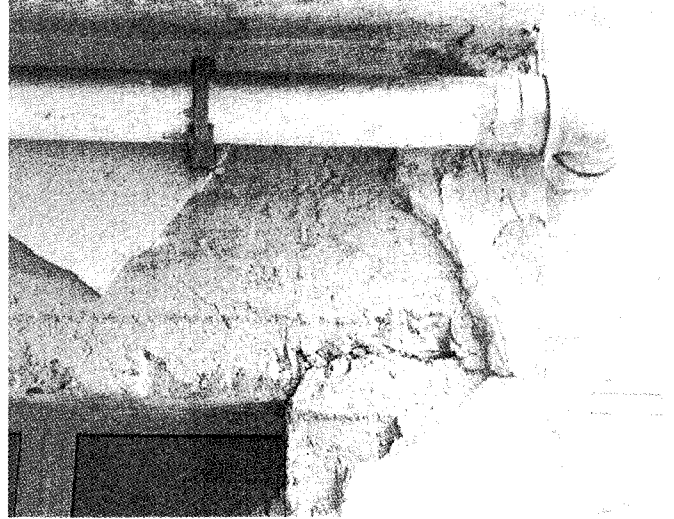
2) Construction joint is observed but negligible.
Visible clear shear crack in the beam is observed.

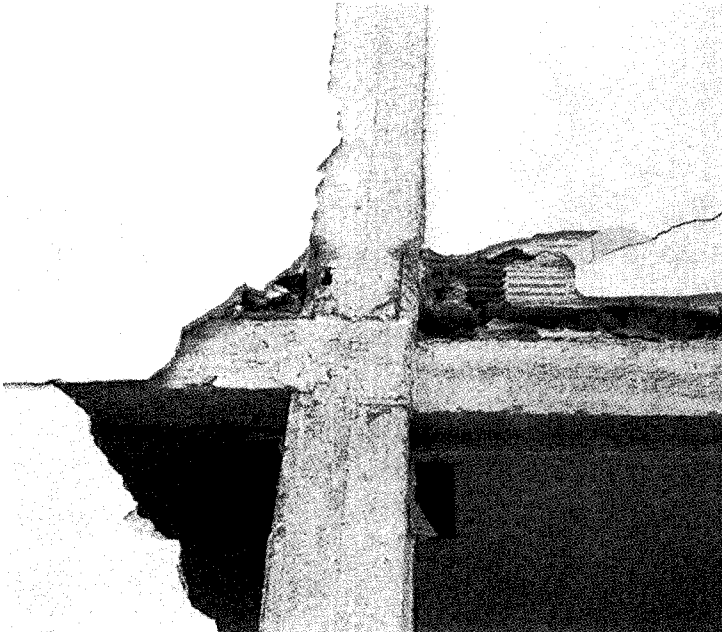
3) Beam has a visible clear crack. (Rank II)
Beam-column joint has no cracks. (Rank I)
Spalling of corner cover concrete of column is negligible.
So, totally the column is Rank II.

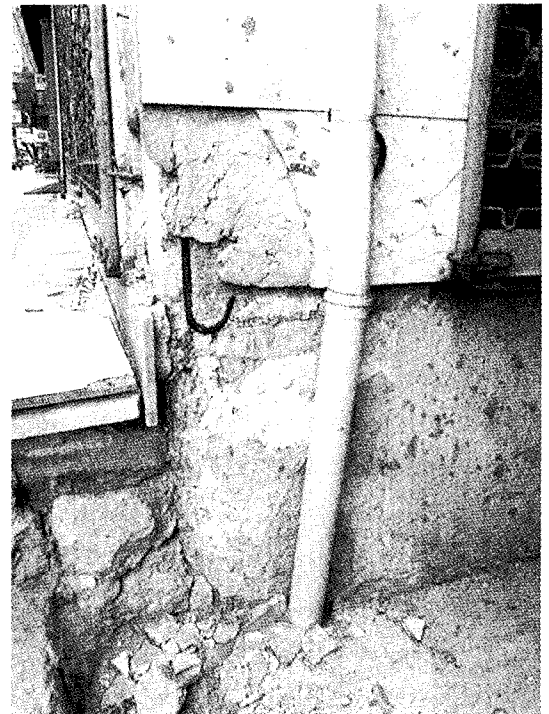
4) Evaluation of damage of this column is difficult. Spalling of cover concrete occurs at only corner. So, damage rank is II.

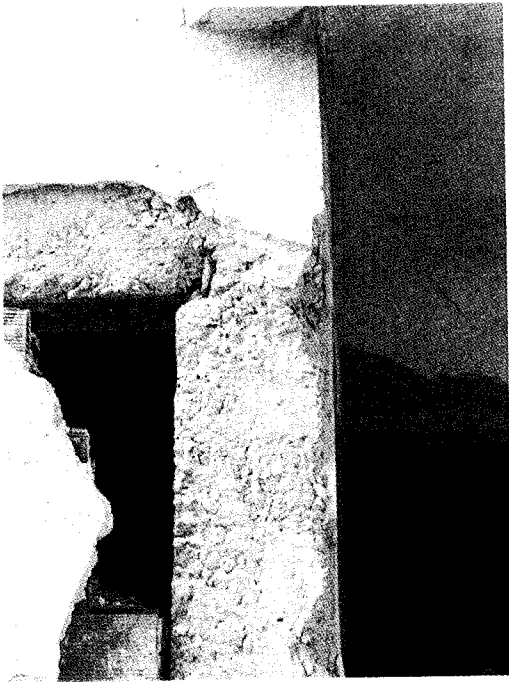
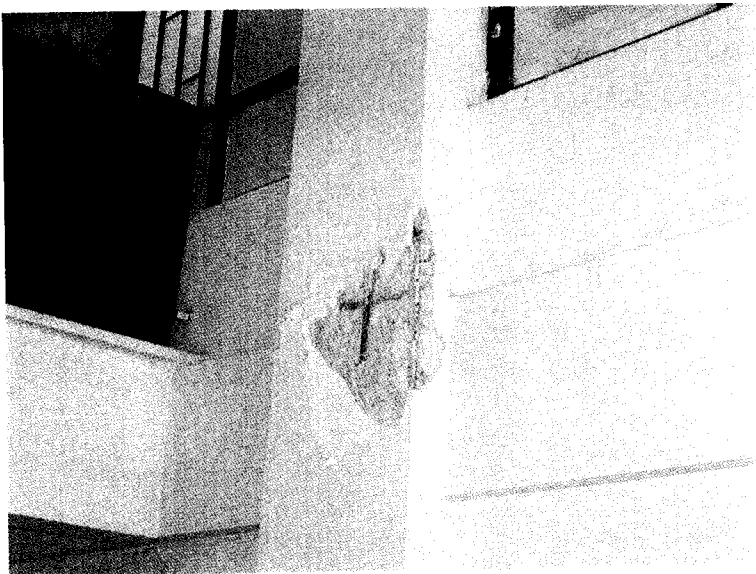
5) Construction quality is not so good.
But almost no damage is observed
in structural members.

6) Mortar is fallen down. There was no cover concrete
initially, so the reinforcing bars are exposed easily, but there
is almost no cracks in concrete. So, damage rank is II

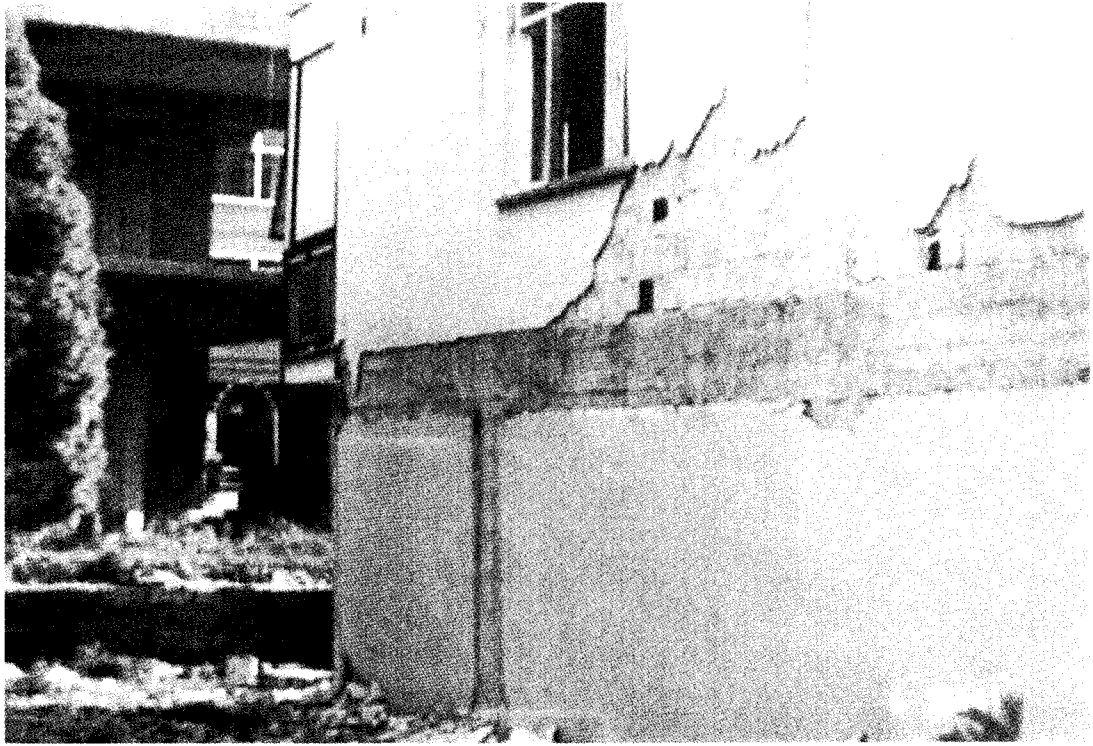
- 7) Mortar is fallen down extensively, but no severe damage and no wide cracks are observed.
So, the inner two columns are estimated as Rank II.

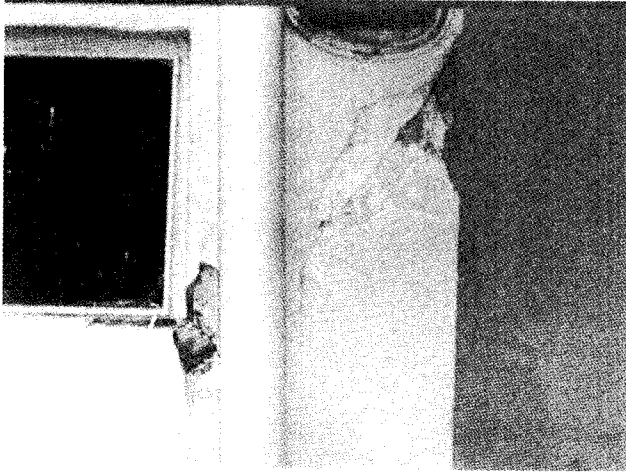
1) Wide shear cracks and local crush of cover concrete are observed at the upper part of column.

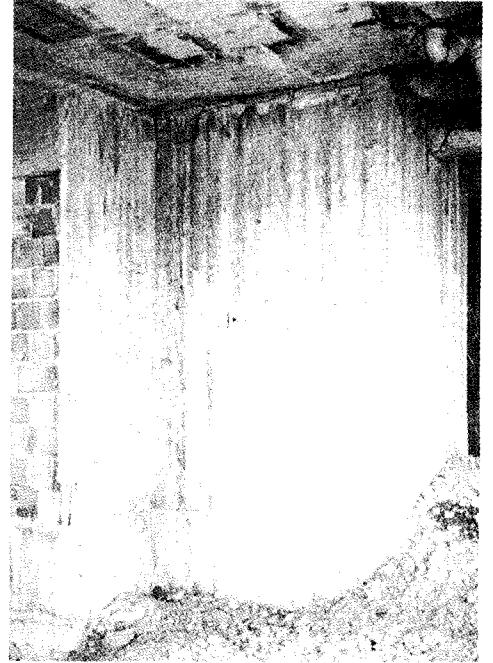
2) Wide shear cracks, local crush of cover concrete and small exposure of reinforcing bars may be observed are observed.

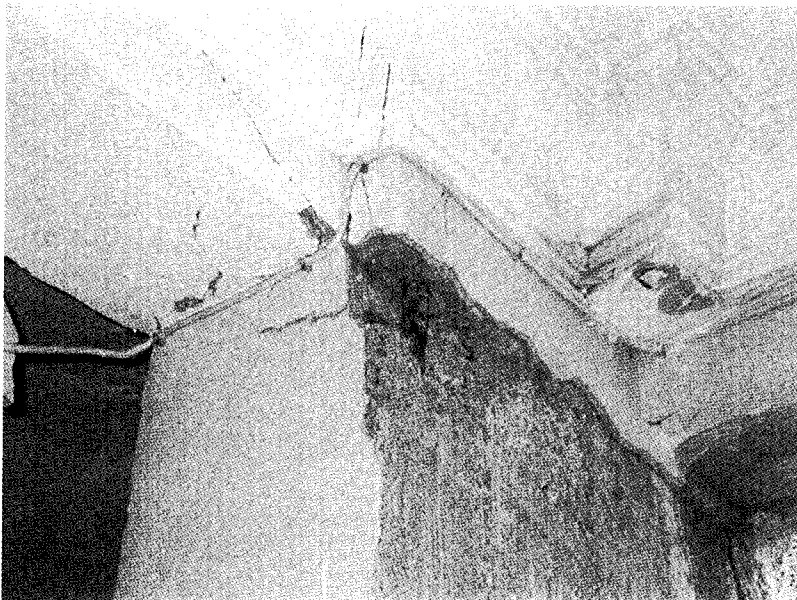
3) Wide flexural crack and local crush of cover concrete and small exposure of reinforcing bars are observed.

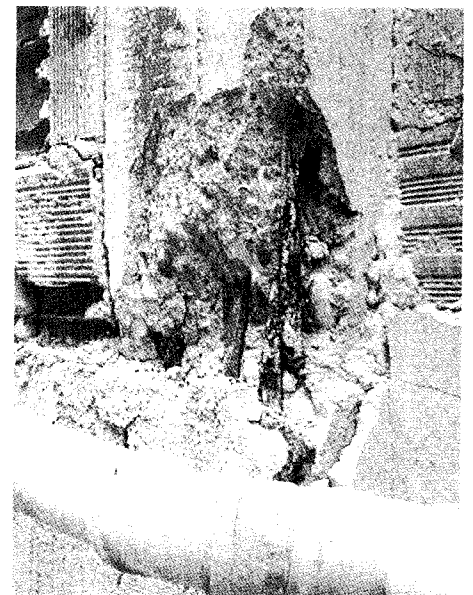
4) Local crush of cover concrete and exposure of reinforcing bars are observed. But no cracks are observed in core concrete.

This column is Rank III as Fig.4.1.3.1 a)

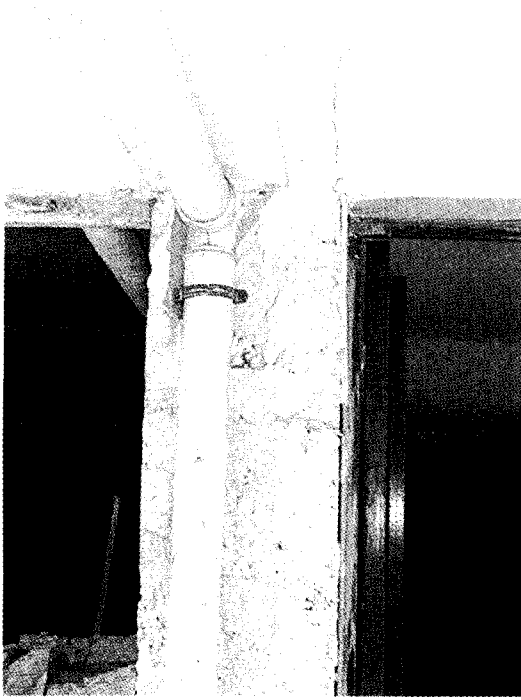
5) Visibly clear shear crack occurs at the top of the narrow face of the column.

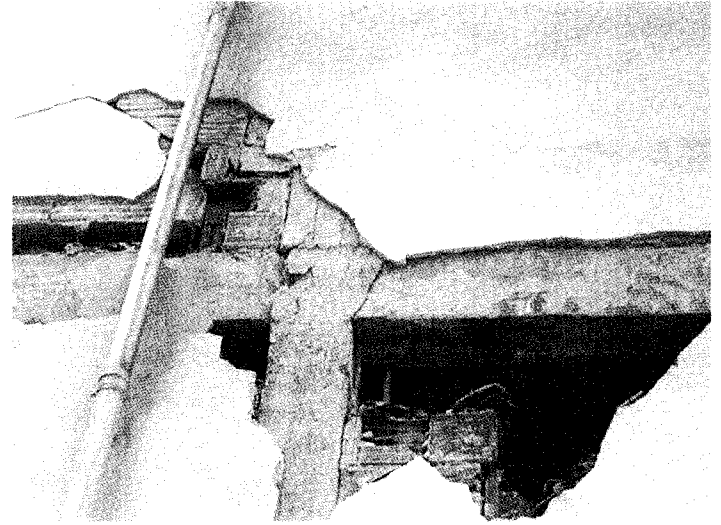
6) Wide shear crack and big flexural crack occur at beam end.

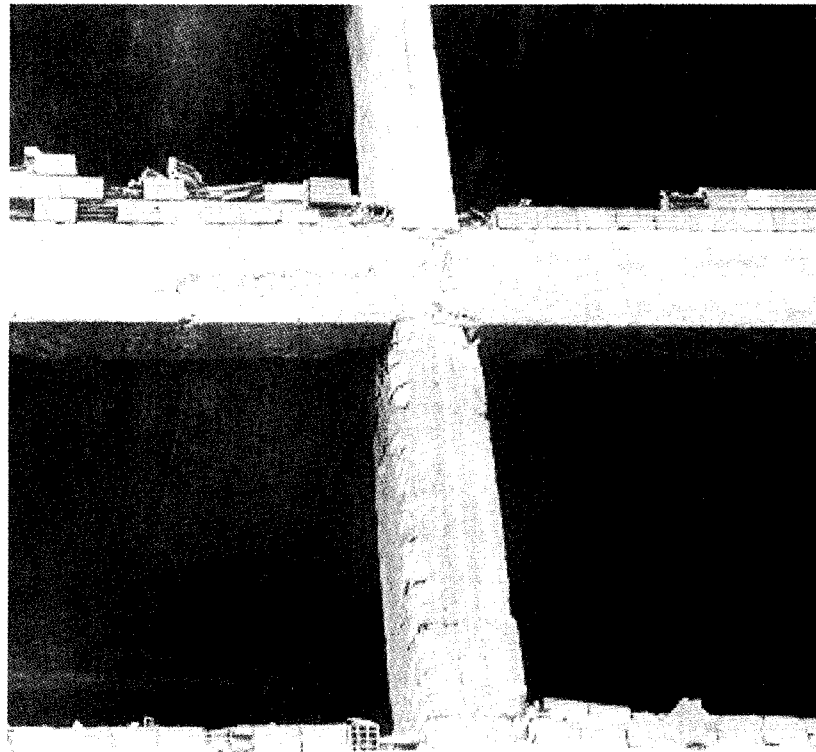
7) Some corner cover concrete are spalled off in the column damage, but damage mainly occurs beam-column joint. Cover concrete is spalled off but no diagonal shear cracks are observed.

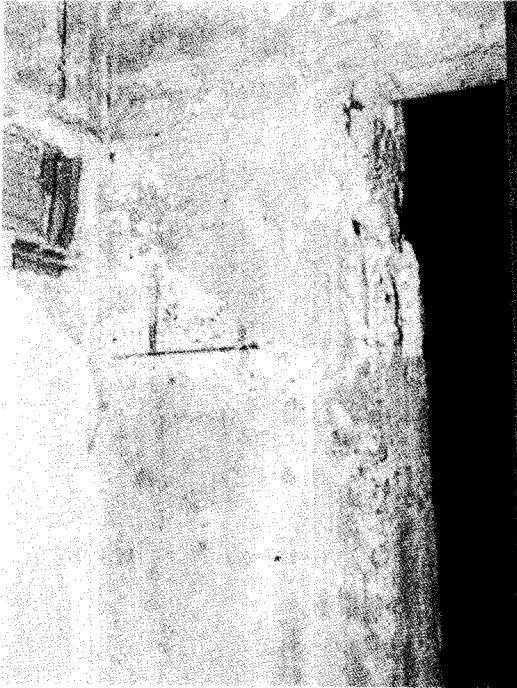
1) Big cracks, Massive Spalling of cover concrete and extensive exposure of reinforcing bars are observed. But buckling of the reinforcing bars is not observed.

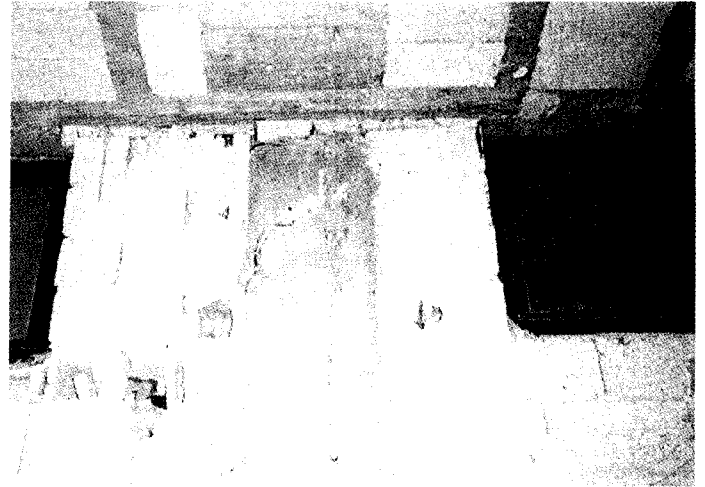
2) Big shear crack is observed on the narrow face of column

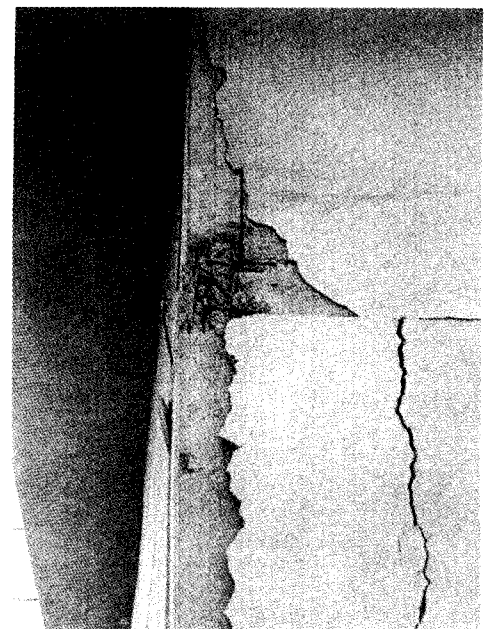
4) Diagonal shear crack is observed in beam-column joint.

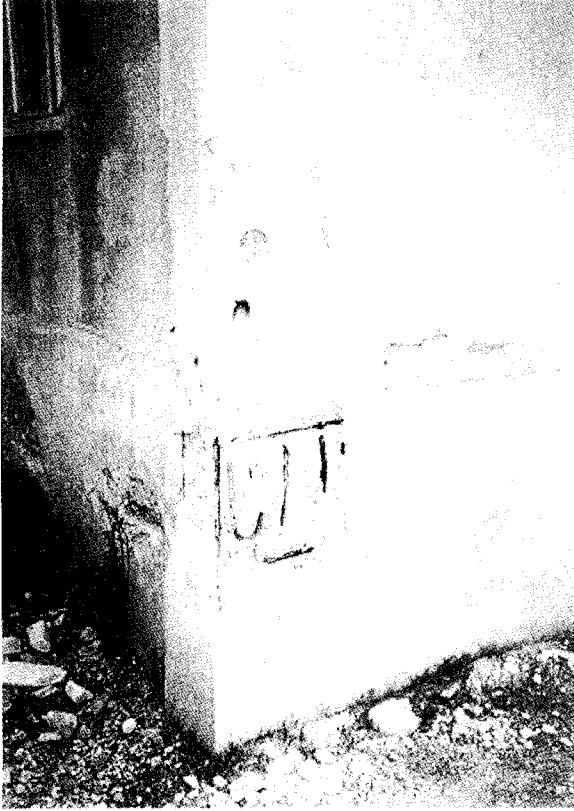
5) Massive Spalling of cover concrete and extensive exposure of reinforcing bars are observed, but buckling of the reinforcing bars is not observed.

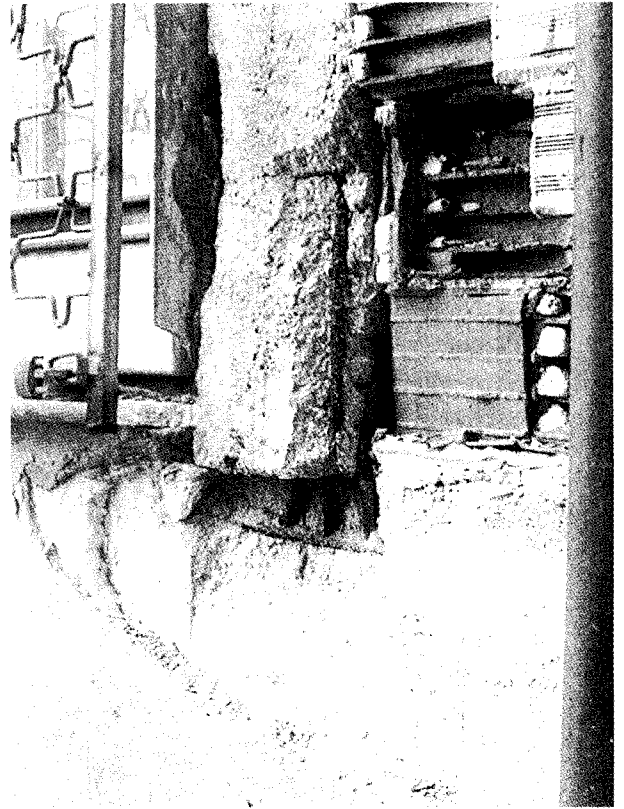
6) Damage is almost same as Fig.4.1.3.1 a). But the damage is heavier and there are cracks in core concrete.

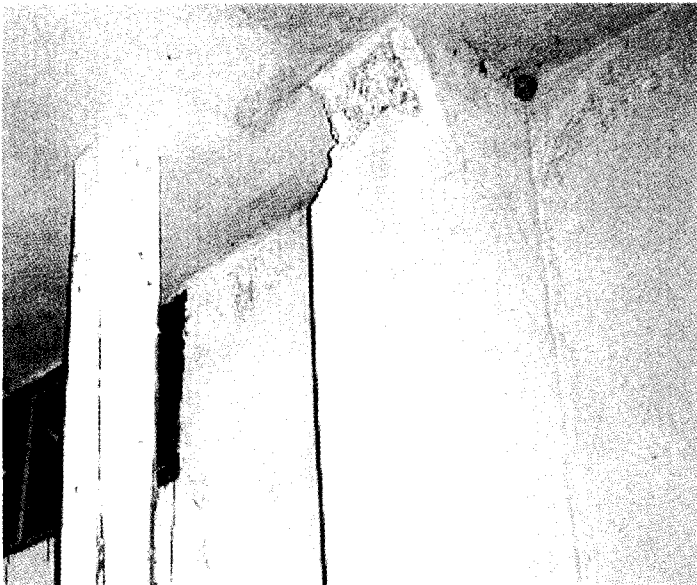
7) Big shear crack and spalling of cover concrete is observed at the top of column.

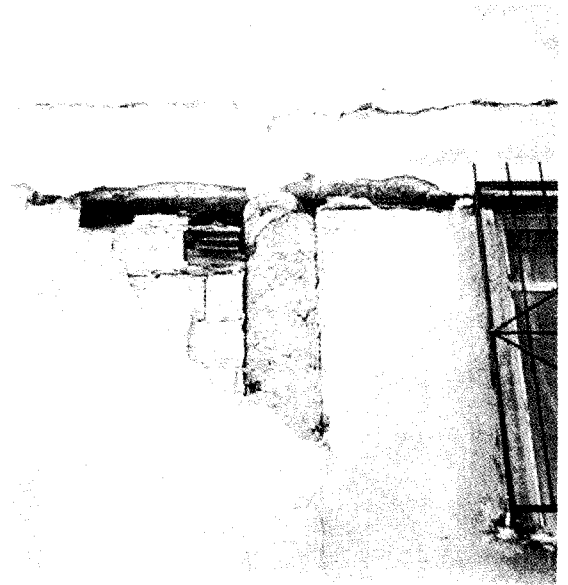
8) Big shear crack is observed at the top of the narrow face of column.

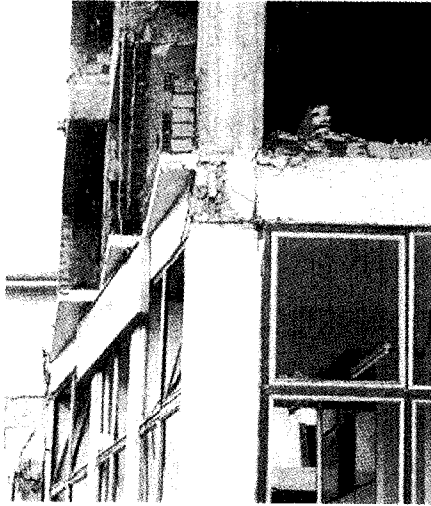
Diagonal shear cracks at the beam-column joint

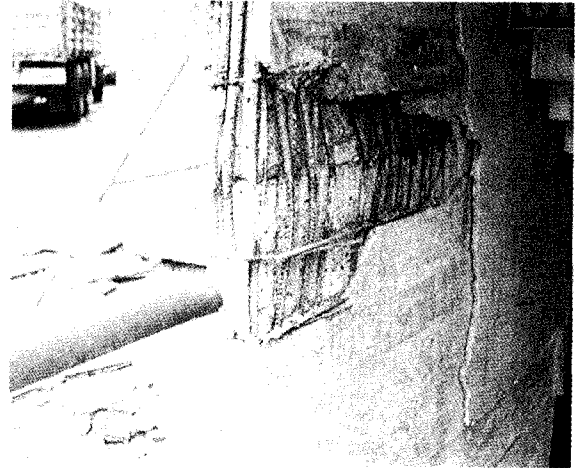
Tensile crack at the middle height of column

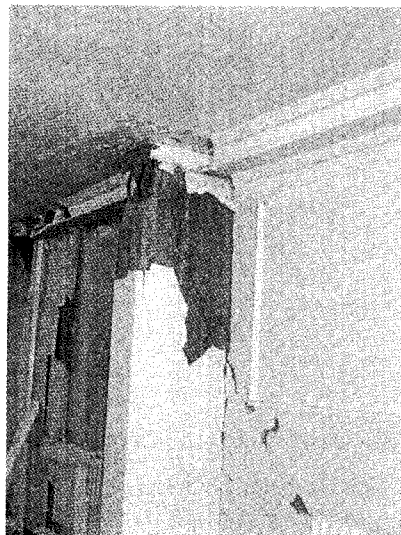
Big shear crack at the top of column

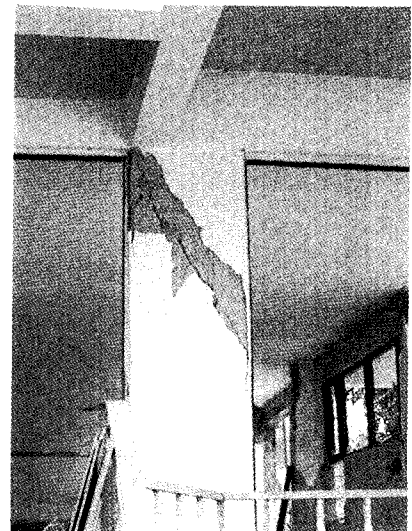
Big shear crack at the top of column

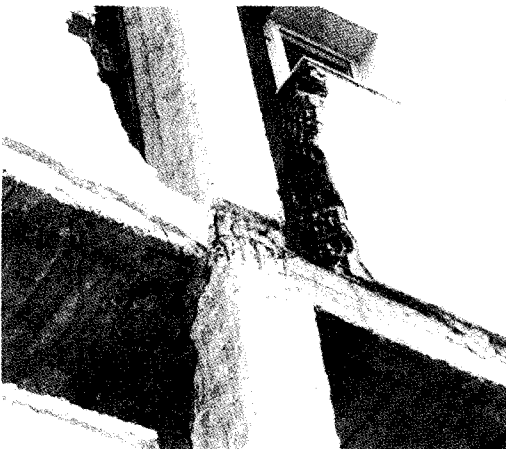
9) Heavy damage at beam-column joint

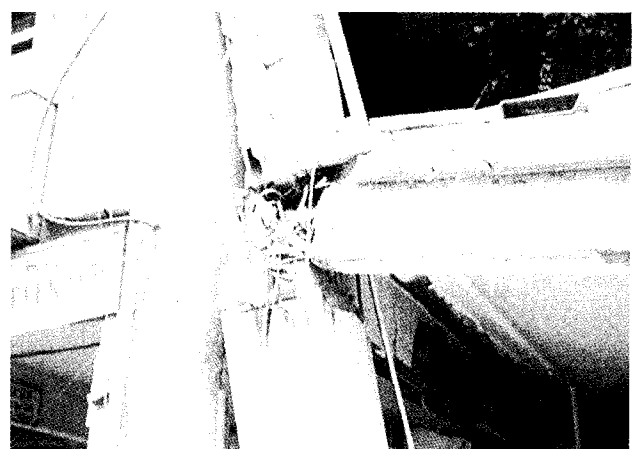
10) Crush of core concrete of beam-column joint

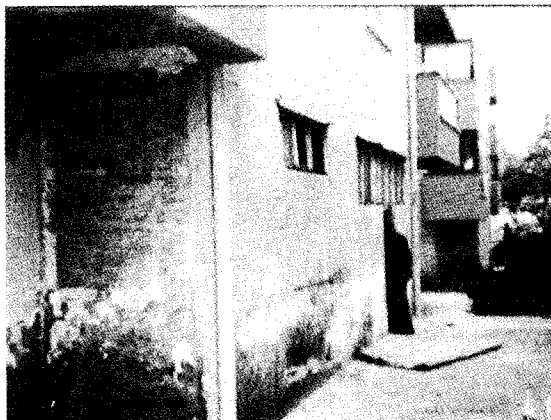
1) Rank A: Local crack and cracks at the
boundary between wall and RC frame

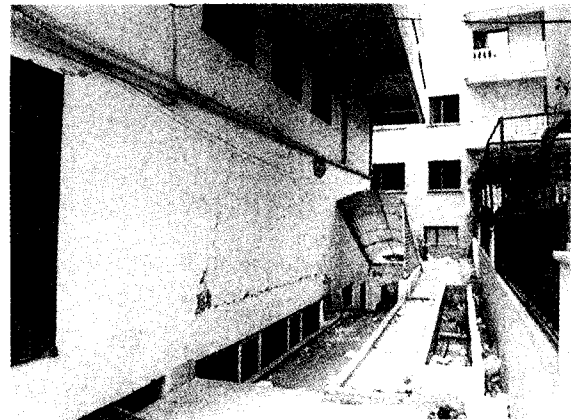
2) Rank B: Cracks observed
but no out-of-plane deformation

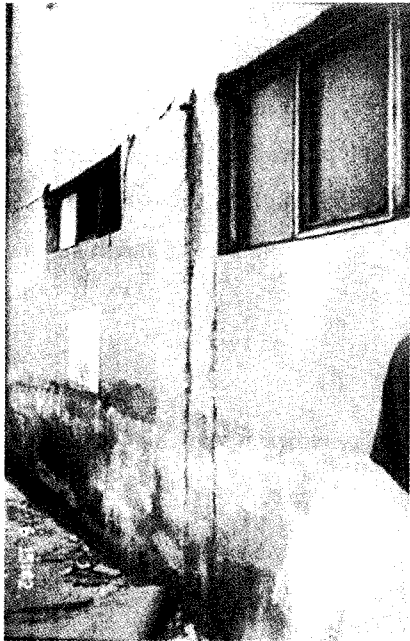
3) Rank C: Offset from RC frame

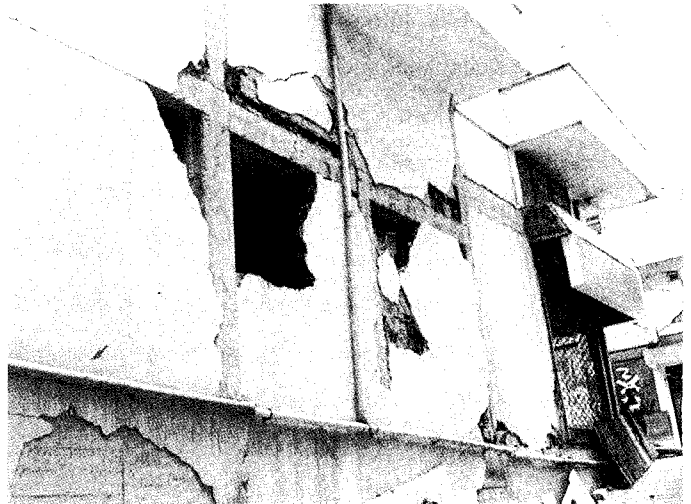
4) Rank C: Extensive cracks penetrated

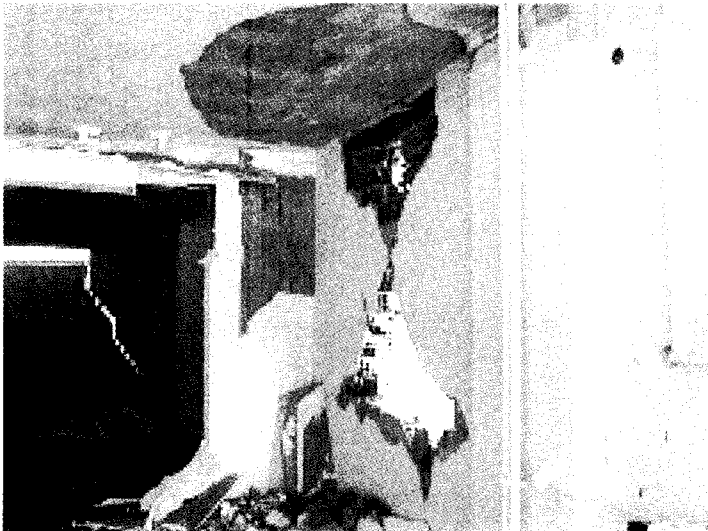
5) Rank C: Extensive diagonal cracks penetrated and
Offset from RC frame

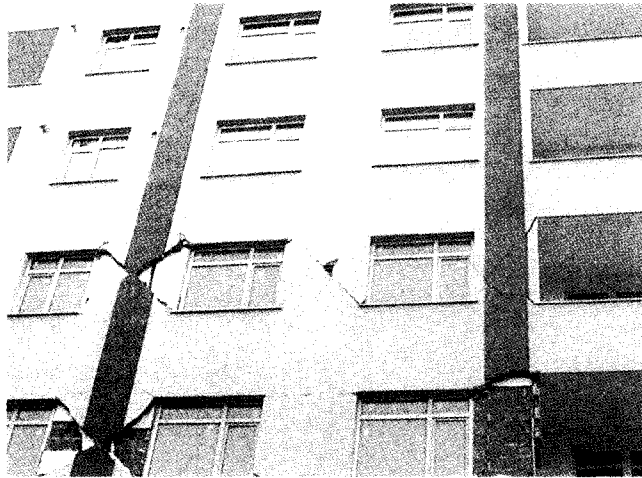
1) Rank C: Diagonal cracks observed

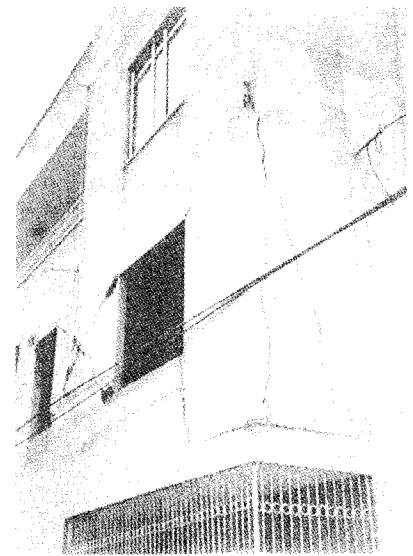
**2) Rank C: Diagonal cracks observed
and offset from RC frame**

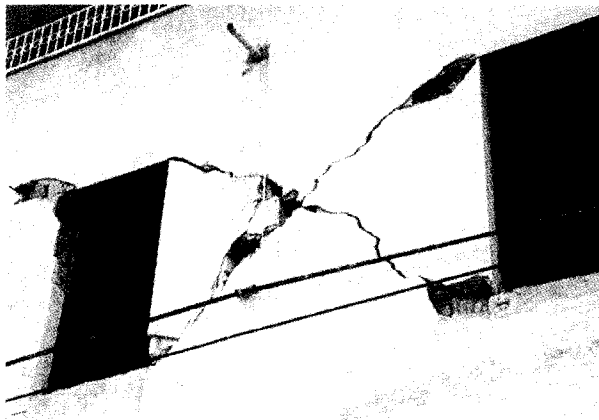
3) Rank C: Diagonal cracks observed

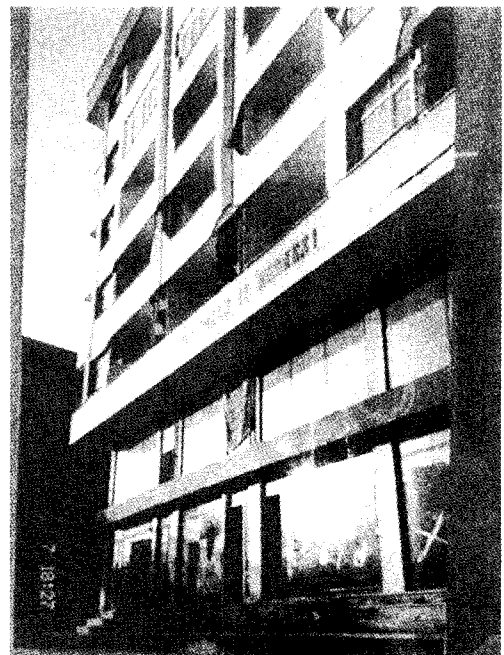
**4) Rank C: Diagonal cracks observed in
upper stories. Keeping out is
needed near the building.**
