1. SCOPE AND OBJECTIVE

The main purpose of this report is to describe an example of quick inspection procedure which can be applied mainly to reinforced concrete apartment houses in Turkey, emphasizing on the technical aspects of the procedure. Although the procedure proposed herein was developed after several field surveys of typical building damage due to the 1999 Kocaeli Earthquake carried out in Avcular (Istanbul), Izmit, Adapazari, Duzce, it should be noticed that the procedure may need some revisions after its further field applications. It should be also pointed out that although not discussed in this report, organizing and managing the inspection work is essential for immediate and efficient inspections, and should be discussed and planned considering earthquake preparedness program in each country and/or community.

QUICK INSPECTION OF DAMAGED BUILDINGS (REINFORCED CONCRETE STRUCTURES)

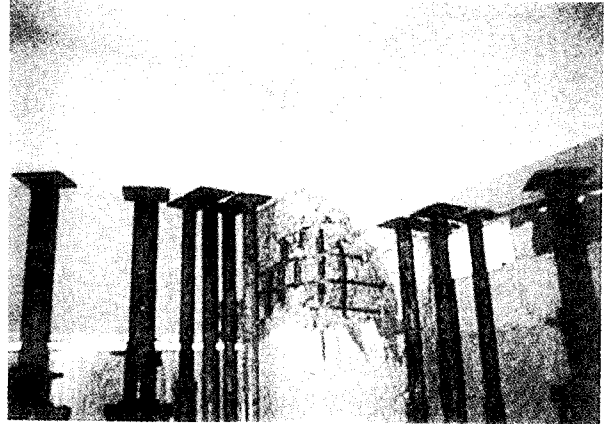
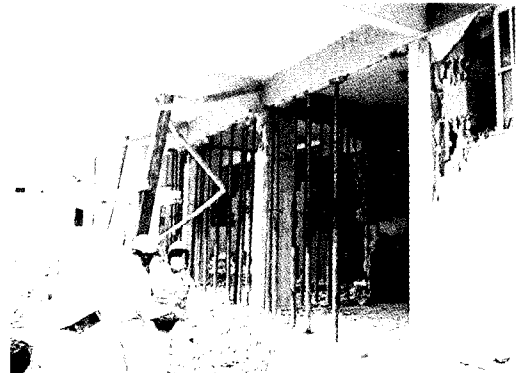
(4) Shoring with steel pipes or screw jacks around heavily damaged column

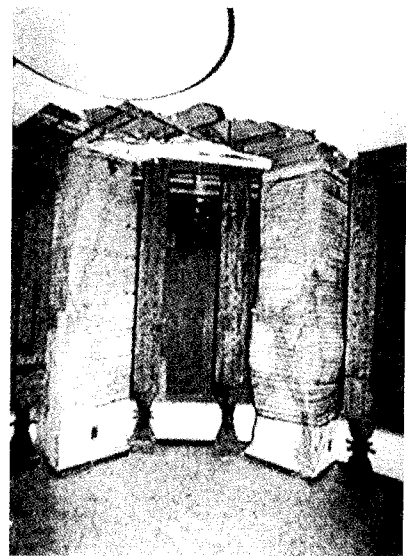
(5) Jacketing of damaged column with steel wires

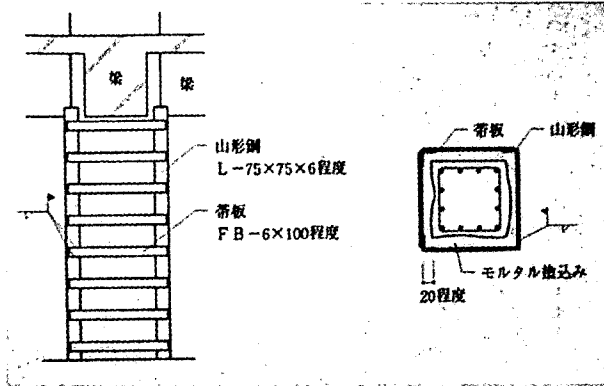
(6) Jacketing of damaged column with steel sections

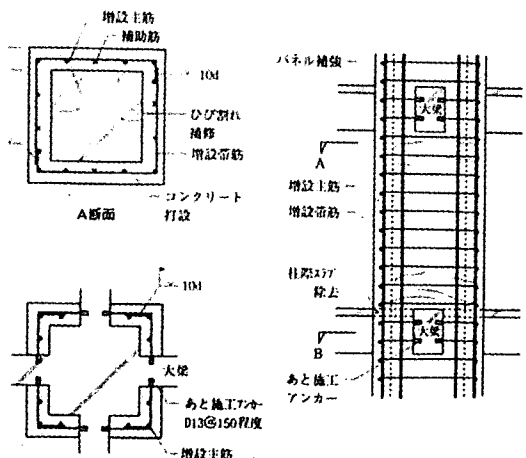
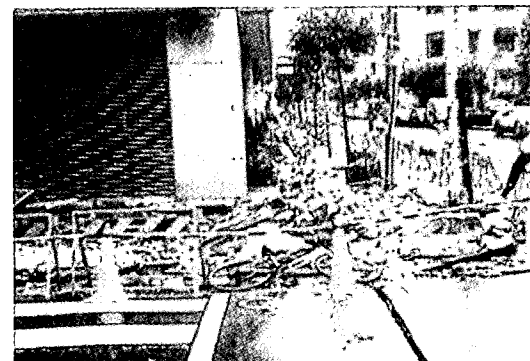
(7) Jacketing with newly cast RC section

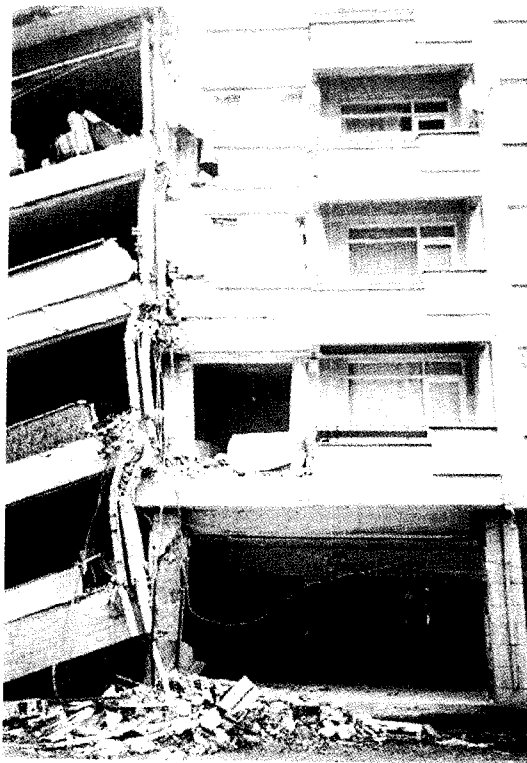
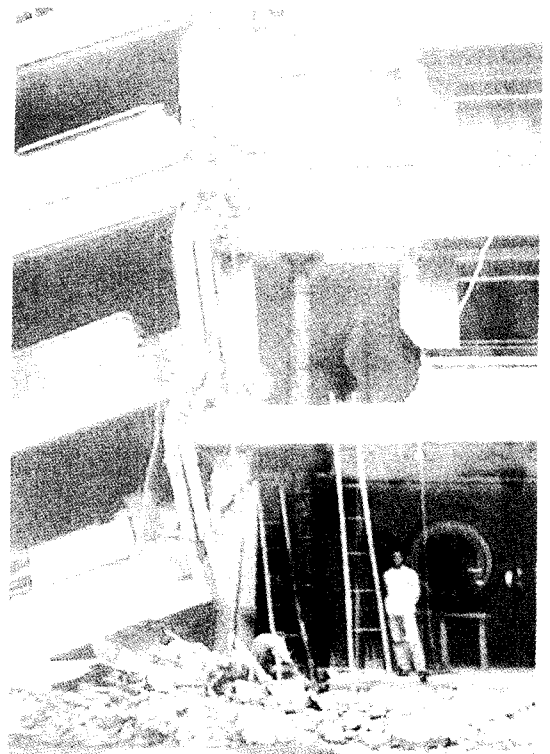
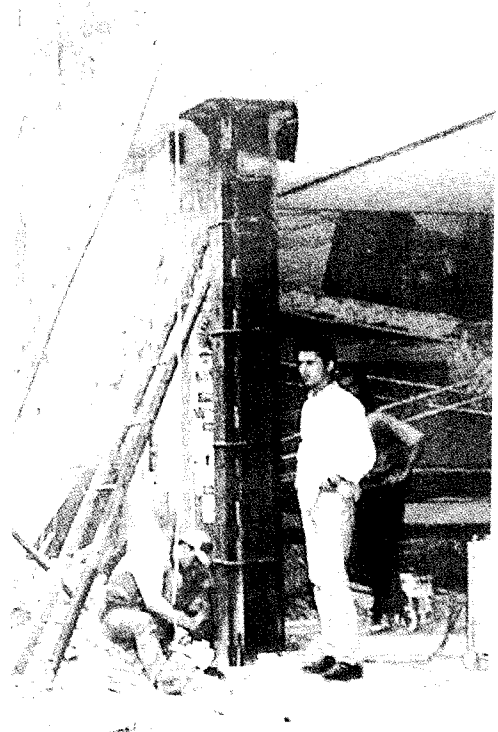
(9) Shoring with steel sections around a column damaged due to pounding
(left: before retrofit / right: after retrofit)

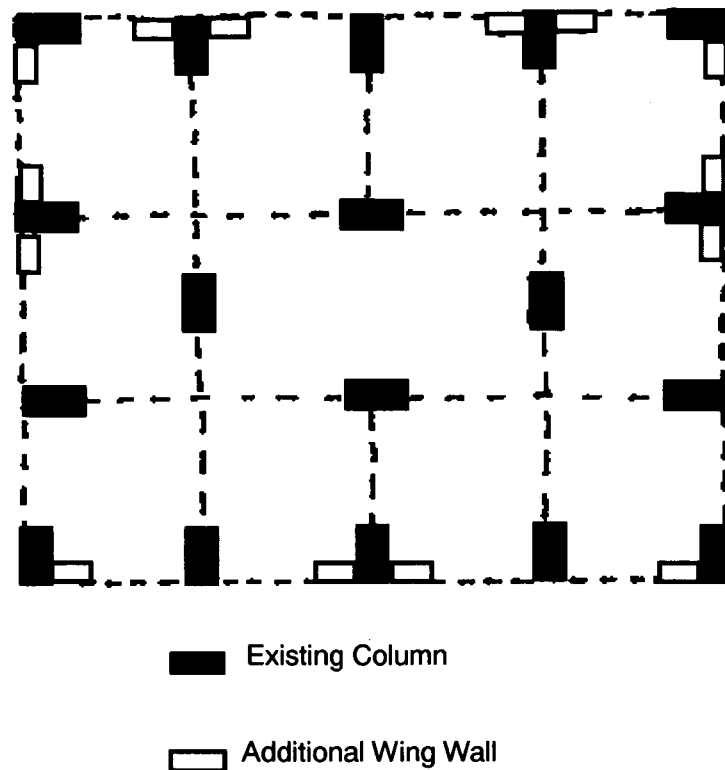
(10) Conceptual temporary retrofit design of damaged columns with wing walls

The most conventional retrofit strategy applied to existing reinforced concrete buildings, both for emergency or temporary use and long-term use, can be installation of new RC shear walls within bare frames. The scheme described above can be a primary candidate for damaged buildings.

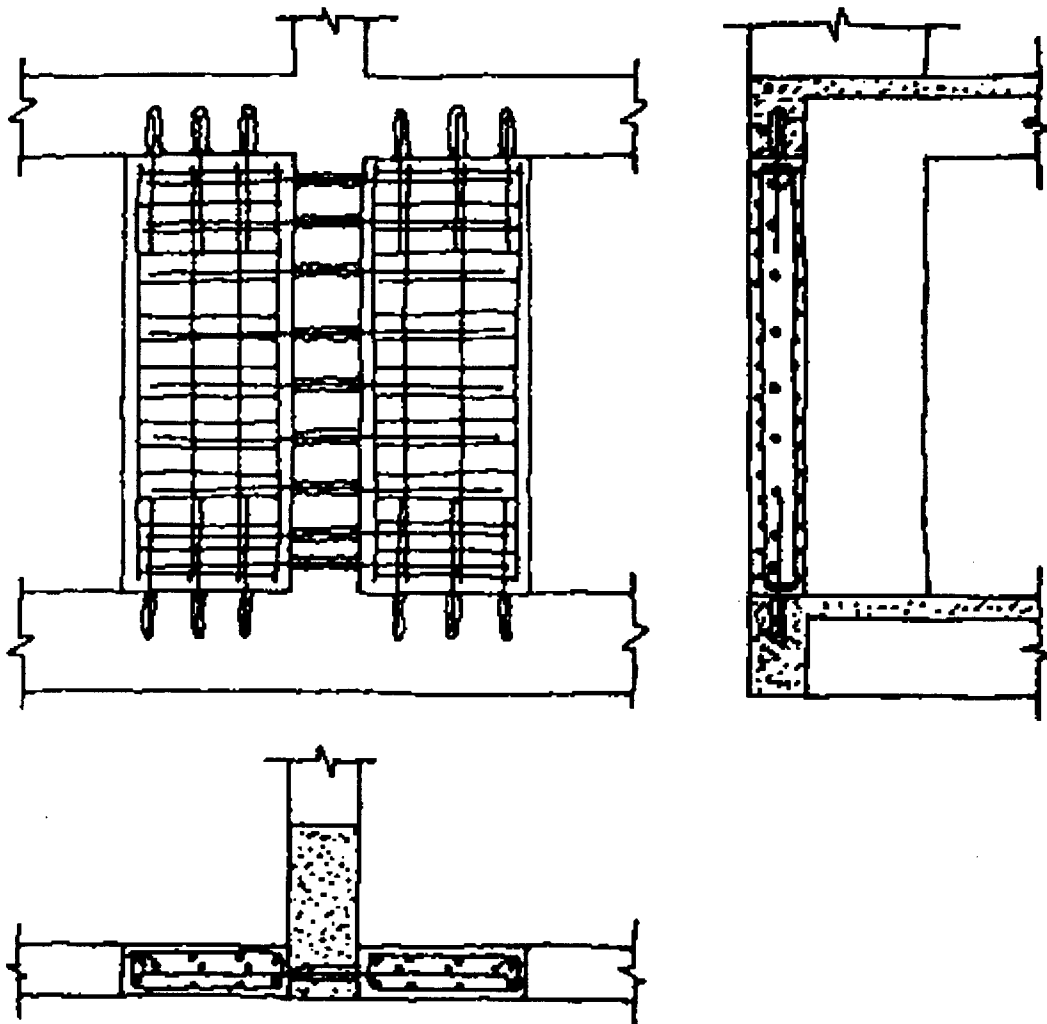
Although the detailed arrangement of reinforcement is not explicitly determined yet, it is strongly emphasized that the following general remarks should be carefully taken into account when this scheme is applied in practice.

1. Re-bars should be deformed bars. They would be placed through drilled holes in existing columns, and epoxy mortar should be injected into gaps around re-bars for smooth action transfer.
2. Longitudinal bars in wing walls should be properly confined with lateral reinforcement having 135 degree hooks. They should be jointed (lap splice joint) with anchoring bars embedded in upper and lower beams at the top and bottom of the wall. Bonded anchors (epoxy adhesive anchors) may be most preferable to connect anchoring bars with existing RC members. When honey-combs are found in existing members, repair them before installing anchors. It should be also noted that embedded length of anchors should be deeper than usual.
3. Quality of concrete for new wing walls should be carefully controlled.
